Sydney Metro Project Barangaroo Station UDHB1 'Barangaroo Boat'

Excavation Report VOLUME 2

Sydney Metro Project: Barangaroo Station

Excavation Report

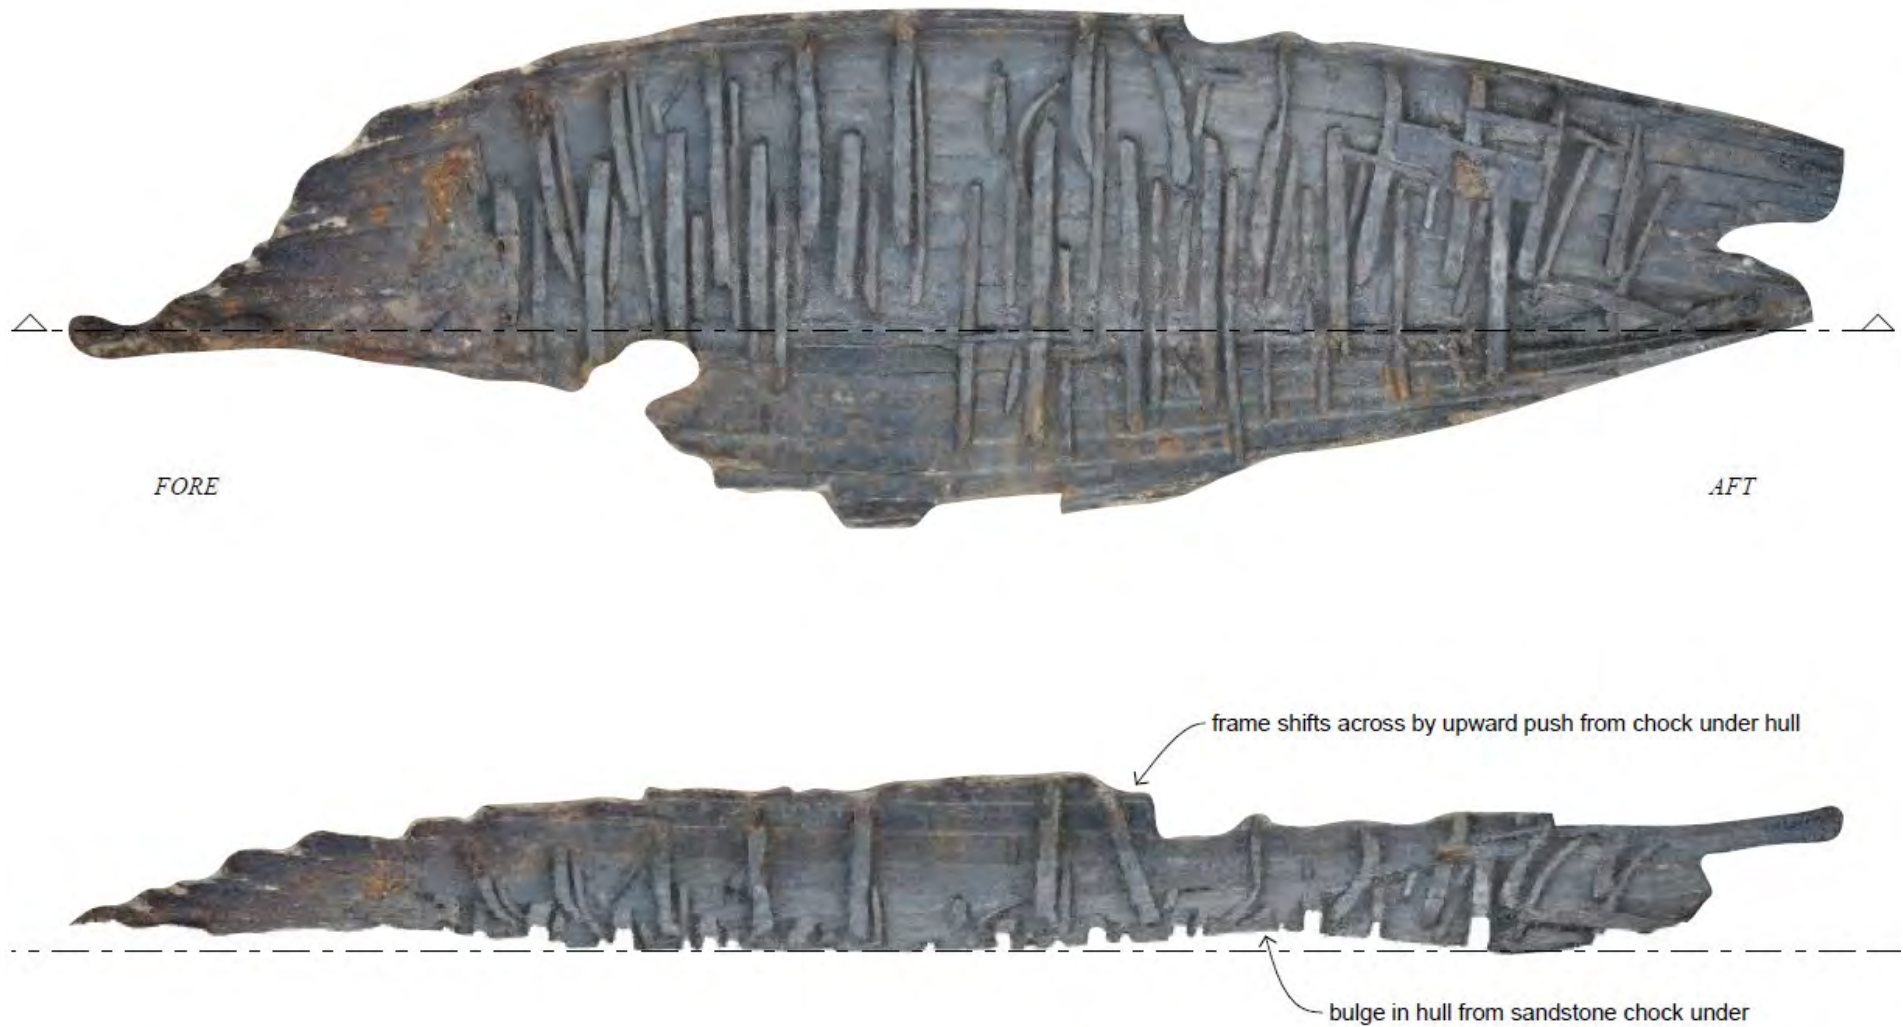
Figure 4.1: UDHB1 in situ plan and side elevation looking starboard. Side elevation cut through keel line shows the bulge from where the vessel rested on the sandstone chock and then slumped over, shifting frames and pulling planks out of the keel. (Source: Photogrammetry by Benjamin Wharton 2018).

The overall keel components combined measure 8.268 m (27' 1 1/2") in length. The remains include more than half of the boat and comprises the bottom of the hull on both port and starboard sides. On the starboard the vessel is preserved up to its topside hull, while the port side only extends out 2.45 m (7 1/2') from its keel to the turn of the bilge (this is basically the maximum breadth of the vessel, where its bottom transitions to its side). The stern is complete up to the tuck with no transom timbers remaining. At the bow, less than 300 mm remains of the stem and there is little hull planking that extends forward of the preserved keel (Figure 4.1). A breakdown of the timber elements of UDHB1 is shown in Table 4.

The condition of the planks, except for those extending to the bow, were in relatively good condition, with their integrity being maintained by the covering of pitch (see Section 4.10). The majority of damage to the individual lengths of planking have been either splits that have occurred along fastening lines or broken and deteriorated ends. The planking has distorted and sagged under strain when the vessel was rested over on its starboard side, and eventually filled with loose timber offcuts and infill. An example of this distortion can be seen where the garboard planks fit into the rabbet of the keel, and the sagging has altered the shape of the hull (see Figure 4.1).

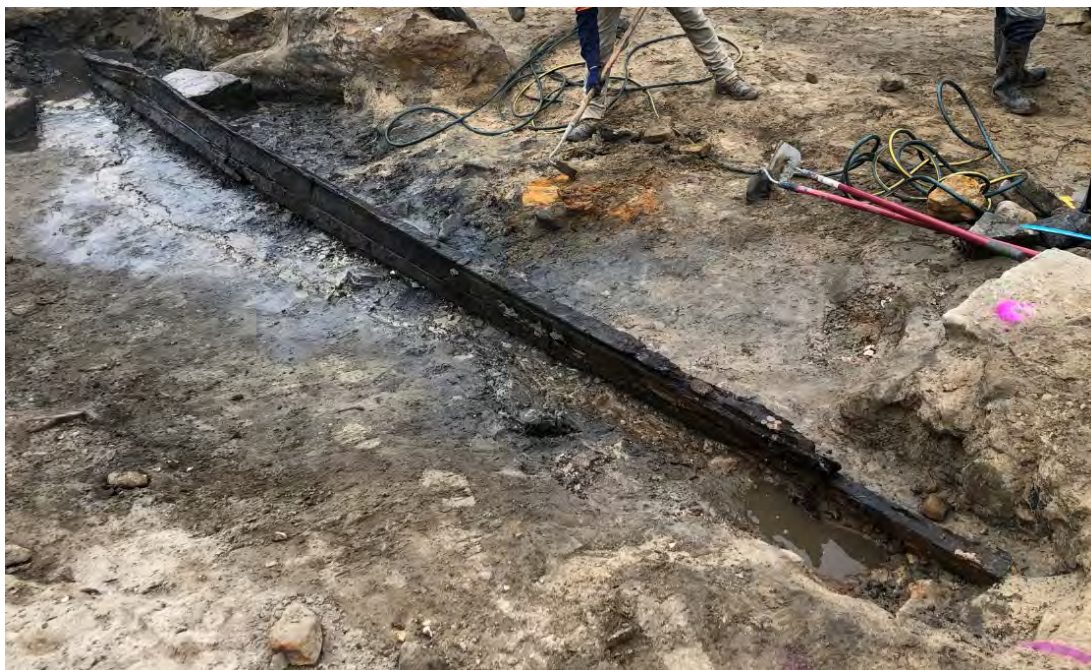
Figure 4.3: Keel [055] in situ remaining on top of rider keel lengths [550 & 551]. Aft to fore being left to right of image. (Source: Casey & Lowe).

The keel is the longitudinal centreline and backbone that supports the axillary structural members of the boat (Figure 4.3). The keel assembly in UDHB1 consists of four components to achieve a keel required for the double-planked hull. First is the primary keel which the sternpost, stern and stem knees, floor frames and inner layer of hull planking are fastened to. Second is a rider keel underneath the primary keel to add structural rigidity to the vessel, and to which the stem and apron are attached (Figure 4.4). Finally, the keel and rider keel are flanked on both sides with planks or boards which provide a shelf to support the second layer of hull planking and laterally brace the keels.

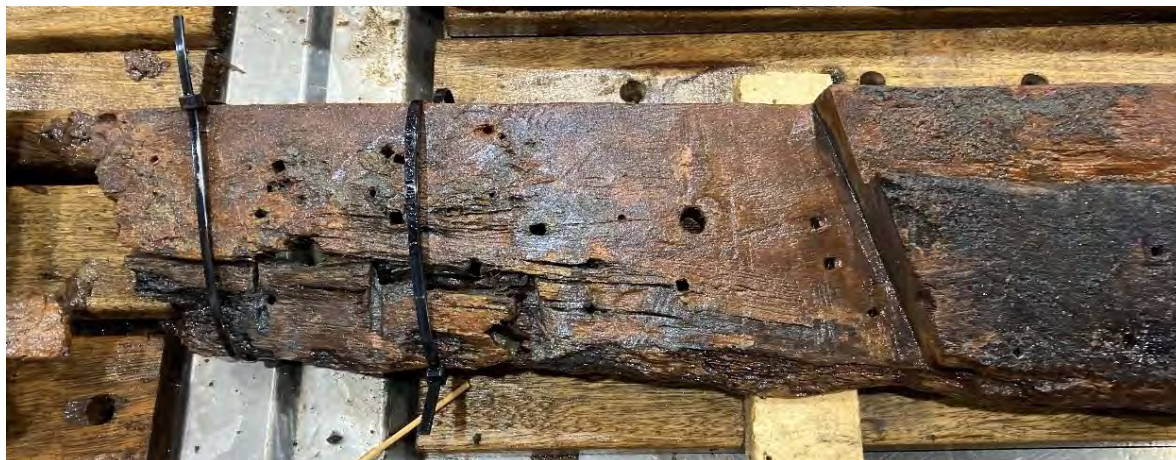
Figure 4.8: Keel [055] half-lap to sternpost. Note various fastener holes and tool marks.
(Source: Benjamin Wharton 2020).

There are fastening holes throughout the keel corresponding with the various attached components and will be discussed in more detail in their respective categories (Figure 4.8). There remains a vast array of different size fasteners evident, such as dump bolts or spikes from structural members including the sternpost, sternpost knee and floor timbers. There is

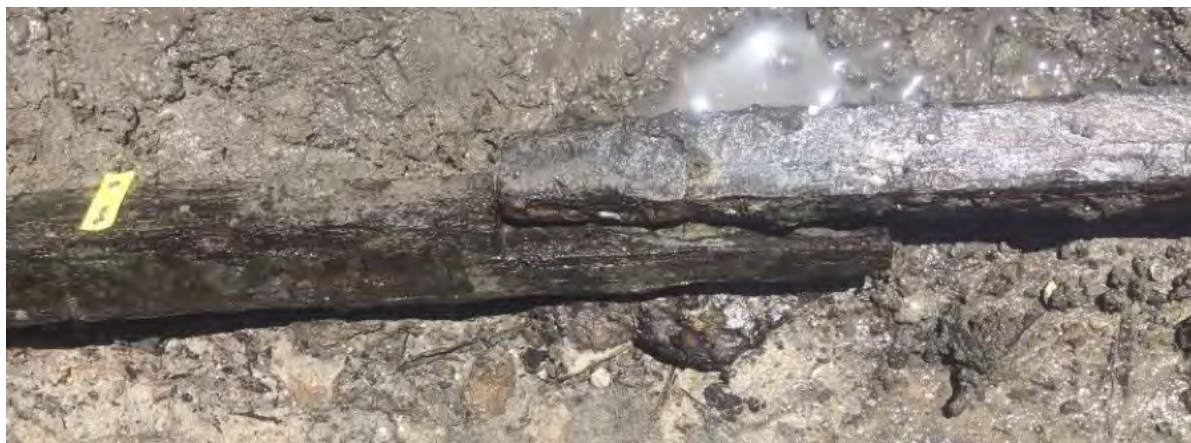
Figure 4.9: Scarf joint of rider keels in situ [550, 551]. (Source: AMBS).

The scarf joint in the rider keel is known as a flat scarf, and being horizontal as opposed to vertical, the diagonal face was cut nibbed perpendicular to the moulded faces (Figure 4.9). From the underside of rider keel [551] the first cut was 27 mm (1") in depth up into the timber, then a tapered horizontal cut tapering upwards for a horizontal length of 252 mm (9 7/8"), then nibbed off perpendicularly again leaving 41 mm (1 5/8") remaining depth at the end of the scarf. This end nib cut went into the keel timbers above it, as previously described. The afterward end rider keel [550] had a scarf to match into. At this point it is noticeable that the two rider keels differed slightly in their sided dimensions, with [550] being wider by only 6.35 mm (1/4") leaving 3 mm (1/8") protruding out either side.

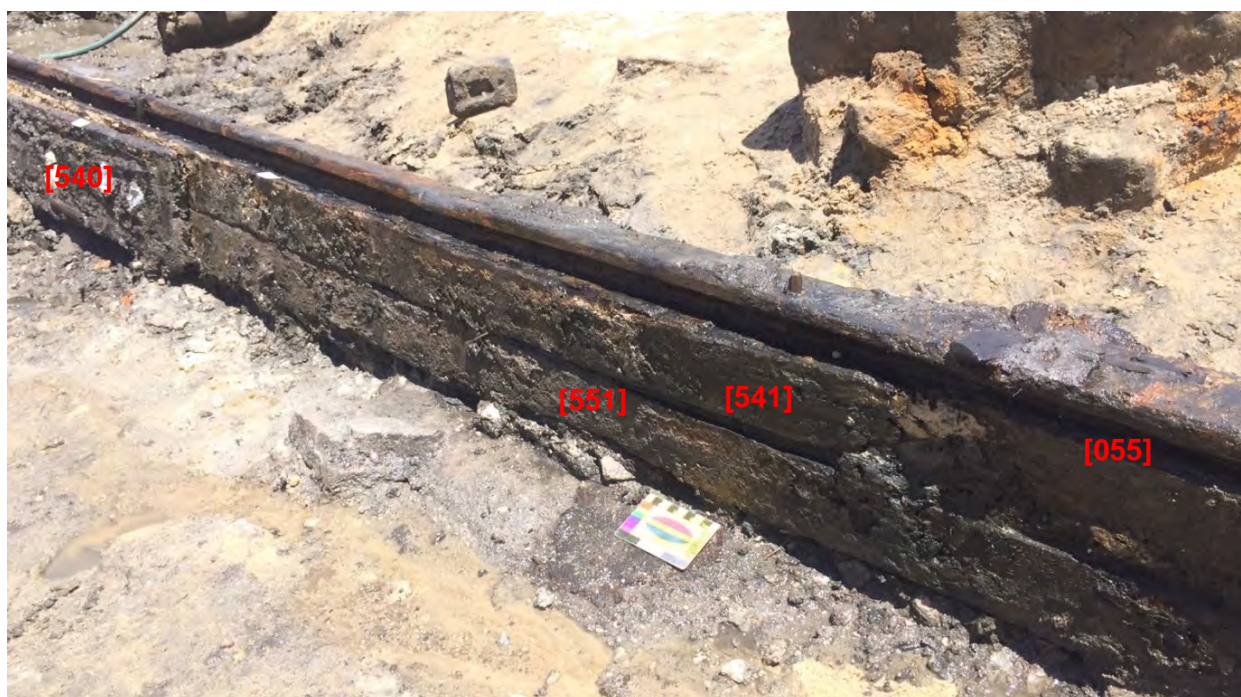
Figure 4.13: Starboard side of keel [055], rider keel [551] under, infill [541], and after-end outer garboard shelf plank [540]. (Source: AMBS).

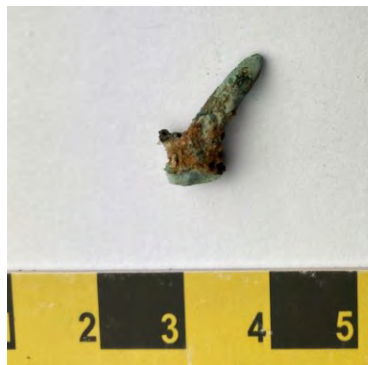
Figure 4.14: Copper alloy fastener from garboard shelf [539]. (Source: Benjamin Wharton 2020).

Sheathing tacks were also used on the garboard shelf boards at the foremost end at the bow where copper sheathing was tacked on. These are found on plank [547] for the portside, and plank [539] for starboard (Figure 4.14).

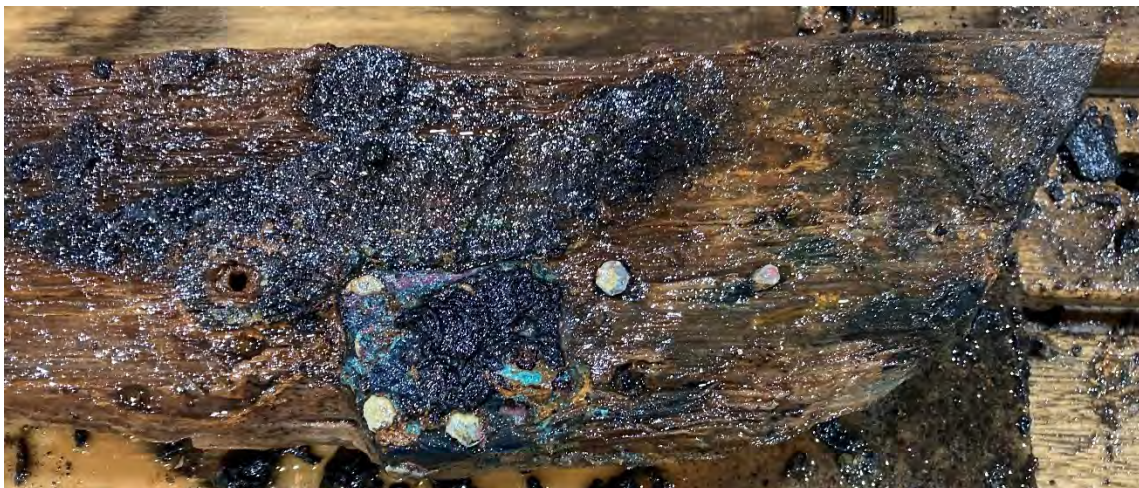
Figure 4.15: Plank [539] with copper sheathing and sheathing tacks intact. Rake and curvature of stem can be seen at the foremost end (right). (Source: Benjamin Wharton 2020).

Remains of copper sheathing was fastened to the forward end of plank [539] in the same manner as plank [547] on the rider keel [551] (Figure 4.15).

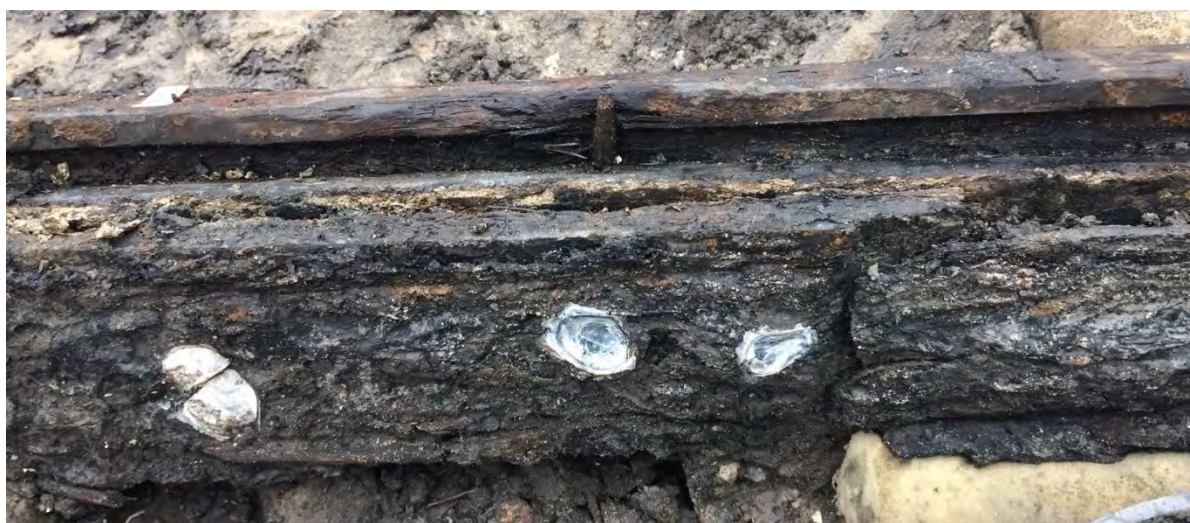
Figure 4.16: External surface of the starboard garboard shelf boards [539] and [540], view of starboard side. Showing scarf joint, heavy application of pitch, and the accumulation of shells. (Source: Benjamin Wharton 2018).

The outer surfaces of the garboard shelf boards, as the final external surface of the keel assembly, were heavily coated in pitch. Attached to the pitch were oyster shells which would have accumulated towards the end of the working life of the vessel, or when it was pulled ashore to its final resting spot (Figure 4.16).

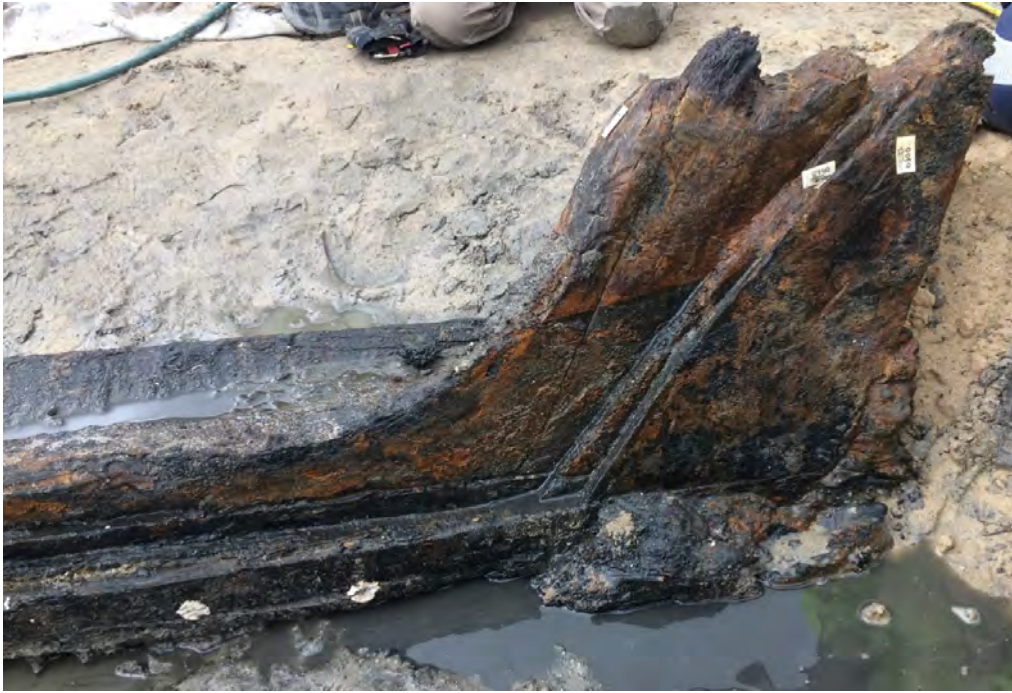
Figure 4.17: Stern assembly in situ prior to disassembly, portside. Visible are the keel [055], stern post [300], Stern knee (or sternson) [301], Outer garboard shelf stern section [465] and Outer garboard shelf [543]. (Source: AMBS).

The stern assembly extends the longitudinal structural centreline upwards from the keel to provide a structure that defines the shape of the stern of the hull and an attachment point for the aft end of the planking (Figure 4.17). The stern assembly of UDHB1 consists of firstly, the sternpost and the stern knee to provide the primary structural support. Secondly, a vertically tapered backing plate which was fastened to the aft-most face of the sternpost. Thirdly, rabbet cheeks were affixed to both port and starboard sides of the sternpost to accommodate the second layer of planking (Figure 4.18). There were no remains of the transom evident during the recovery of the vessel, however the profile of the planking and framing in this area can provide an indication as to the general shape.

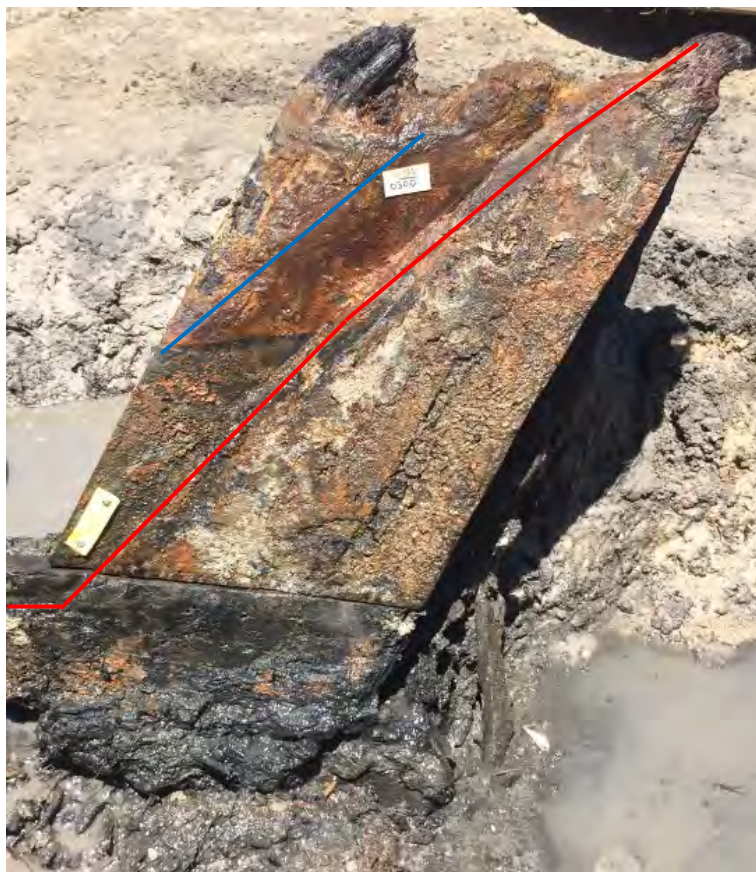
Figure 4.21: Sternpost [300] in situ attached to keel [055]. Rabbet line shown red; bearding line shown blue. (Source: AMBS).

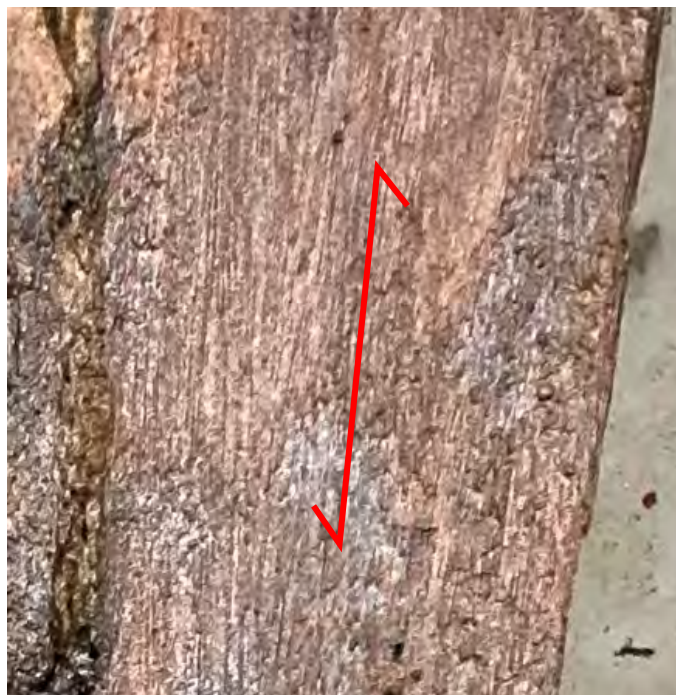
Figure 4.23: Sternpost grain orientation, port side. Aft edge on the right. Grain direction shown in red. (Source: Benjamin Wharton 2020).

A sample was taken of the sternpost and was identified as Southern Mahogany. The timber grain runs parallel along its length (Figure 4.23).

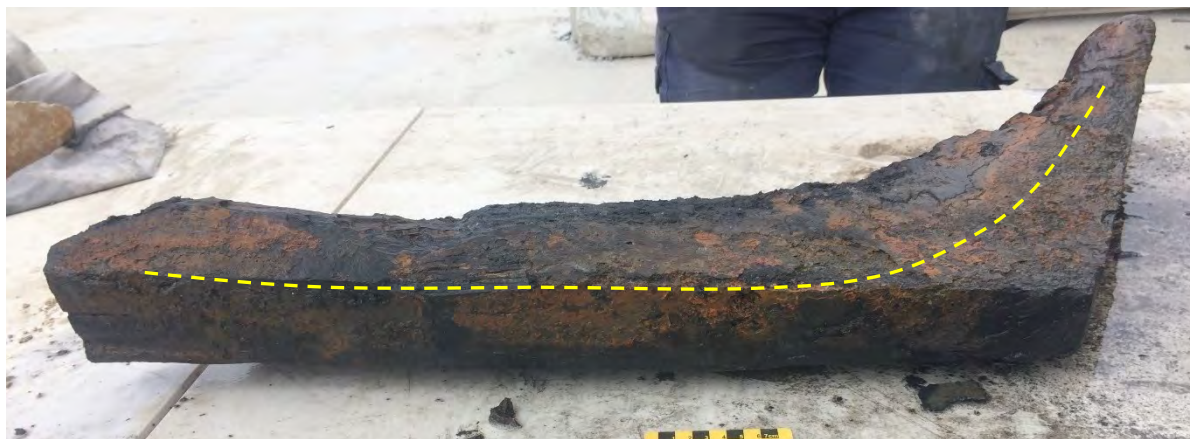
Figure 4.25: Underside face of stern knee that connects to the top face keel line. Note the taper in plain view reducing abaft. Also note the bearding line shown dashed which in cross section tapers also down from this line. (Source: AMBS).

The stern knee is 610 mm (2') long along the keel line and 455 mm (1¹/₂') along the inner face of the sternpost to below the tuck; a ratio of 1 to ³/₄ length to height. The moulded dimension starts as 103 mm (4") thick, and from the bearding line cuts in with an angled face the same as its respective adjoining keel and sternpost (Figure 4.25 and Figure 4.26).

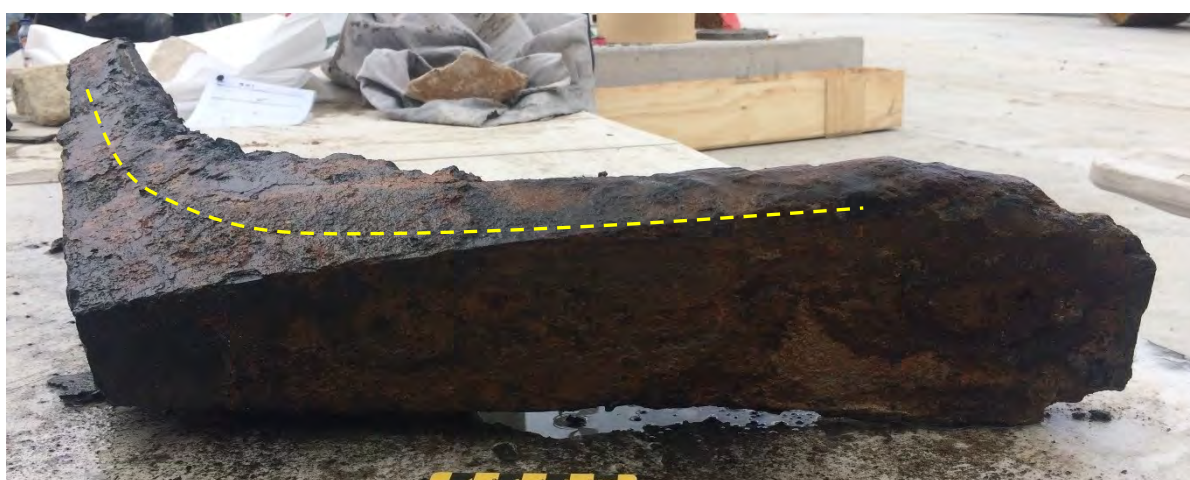
Figure 4.26: Aft-most face of the stern knee that connects to the sternpost. Note the taper from top to bottom, also from the bearding line (shown dotted) down too. (Source: AMBS).

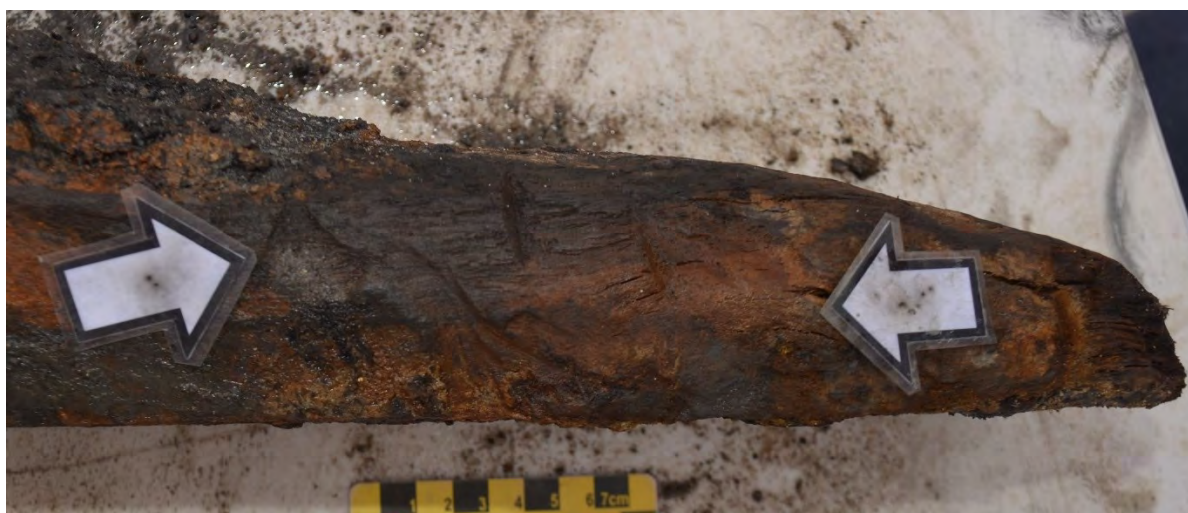
Figure 4.27: Tool marks on upper port side of stern knee [301]. Presumably from an adze or hand axe/hatchet. (Source: Casey & Lowe).

Distinct tool marks were noticed on the upper port side of the knee for cutting in from the bearding line (Figure 4.27).

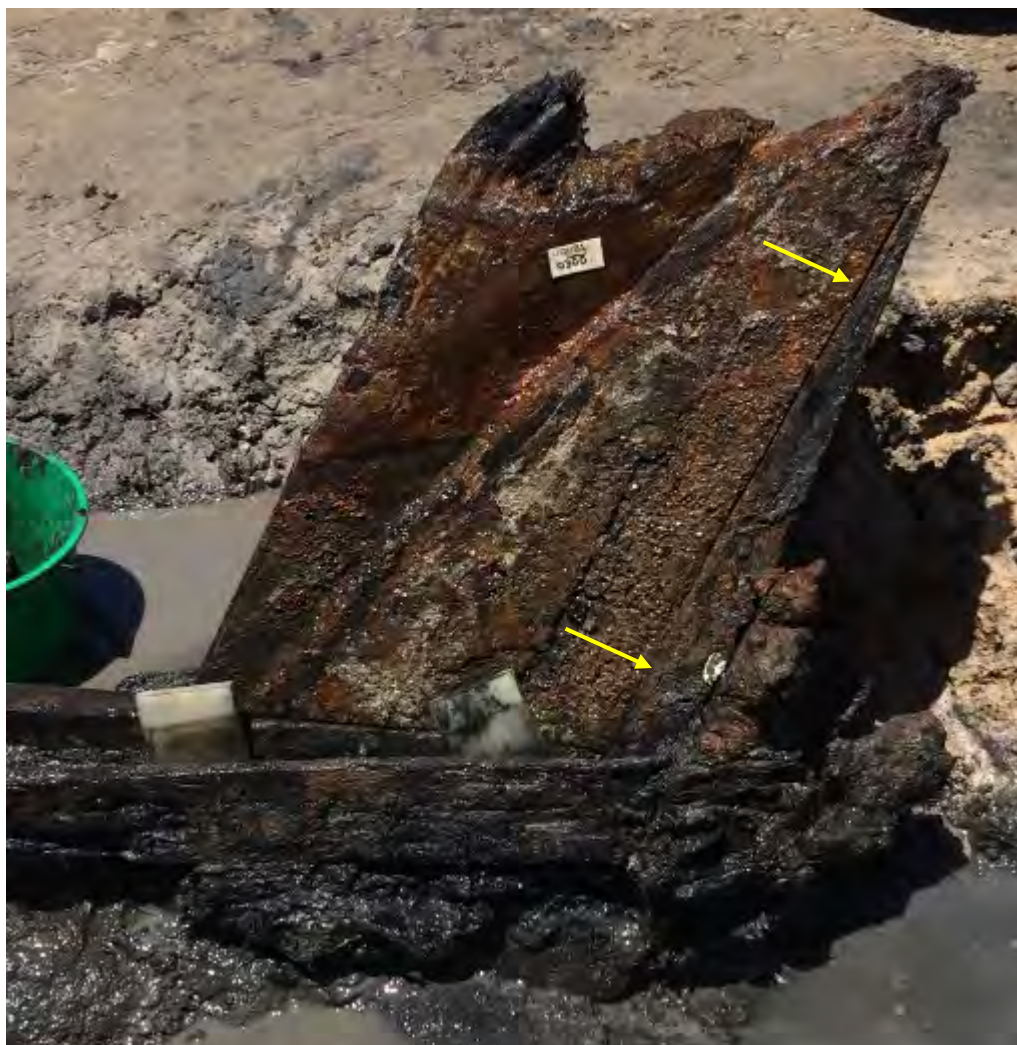
Figure 4.28: Backing plate [545] in situ prior to removal of garboard shelf [543].
(Source: AMBS).

The aft-most surface of the sternpost [300] was covered with a backing plate that extended down to also cover the aft-end of the primary keel [055] (Figure 4.28).

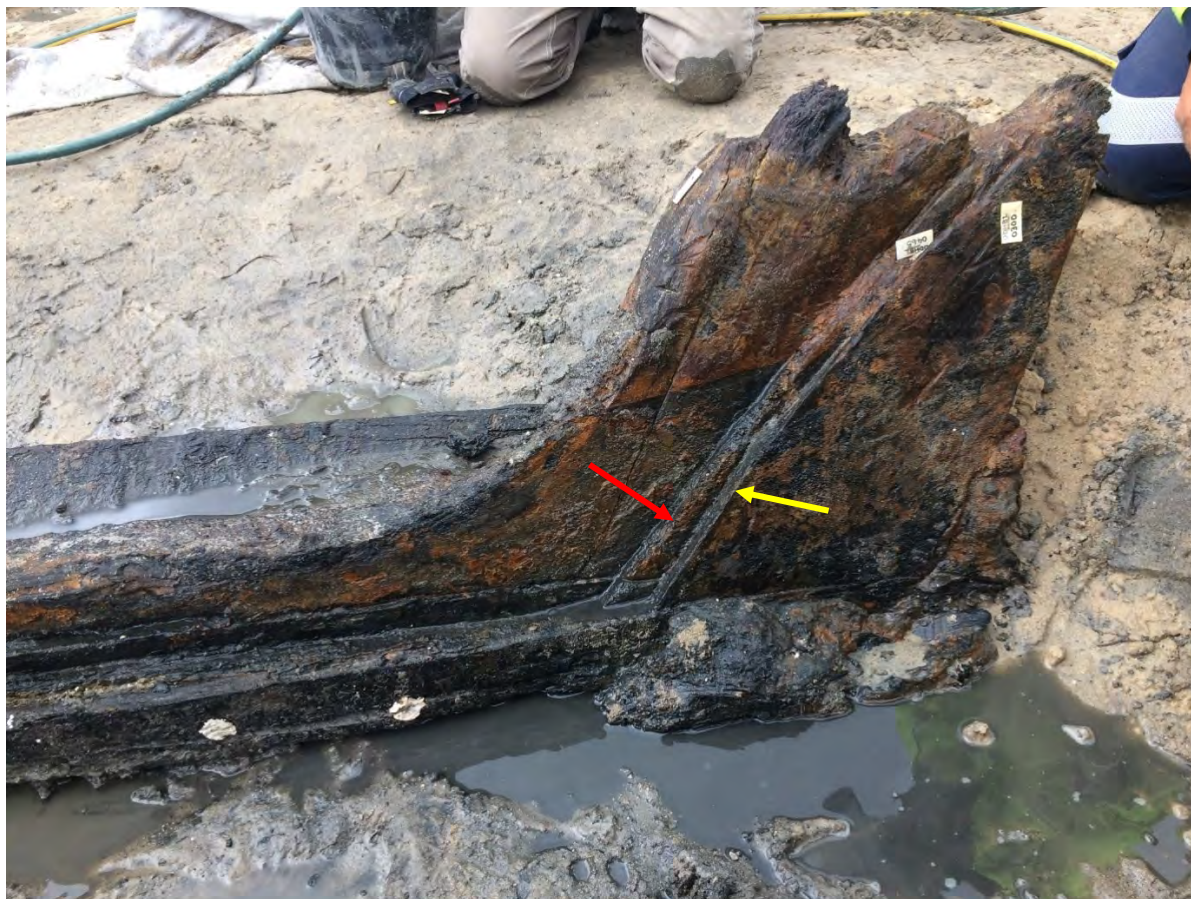
Figure 4.29: Port side image of rabbet shelf [465] in situ. The secondary rabbet line (yellow arrow) provided by the shelf panel abaft the primary rabbet line (red arrow). (Source: AMBS).

The secondary rabbet line that was added to the keel with the additional shelf pieces in the keel assembly had to continue at the stern also and so shelf panels were added on both sides of the sternpost. The shelf panels were triangular shaped timber pieces fastened to both port [465] and starboard [534] sides of the sternpost to provide the shelf for the second layer of hull planking to abut into (Figure 4.29).

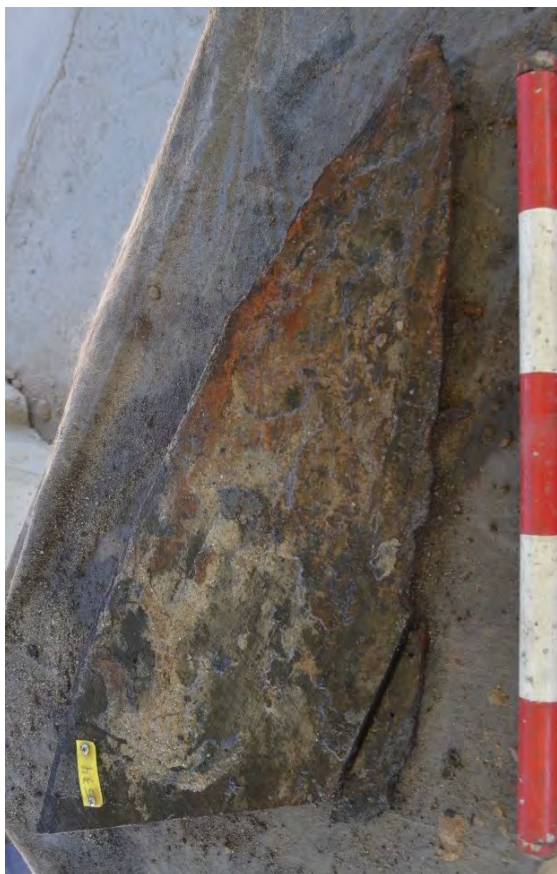
Figure 4.31: Internal side of starboard rabbet cheek panel [534]. Showing assembly white putty, nail holes. Scale is in 100 mm increments. (Source: Casey & Lowe).

The outer surfaces, more particularly for the starboard panel [534], were coated in pitch and shells. The internal faces, upon removal had a layer of the assembly white putty also found between planking layers (Figure 4.31 and Figure 4.32).

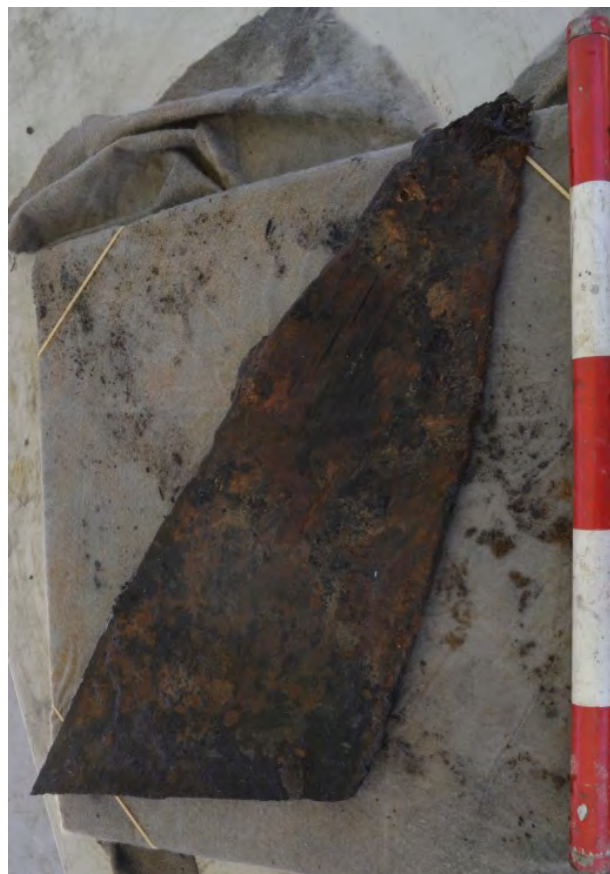
Figure 4.32: External side of starboard rabbet cheek panel [465]. Scale is in 100 mm increments. (Source: Casey & Lowe).

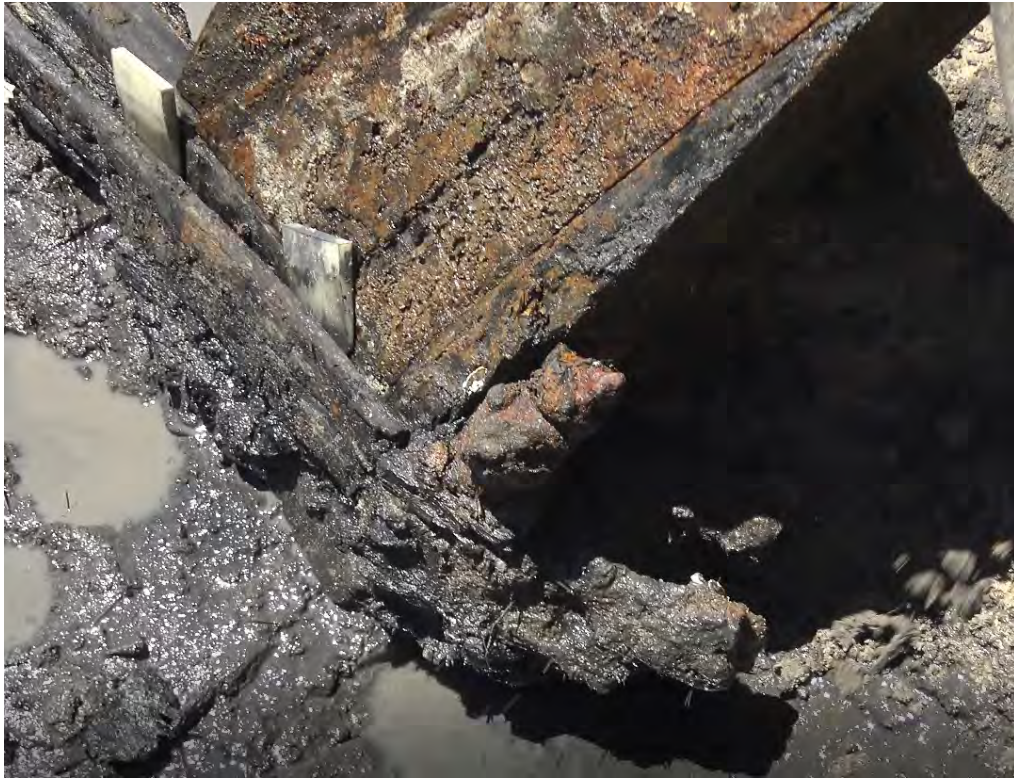
Figure 4.33: Gudgeon and pintle prior to removal. (Source: Casey & Lowe Recovery Video still, #150, 2018, 0:00:07).

There appears to be the remains of a gudgeon and pintle in the form of an iron concretion attached to the aft-most end of the portside garboard shelf boards [540] and [543] (Figure 4.33). Further conservation and cleaning of the artefact pieces will provide a clearer understanding of what exactly was removed. At the time of excavation, within the main concretion [544A] removed from the aft end of garboard shelf board [543], there was a ghost image or imprint of a rectangular section of strap being approximately 250 mm (10") long, with a cross section approximately 10 mm x 35 mm ($\frac{3}{8}$ " x $1\frac{3}{8}$ "). Two nail holes were also evident along this ghost impression (Figure 4.34 and Figure 4.35). Concreted to the end was what appeared to be 'U' shaped remains of the corresponding strap for the rudder, with a pin protruding upwards. The strapping for the rudder, although removed in one piece, broke before the recording and packing stage which resulted in the loss of the dimension of the rudder thickness. Conservation and reconstruction of these parts will be beneficial to a greater understanding of the details of the gudgeon, pintle and rudder components. Due to the fact that the pin was above the rudder strap, not below, it is presumed that the assembly consisted of the pintle being affixed to the stern of the vessel while the gudgeon held the rudder. With the placement of the pintle strap on the garboard shelf board the pin would have to be bent to the angle of the rake for the rudder to turn, or the strap could have been higher and affixed to the rabbet cheek panels and slipped down after the fasteners corroded (see Figure 4.36).

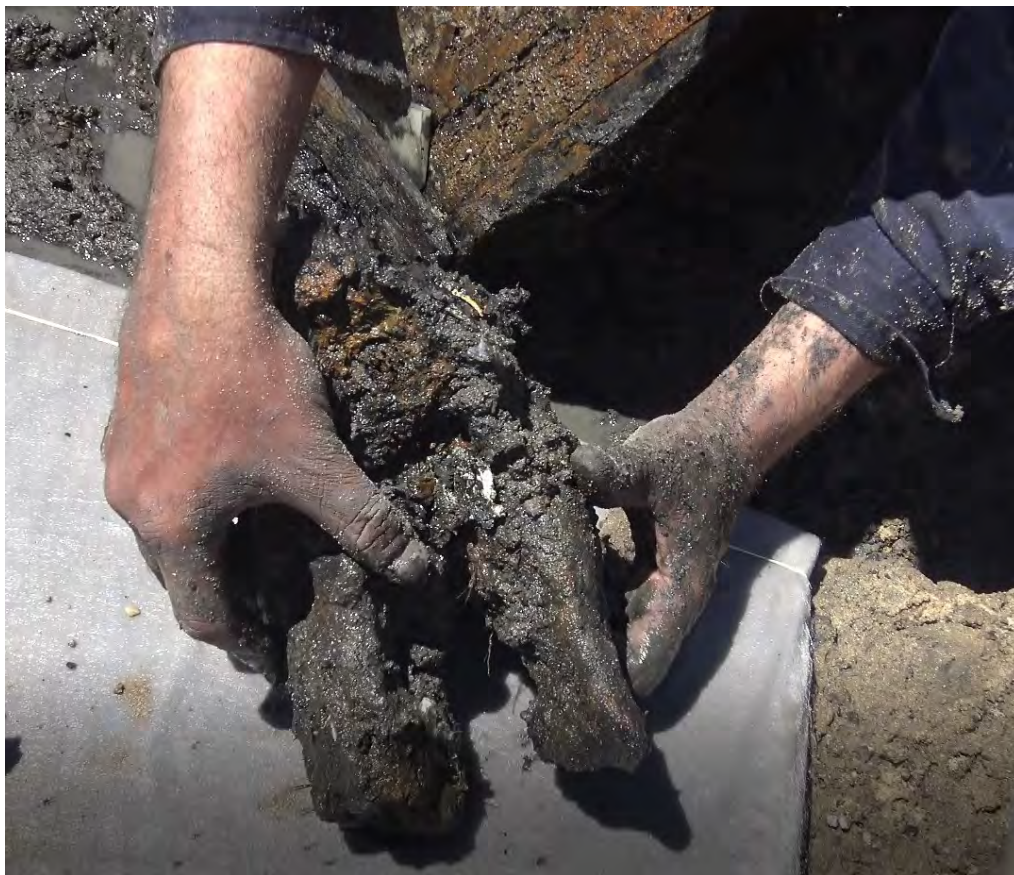
Figure 4.34: Rudder gudgeon strap at time of removal. (Source: Casey & Lowe Recovery Video still, #151, 2018, 0:00:54).

At the stern, on the after ends of planks [540] and [543] are long iron concretions presumably being or originating from the pintle strap (see Figure 4.34), which provide information regarding the use of a rudder on the vessel.

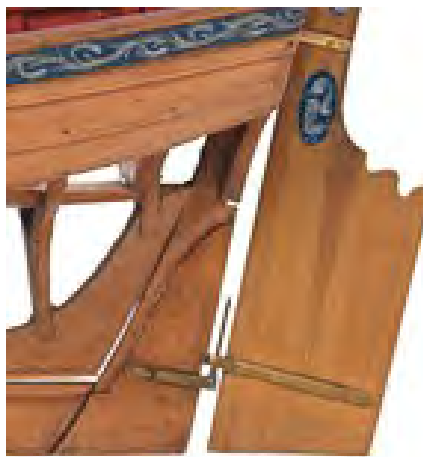
Figure 4.37: Gudgeon and pintle on model longboat.

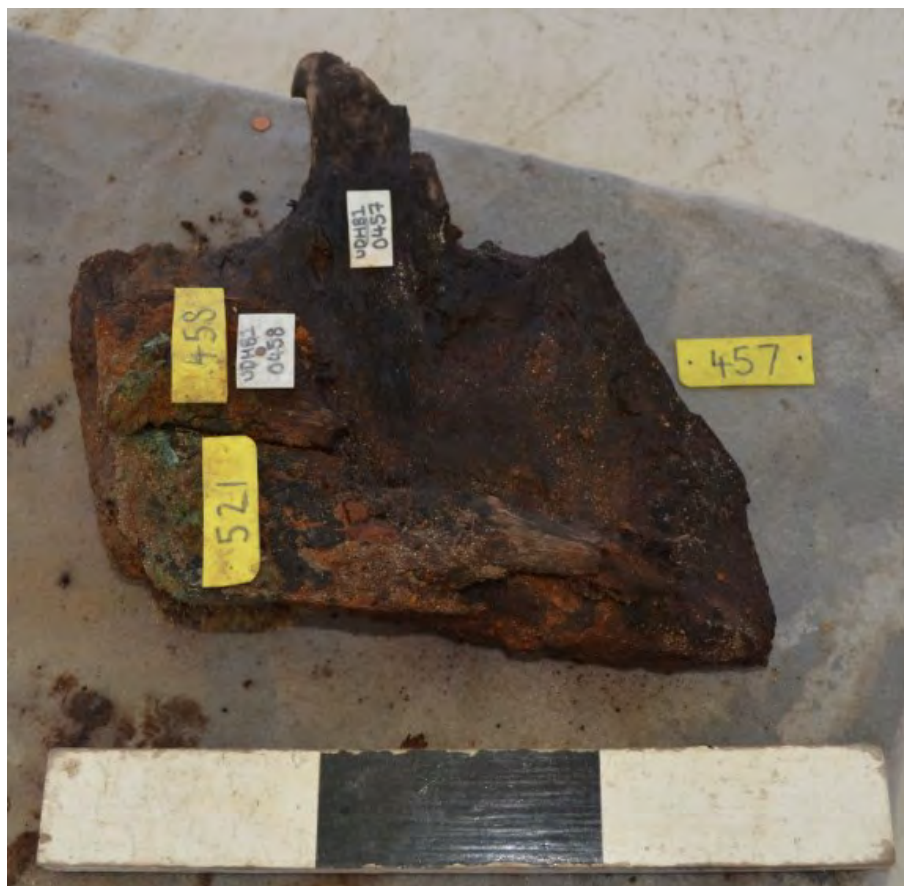
Figure 4.39: Stem [457] starboard side with garboard strake plank pieces [521] and [458] in place. Scale is in 100 mm increments. (Source: Casey & Lowe element recording photograph collection 2018).

Very little remains of the stem, however, what remains provides useful information to assist in understanding the form and construction of the vessel (Figure 4.39).

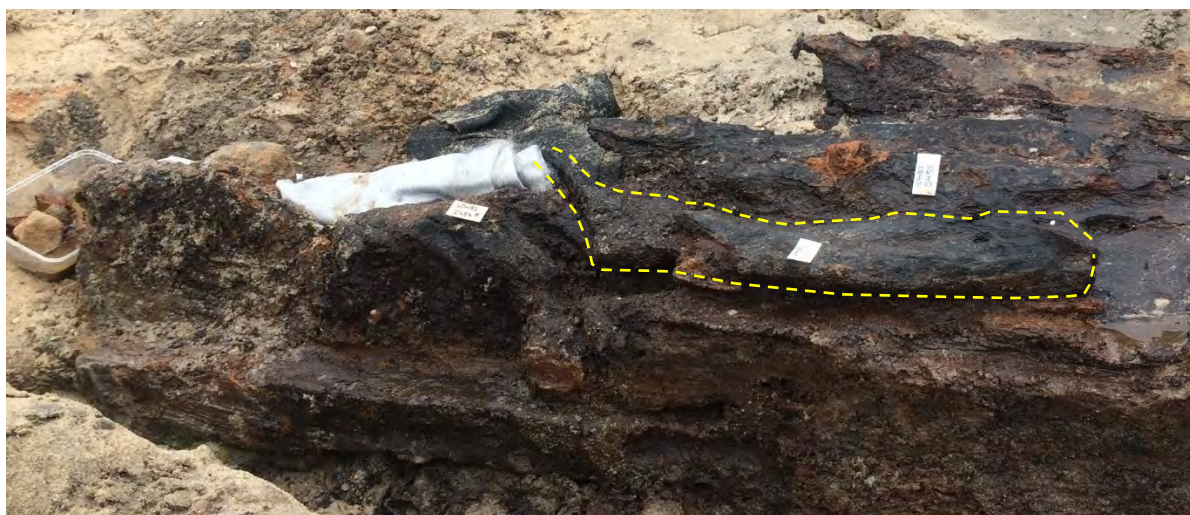
Figure 4.40: Stem knee in situ prior to removal. Note the stem is leaning over starboard side. (Source: AMBS).

The stem knee provided structural reinforcement and lateral support joining the keel and apron of the stem. The element [456] in the remains of wreck UDHB1 was positioned on top of the primary keel [055] and behind the stem and apron (Figure 4.40). There was a slight upturn in the remains, which together with its location, makes it likely this element is the stem knee. A small triangular ferrous plate was recorded as having been on the side of this element, presumably the starboard side.

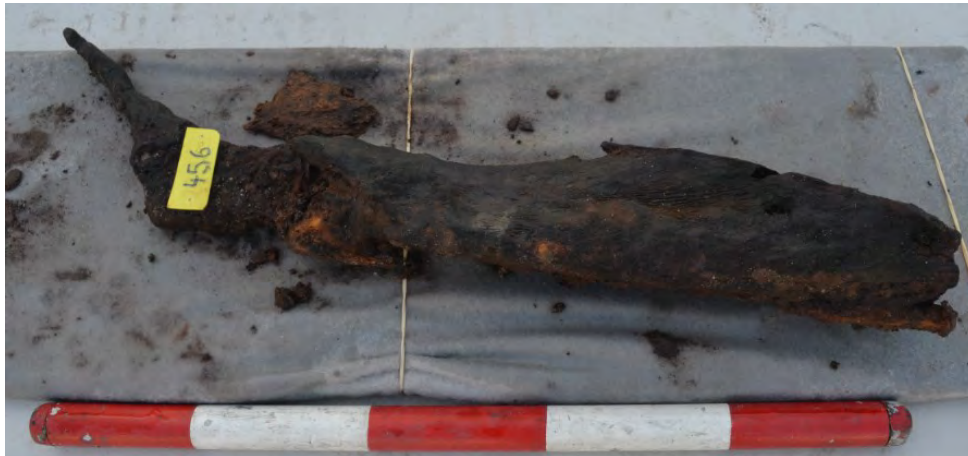
Figure 4.41: Stem knee [456]. Scale in 100 mm increments. (Source: Casey & Lowe).

Little remains of what was identified to most likely be the stem knee. Along with the rest of the bow end of the vessel, the remains were severely degraded and in poor condition (Figure 4.41 and Figure 4.42). What remains of the stem has broken into two pieces, about halfway.

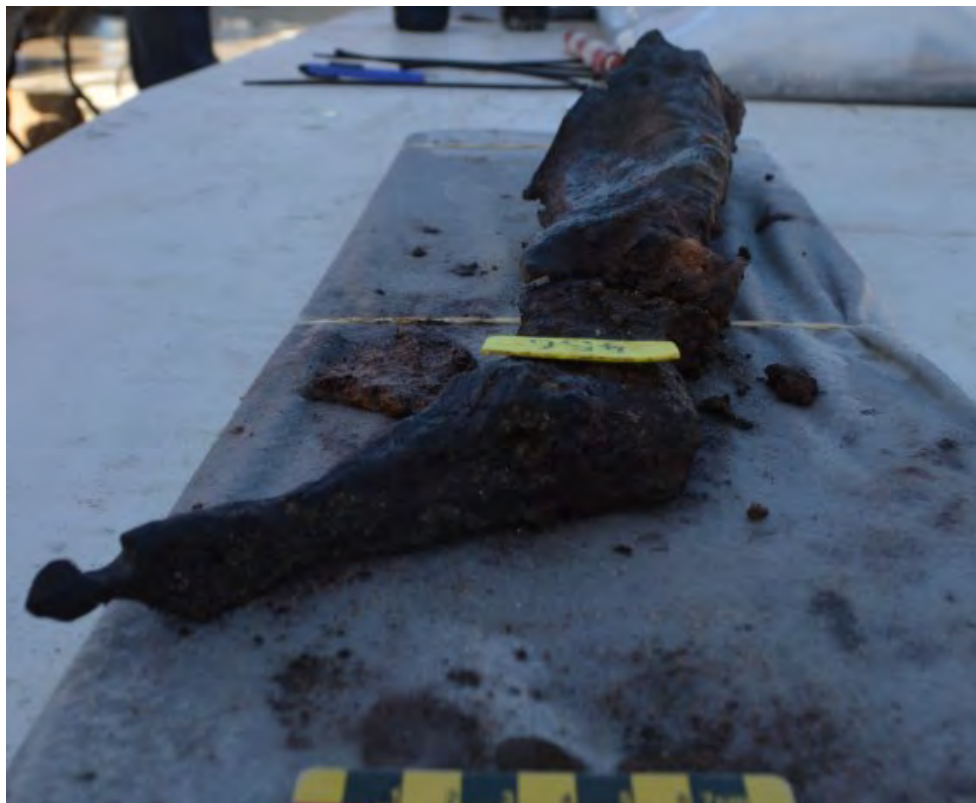
Figure 4.42: Stem knee [456] view aft from stem. Scale in 10 mm increments. (Source: Casey & Lowe).

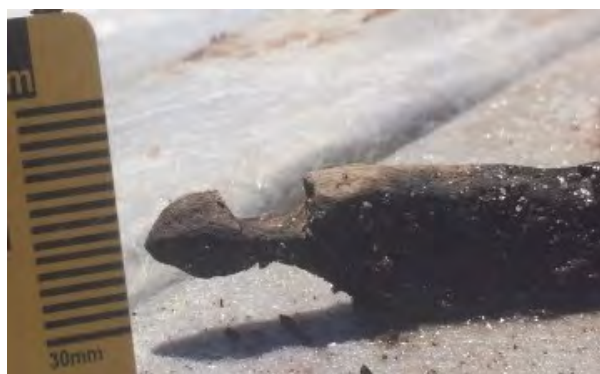
Figure 4.44: $\frac{3}{8}$ " treenail hole in stem knee [456]. Scale in 1 mm increments. (Source: AMBS).

Fastener holes were identified during the recording phase. There were two square holes, approximately 5-7 mm ($\frac{1}{4}$ ") in size in the sides of the knee, and a possible hole of a 9-10 mm ($\frac{3}{8}$ ") treenail at the broken end of the upturn which could have fastened the stem to the apron (Figure 4.44). The size of the fastening suggest it might have served as a substantial fastening, such as a dump bolt.

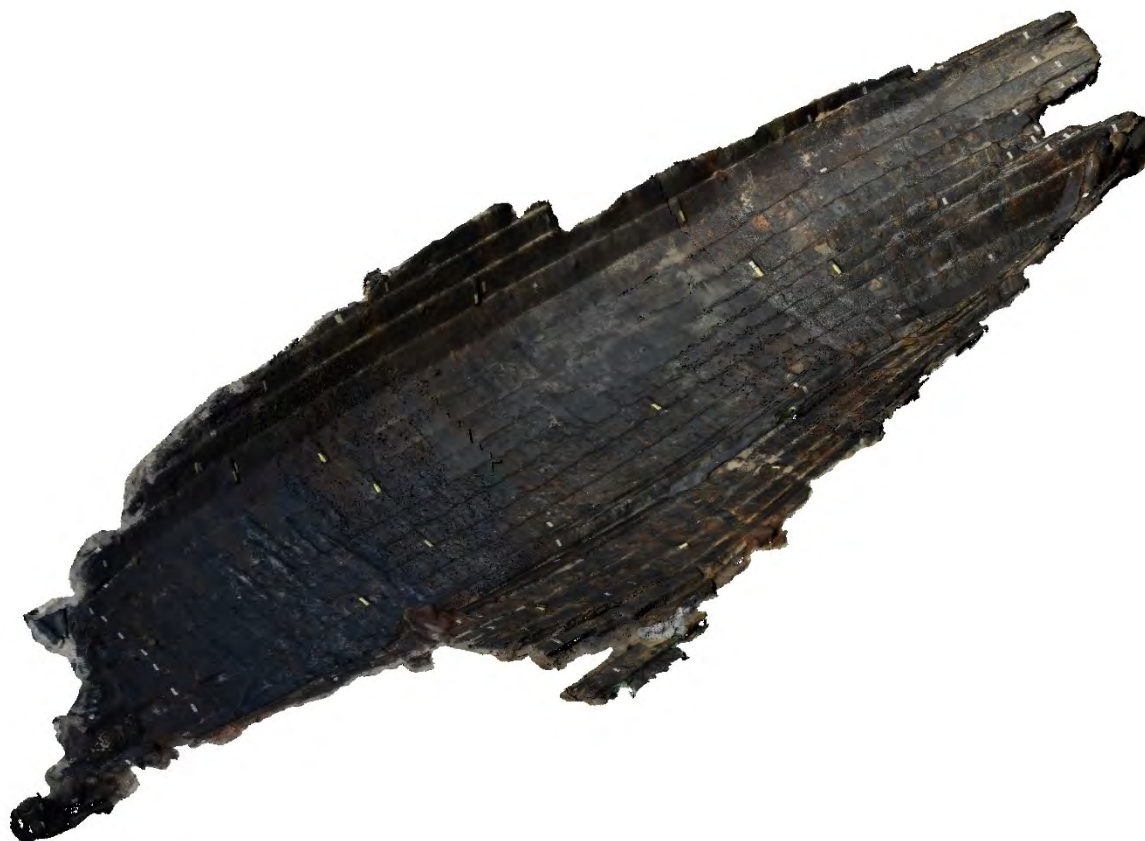
Figure 4.45: Isometric view of inner hull planking after frames removed. Chine visible between the eighth and ninth strakes being the intermediate bilge area between the bottom and topside strakes of the hull. Bow bottom left. (Source: photogrammetry recording and model by Guy Hazel 2018).

With regard to the hull shape, the planks from the garboard strake to the eighth strake form the bottom of the hull, then the ninth to the twelfth strakes formed the topside of the hull with possibly another two strakes that are missing. The bottom and topside planks were lapped with little to no bevelling, with only the strakes at the bilge using a bevel to change the hull shape leaving a visible single chine between the bottom and topside (Figure 4.45).
