Sydney Metro Project Barangaroo Station UDHB1 'Barangaroo Boat'

Excavation Report VOLUME 2

Sydney Metro Project: Barangaroo Station

Excavation Report

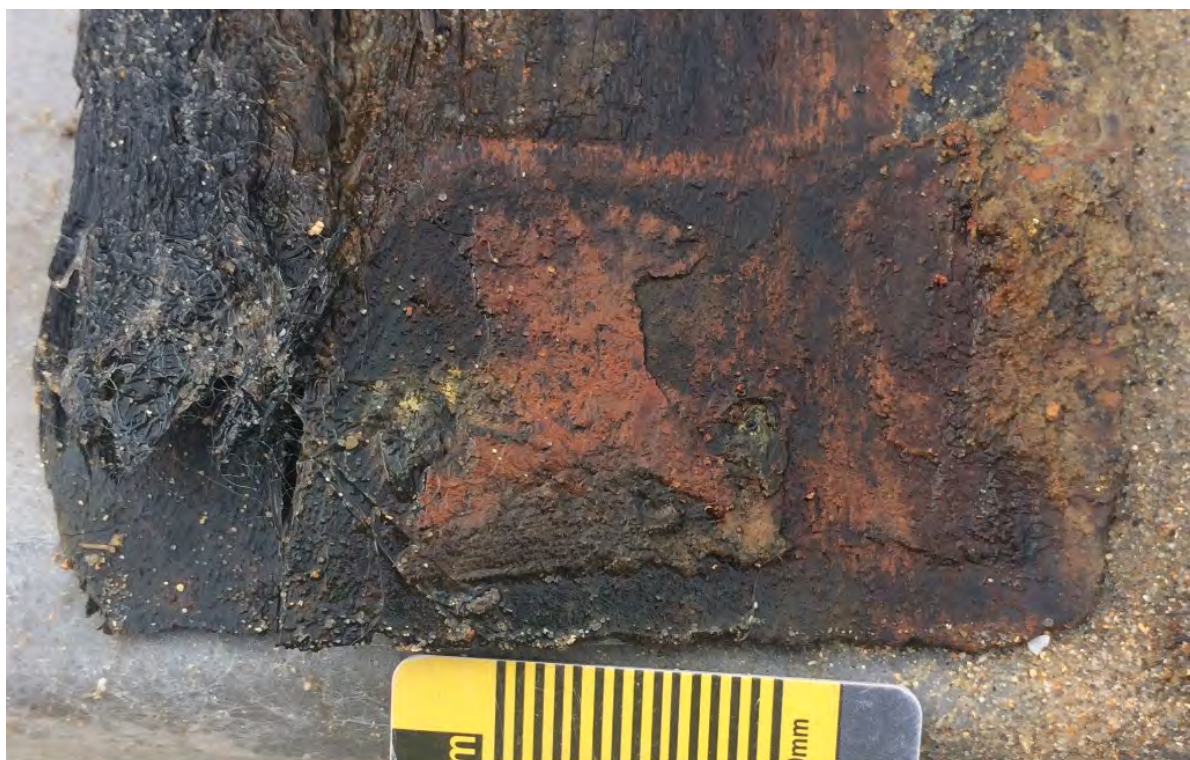
Figure 4.48: Scarf joint on aft end of portside plank [346]. The weave of the fabric can be seen under the film of iron staining. Scale in 1 mm increments. (Source: AMBS).

On the inner planking the scarf joints were sealed with a strip of fabric to provide a matrix for a sealant to adhere to both surfaces (Figure 4.48). It is unknown at this stage what type of fabric was used, nor what was used for the sealing mixture. Further research is required to analyse the type of fabric used and what constituted the sealant. Future research is also required to examine the outer plank scarfs more closely, in order to determine if fabric was also used on these.

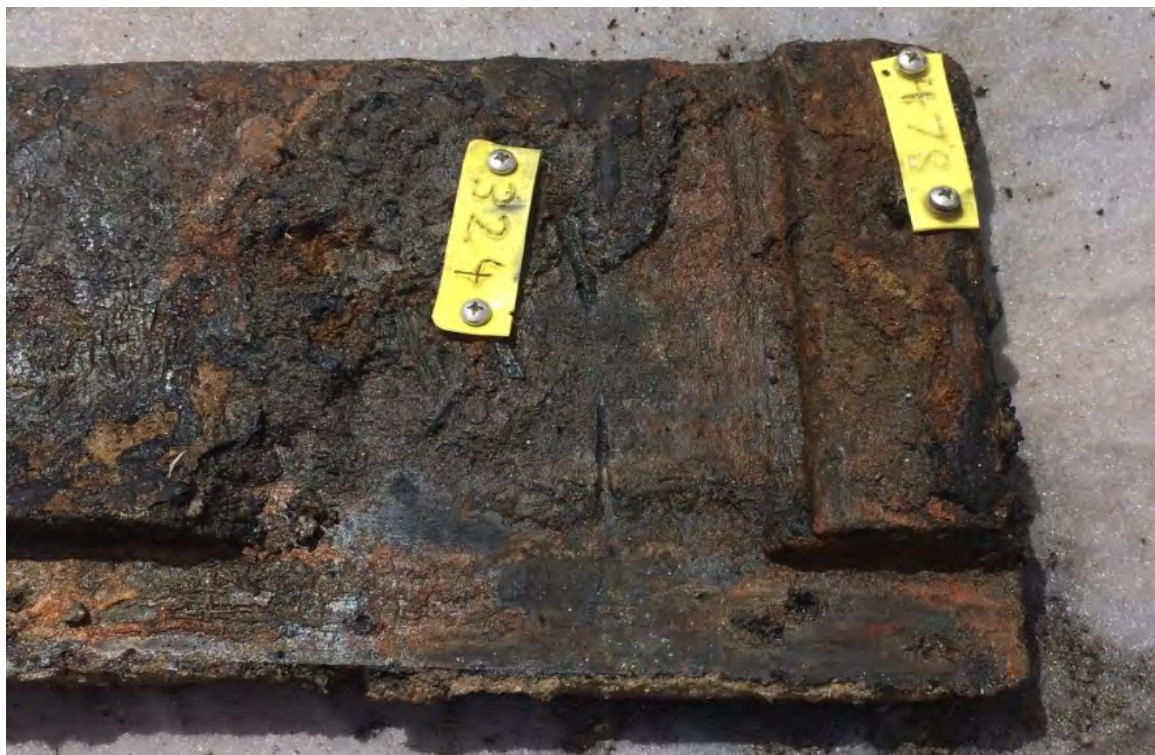
Figure 4.49: Scarf plate [478] in situ on plank [324 P-I-S3-A]. Note the length of scarf plate ends at land of overlapping plank. (Source: Casey & Lowe).

Twenty-six scarf joints were identified in the remains of the inner planking. Sixteen of these were reinforced with a scarf plate, and the remaining ten were either covered with frames at the joint, or if now exposed may have originally been covered (Figure 4.49).

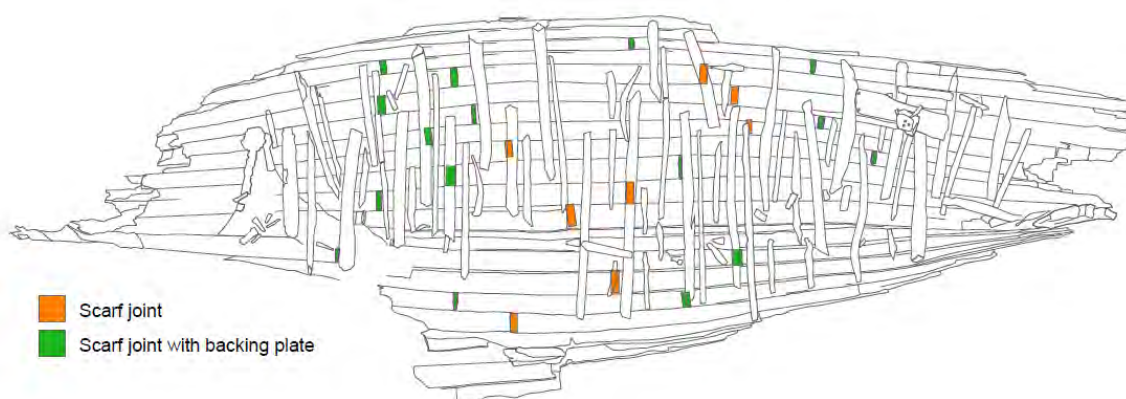
Figure 4.50: Scarf joint layout. Diagram shows placement of frames over scarf joints, and scarf joints with scarf plates. (Source: Benjamin Wharton 2020 using Casey & Lowe base plans: Plan_16.W5 and Plan_16.W6).

In some cases, as shown in Figure 4.50 and Table 7, the frames were located where a scarf plate was, and the frame was simply joggled to fit over the top. It has been suggested that scarf plate [348] over plank 518 may have been a thwart shelf.

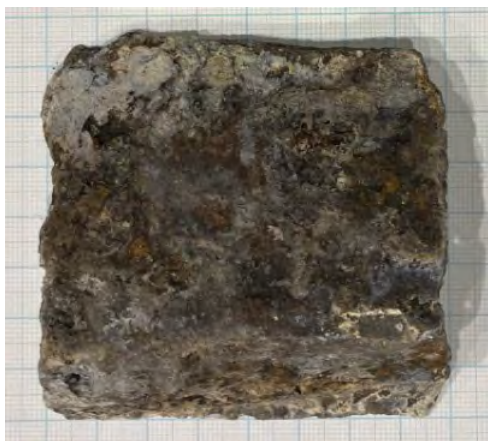
Figure 4.51: Tingle [515] external view.
Smallest box on graph paper = 1 mm. (Source: Benjamin Wharton 2020).

Tingle [515] was not recovered from the vessel directly; it was located in the soil deposit near the bow on the starboard side. It was made of lead and measured approximately 80 x 75 mm (3¹/₄" x 2¹⁵/₁₆"") with a step of 22 - 25 mm (1³/₁₆"-1"), and 1.5 – 2 mm thick. At the time of recording only one fastener hole was visible, and measured 3 mm (1/8") diameter (Figure 4.51 to Figure 4.52).

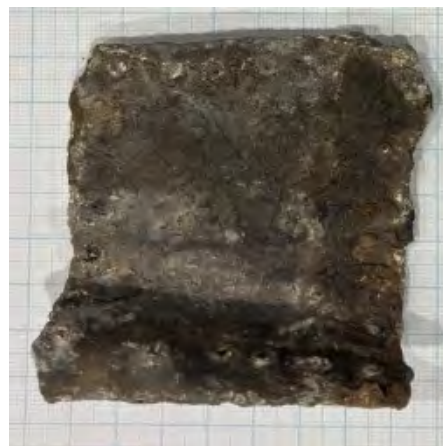
Figure 4.52: Tingle [515] internal view.
Smallest box on graph paper = 1 mm. (Source: Benjamin Wharton 2020).

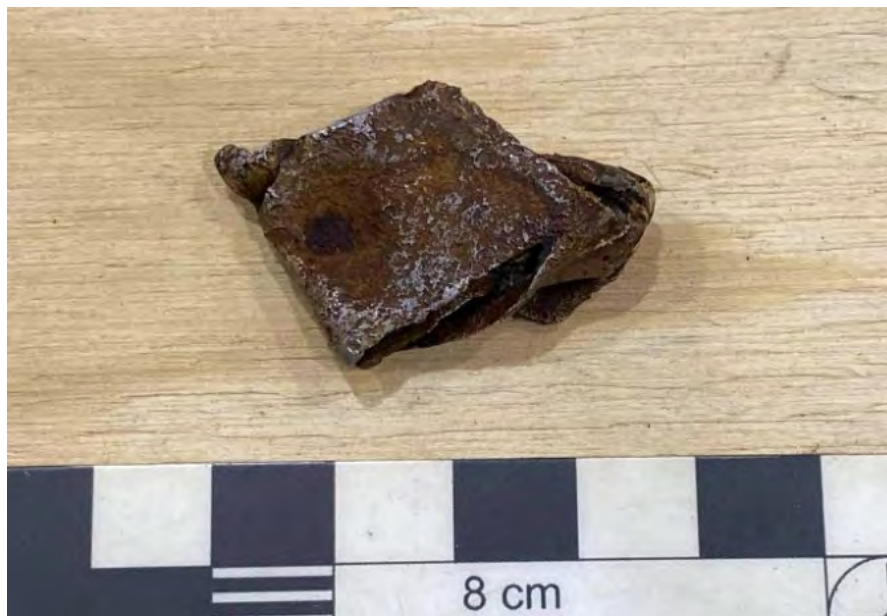
Figure 4.56: Lead square [601] from unknown timber located in tanks during cleaning and conservation phase. Reverse side has pitch coating on it. (Source: Silentworld Foundation 2021).

The fourth tingle was located as a separate item during the cleaning phase and it is not known what timber it was attached to. It is possibly also made from lead, though it is iron stained. It is approximately 200 mm ($7\frac{7}{8}$ "") long and 55 mm ($2\frac{3}{16}$ "") wide. The angle may provide a clue as to the strake from which it came (Figure 4.56).

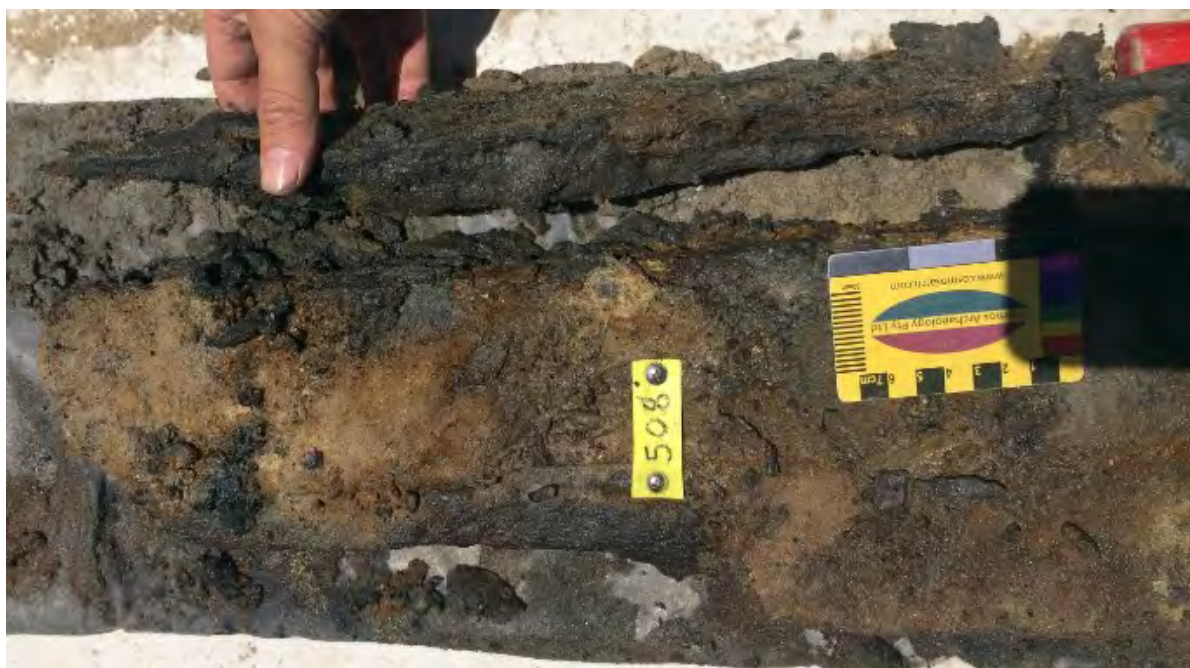
Figure 4.58: Plank [508 P-O-S5-M] 'Dutchman' repair. (Source: AMBS).

The other repair noticed during the recovery disassembly stage was a filler piece, or a 'Dutchman' repair. The bottom edge of plank [508 P-O-S5-M] of the fifth strake, midships port side, had a section that had been attached with fasteners driven in from the edge (Figure 4.57 and Figure 4.58). This sort of repair does not necessarily have to be a repair from damage during working life, but could simply be added to a plank, or could fix a break during the working of shaping or fitting the plank during construction. The plank [345 P-O-S5-A] of the same strake scarfed to [508 P-O-S5-M], also had this infill repair on the same edge, however, the infill piece was missing and only the caulking material remained (see Section 1.9.1.3).

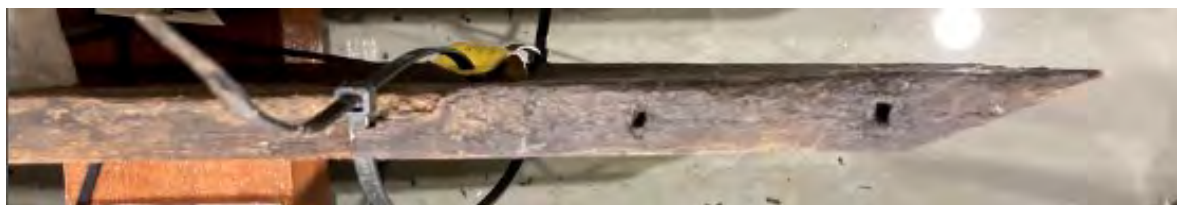
Figure 4.59: Starboard plank [338 S-I-S10-M] with 2 x $\frac{1}{4}$ " square nail holes on top edge.
(Source: Benjamin Wharton 2020).

Another plank [338 S-I-S10-M], on the aft end of strake 10 on the starboard side, had evidence of what at first appeared to be a Dutchman repair with two square 5-7 mm ($\frac{1}{4}$ ") nail holes on its top edge (Figure 4.59). However, when analysed more closely, the nail holes should have continued along the length of the edge face to a shoulder for this type of repair, which it does not. Also, the edge of the land on the outer face continues evenly suggesting this was the top edge of the plank with no damage. It is possible that these two nail holes, given they are high in the strake order, would perhaps be for fastening something inside the hull such as support for a stringer or rising or shelf.

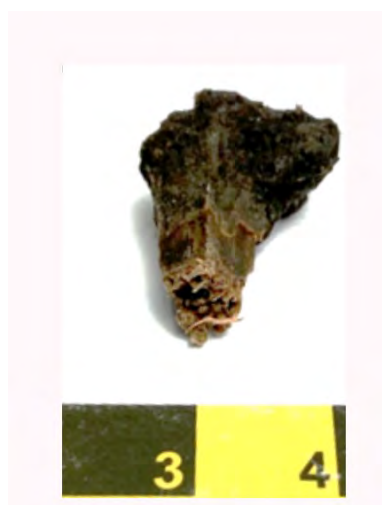
Figure 4.60: Treenail in plank [495 S-I-S2-F].
(Source: Benjamin Wharton 2020).

Another repair that was identified on the vessel planking was the use of wooden treenails to replace missing or perished old iron nails. These were recognisable as treenails that were square shanked and tapered the same as a hand-forged iron nail. The example shown below was extracted from the scarf of plank [495 S-I-S2-F] during the cleaning and conservation phase (Figure 4.60).

In the planking there were two recognisable types of treenail fasteners: one being round-shanked and the other square-shanked. It is likely that the smaller square-shanked treenails in the planking are repairs to replace failed iron nails, with the square shanks to match the existing hole made by the iron nail (see Figure 4.60). Figure 4.76 and Figure 4.77 are examples of square shanked treenails *in situ*.

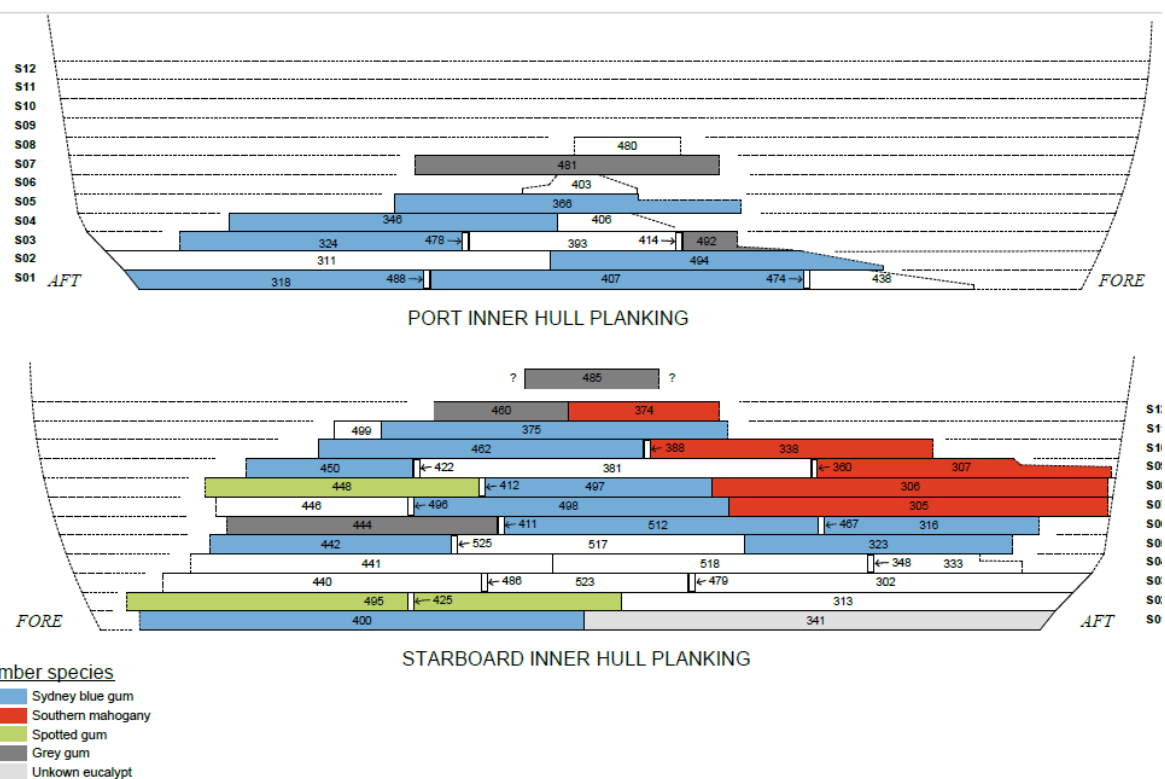
Figure 4.62: Inner planking layout. Showing element numbers, timber species, and scarf plate. (Source: Benjamin Wharton 2021).

Timber samples were taken from various parts of planking, such as the ends of breaks, so as not to ruin the integrity of a plank (Figure 4.61 to Figure 4.64).

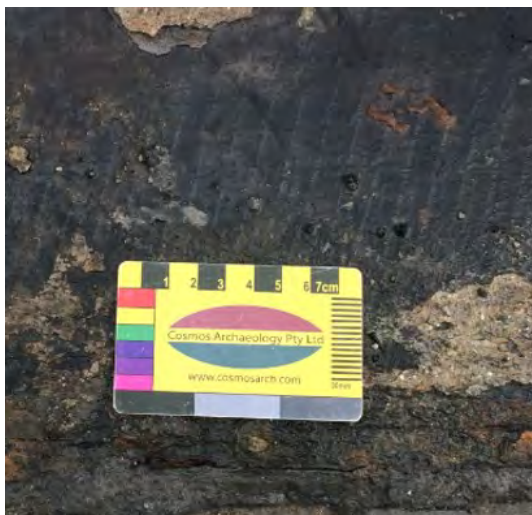
Figure 4.65: Pitsaw marks on plank [529] S-O-S2-A. (Source: AMBS).

The planking shows signs of saw marks that appear to have been pit sawn, either with an open blade pit saw, or a frame pit saw (Figure 4.65 and Figure 4.66).

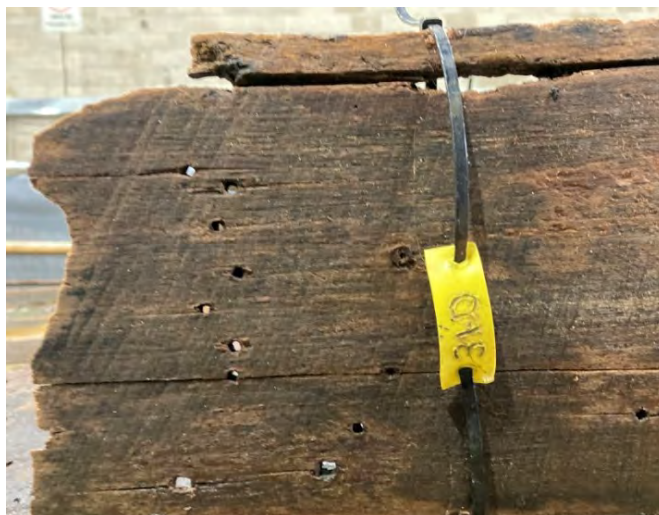
Figure 4.66: Pitsaw marks on plank [310] P-O-S2-A. Some cut lines with a pit saw sometimes appear curved from when sawyers changed stance or grip. (Source: Benjamin Wharton 2020).

While the majority of pit-saw marks are relatively uniform, there are examples with anomalies, such as curved marks. These curved marks were found on planks that also had a majority of pit saw marks (see Section 5.6 for further discussion). These are usually either made from the non-cutting free upstroke of the tiller man, or 'top dog', or are evidence of a difficult section of the timber to cut through, either the timber itself, or the positions and stances of the sawyers changing and shifting to a better position.

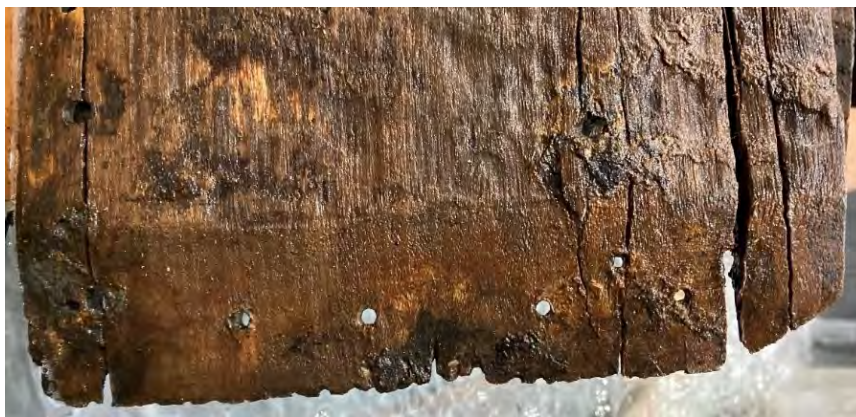
Figure 4.67: Scarf showing perpendicular grain having been quarter sawn [498 SI-S7-M]. (Source: Benjamin Wharton 2021).

While not every plank will be able to be analysed for its cut from within the log, the grain should be seen more clearly after the cleaning and conservation phase. All of the planks where grain was visible, showed characteristics of having been quarter sawn, except one. Quarter sawn timber is required for its integrity to hold a shape without cupping or warping where the rings of grain attempt to straighten out after being cut. The stability and straight running grain of quarter sawn timber is required when forming the wood into shape by purposeful bending and twisting achieved through steam, heat or a period of submergence in water (Figure 4.67). The one timber which was recognised as plain sawn [517 S-I-S5-M] was positioned midships, meaning that it wasn't required to be bent and strained too much, allowing this plain sawn cut of timber to be suitable for this area of hull (Figure 4.68).

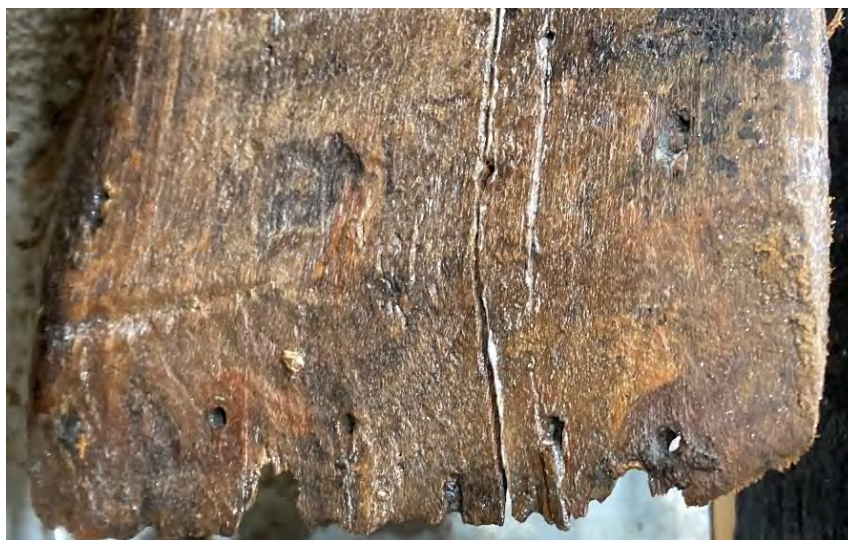
Figure 4.68: Scarf showing rings of grain having been plain sawn [517 SI-S5-M]. (Source: Benjamin Wharton 2021).

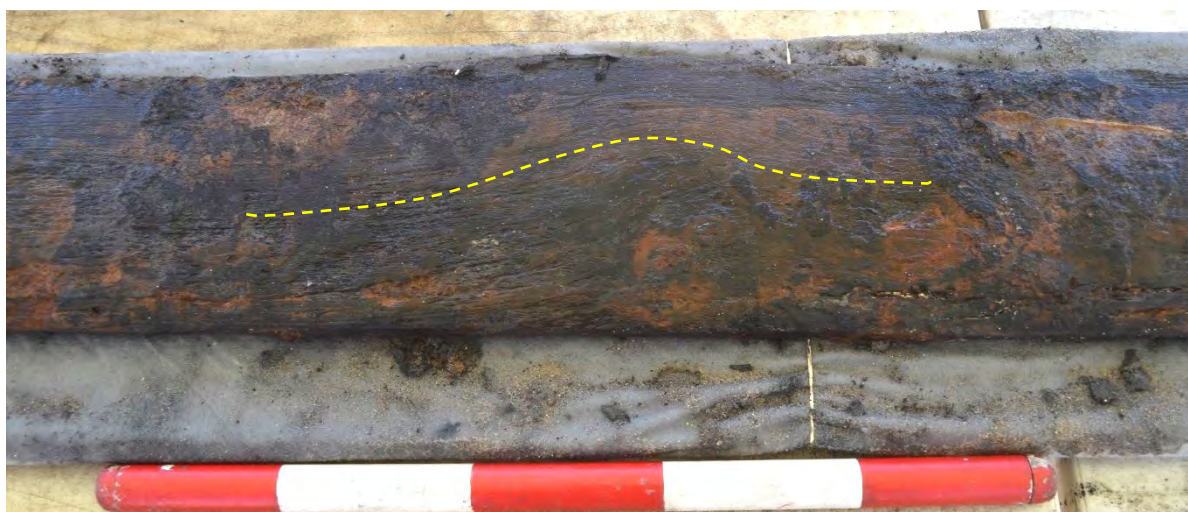
Figure 4.69: Garboard plank [407 P-I-S1-M] of the port side. Swirl evident on plank (direction shown with yellow dashed line) around a 'sound' knot in Sydney Blue Gum. (Source: Casey & Lowe).

Not all the planks used were straight grained. Garboard plank [407 P-I-S1-M] of the port side had swirled grain around a *sound* knot, – being a knot which is part of the surrounding timber and will not separate from the parent material (Figure 4.69).⁷⁵

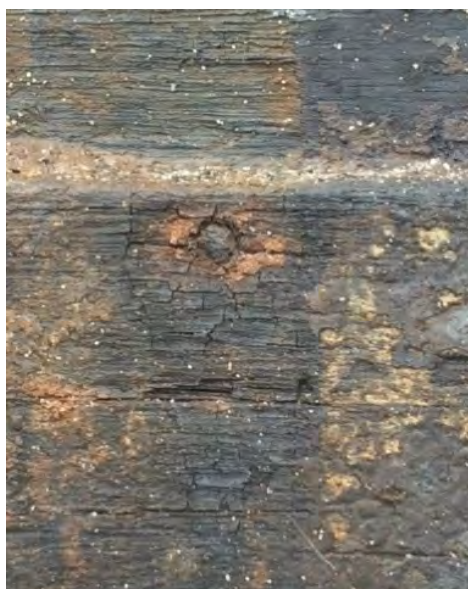
Figure 4.71: Ferrous $\frac{1}{4}$ " framing nail in situ on plank [375 S-I-S11-M]. (Source: AMBS).

It is apparent from what remains that the nails used to fasten the planking together were iron, with a 5-7 mm ($\frac{1}{4}$ " square shank (Figure 4.71). One iron nail was recovered from the surrounding context near the stem of the boat which provides an example of a hand-forged rosehead with angled facets up to a point (Figure 4.72). Although there were no other remains of nail heads, it is likely they would have been hand-forged with a rose head.

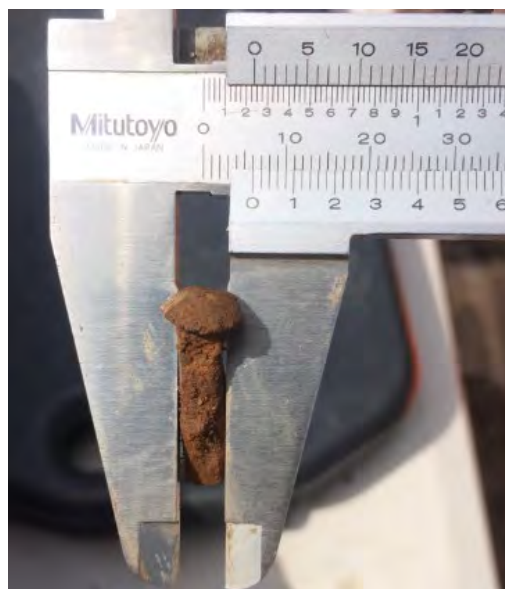
Figure 4.72: $\frac{1}{4}$ " hand forged iron square shanked nail with rosehead. Catalogue #2245. (Source: AMBS).

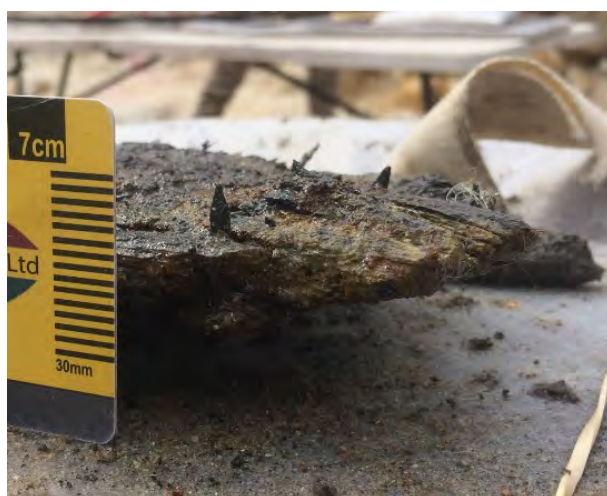
Figure 4.73: Tips of copper fasteners in situ. Aft-end of plank [464, SO-S09-A]. (Source: AMBS).

Copper/copper alloy nails, or clouts, were identified in the planking during the recording phase and later in the cleaning and conservation phase. The nails were located in the outer planking, mostly at the aft-most end in planks [464 S-O-S9-A], [506 S-O-S8-A], and [304 S-O-S7-A], where the transom may have been (Figure 4.73 to Figure 4.75). There were also two copper alloy nails identified amidships on planks [504 S-O-S8-F] and [508 P-O-S5-M].

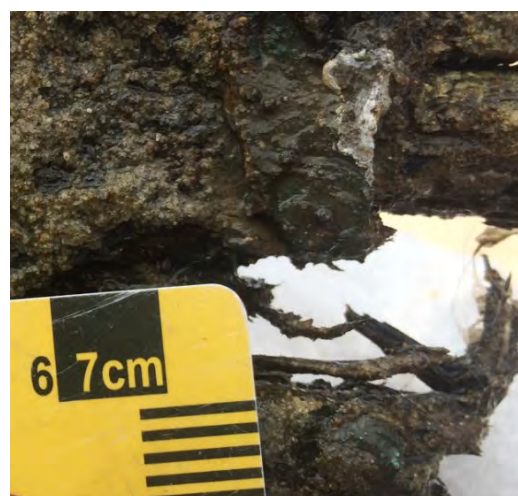
Figure 4.74: Head of copper fastener in situ. Aft-end of plank [464, SO-S09-A]. (Source: AMBS).

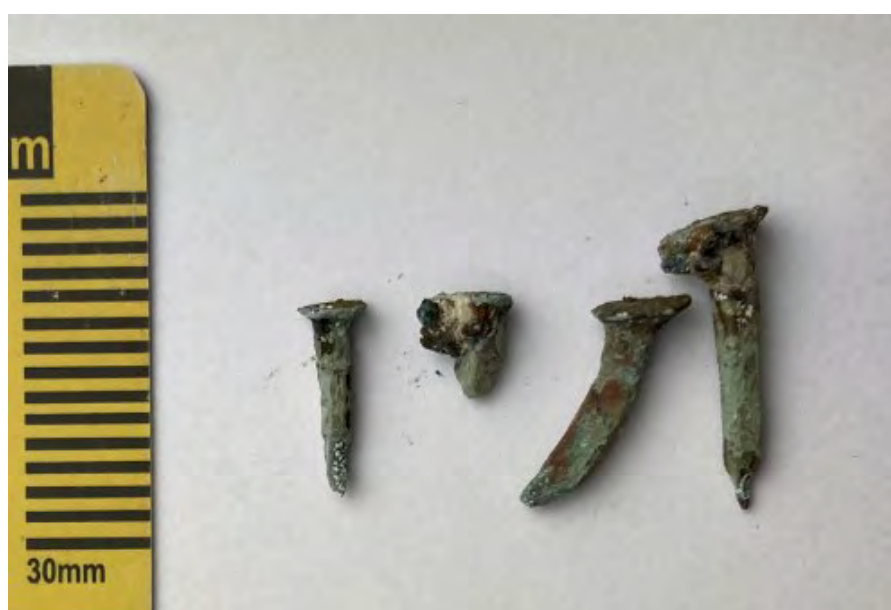
Figure 4.75: Copper alloy fasteners from plank [506 S-O-S8-A]. (Source: Benjamin Wharton 2020).

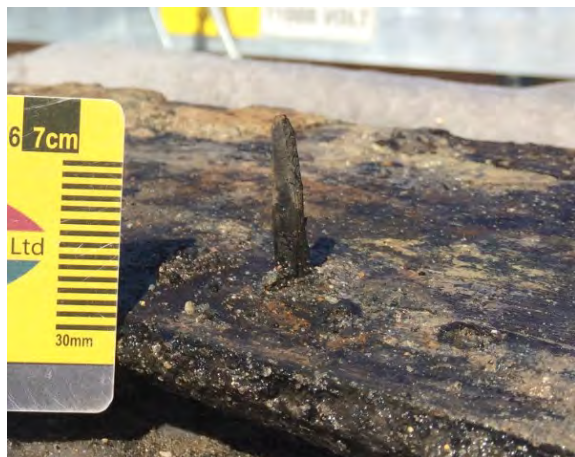
Figure 4.76: Treenail in plank [545 S-O-S3-F].
(Source: AMBS).

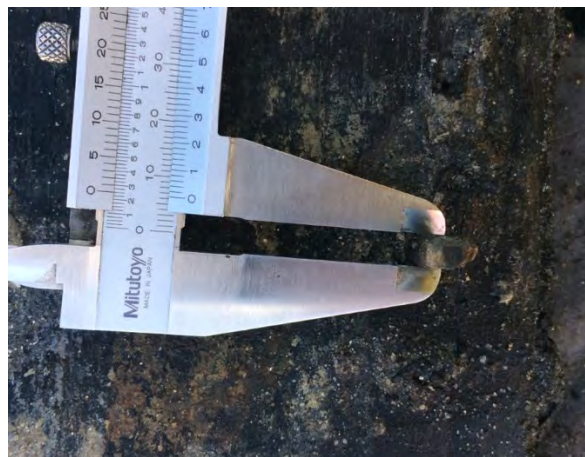
Figure 4.77: Treenail in plank [545 S-O-S3-F].
(Source: AMBS).

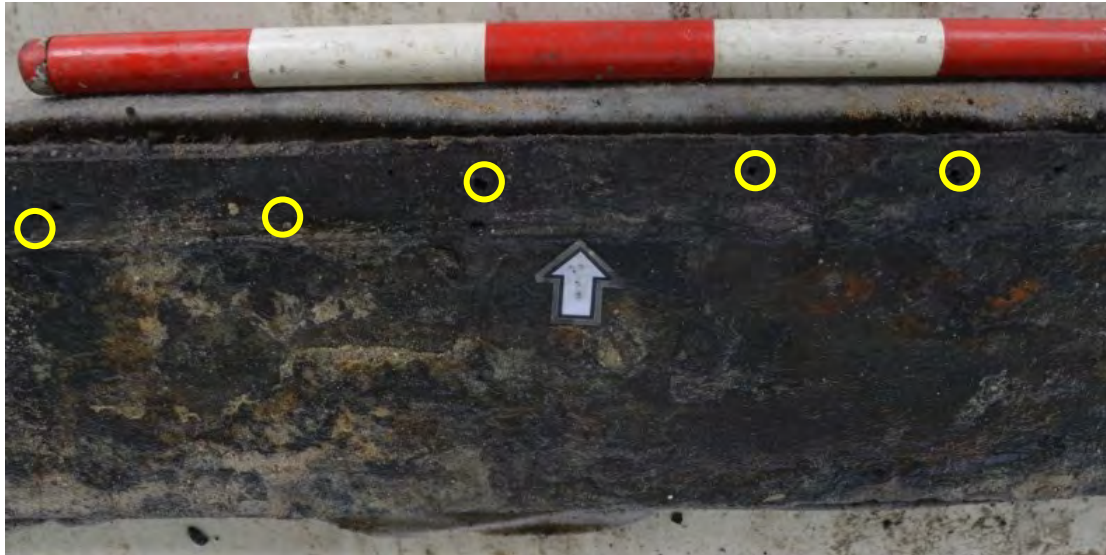
Figure 4.79: Plank [311 P-I-S2-A] nail holes on land. Fastener holes positioned approximately 100 mm (4") apart. (Source: Casey & Lowe).

The nail holes that remain in the planking will have been used for various reasons. Horizontally at the land in the inner planking there will be holes for plank-to-plank, which will be evenly spread about 75-100 mm (3"-4") apart; possibly two holes near each other – a standard 1/4" size with a small blind hole for a tip representing the double-clench (Figure 4.79). On the vertical there will framing fastener holes. Some of these holes may finish close to one another unintentionally. The same may happen for fastening holes from the outer layer of planking, where the lands are close to each other. Some may end up too close, as they were fastened without thought to the inner planking edges or other existing fasteners (Figure 4.80).

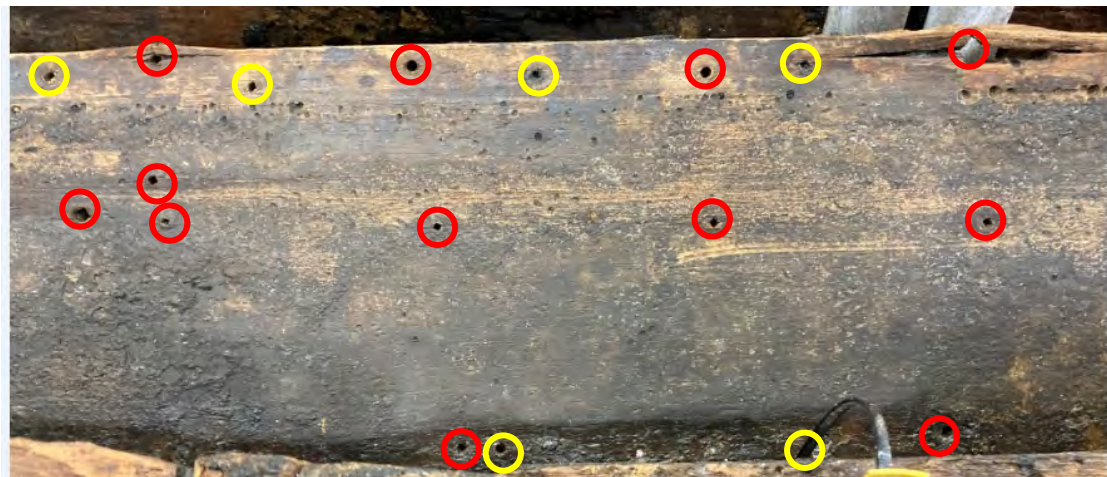
Figure 4.80: Plank [313 S-I-S2-A] possible fastener pattern. Red circles for plank-to-plank, yellow for frame-to-plank. External side of plank may show blind holes from secondary outer planking. (Source: Benjamin Wharton 2020).

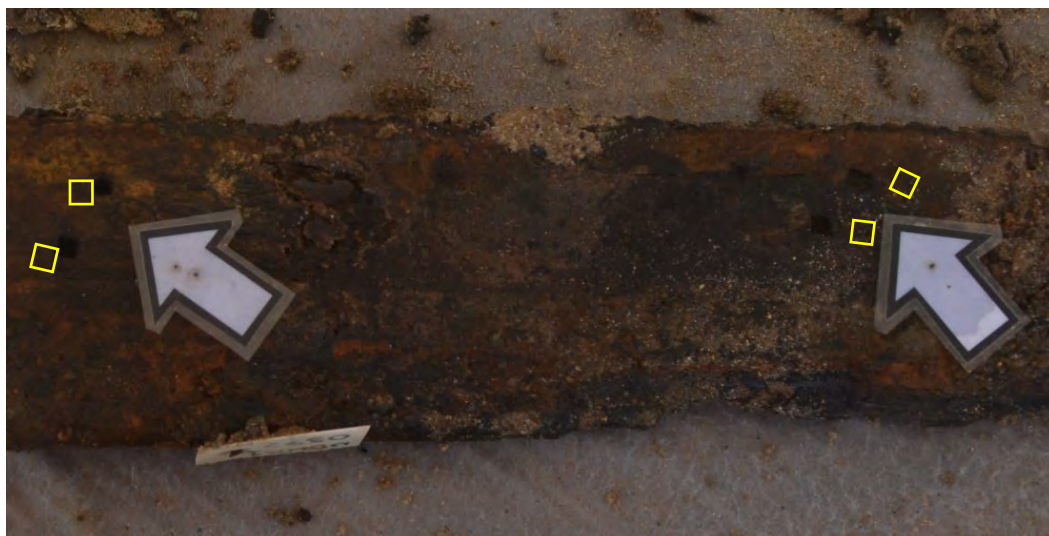
Figure 4.81: Plank [372 P-O-S7-M] fastener pattern for paired nails used in outer planking. Square nails shown in yellow. (Source: Casey & Lowe).

While the inner planking fasteners along the land are likely singular, as they can be clenched to increase holding power, the secondary outer planks appear to use pairs of fasteners, perhaps in a dovetail fashion to increase their holding power where it is not possible to use the clench (Figure 4.81).

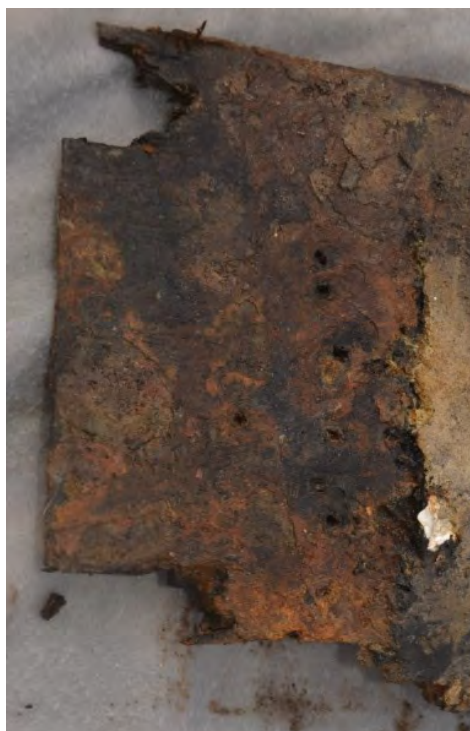
Figure 4.83: Scarf joint of plank [345 P-O-S5-A]. Fastener holes evidently closer to the heel of the scarf, indicating a need to be closer to the outer edge of the complementing outer scarf to ensure it does not open. (Source: AMBS).

The outer layer scarf joints were longer, since they could not be backed with a plate and the nails could not be clenched in the joint. Therefore the joints were longer, with the fasteners being positioned more towards the end of the outer edge, so it limited the chance of the scarf opening (Figure 4.83 and Figure 4.84). The fasteners in the inner planking, in contrast, are located in the middle of the join.

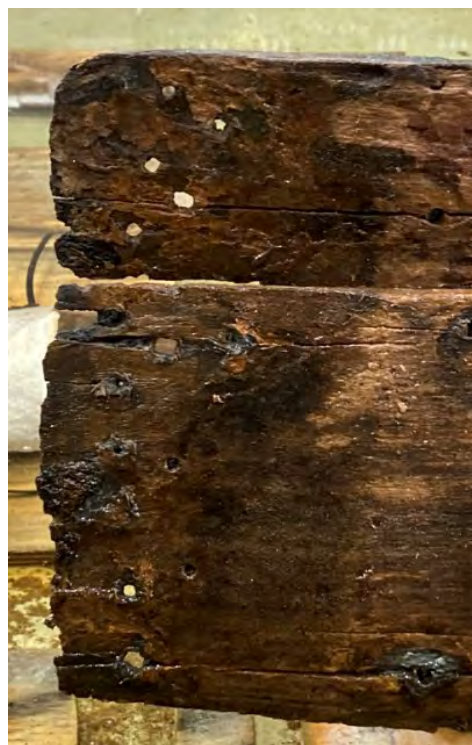
Figure 4.84: Scarf of plank [452 S-O-S5-F]. Fastener holes for scarf towards the tip being the outer scarf. (Source: Benjamin Wharton 2020).

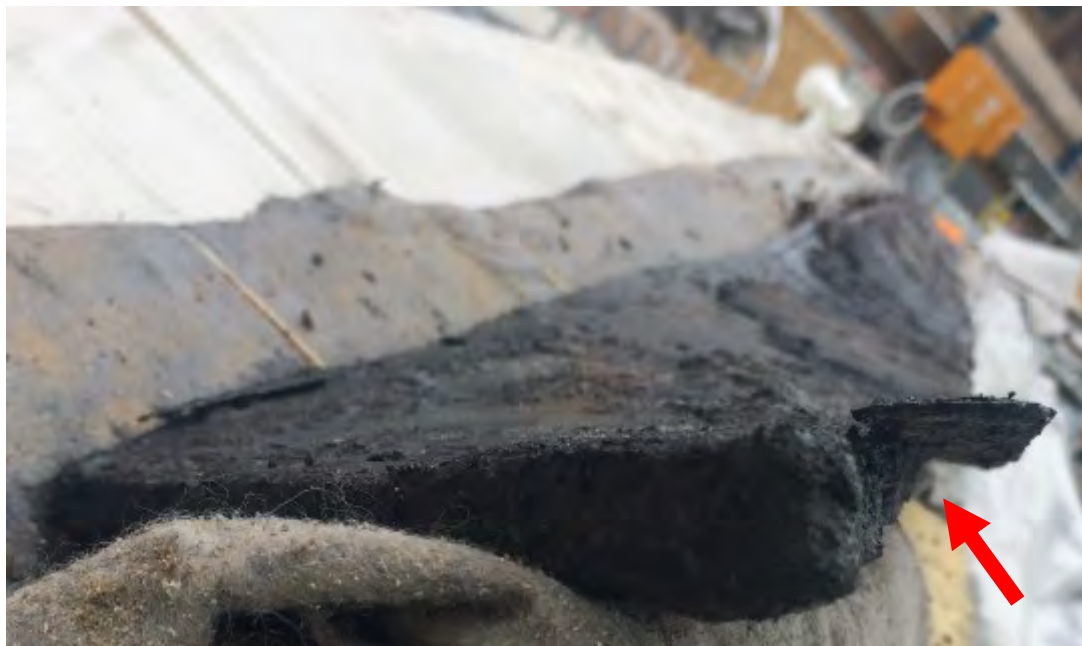
Figure 4.86: Gerald rabbet (red arrow) in plank [341 S-I-S1-A] looking forward from the end.
(Source: AMBS).

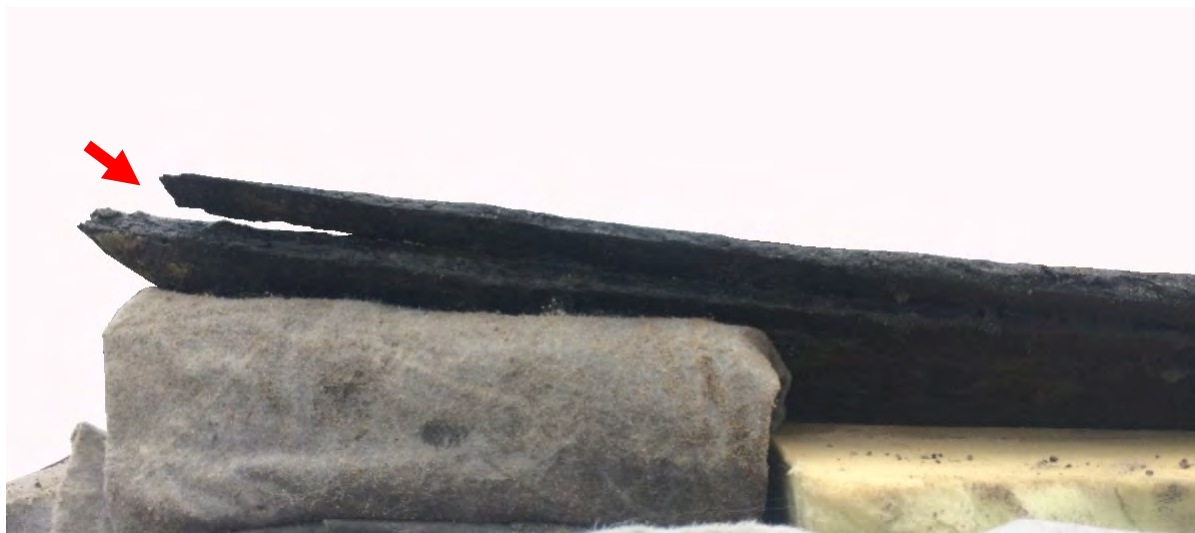
Figure 4.87: Gerald rabbet (red arrow) in plank [341 S-I-S1-A] looking from outside of hull.
(Source: AMBS).

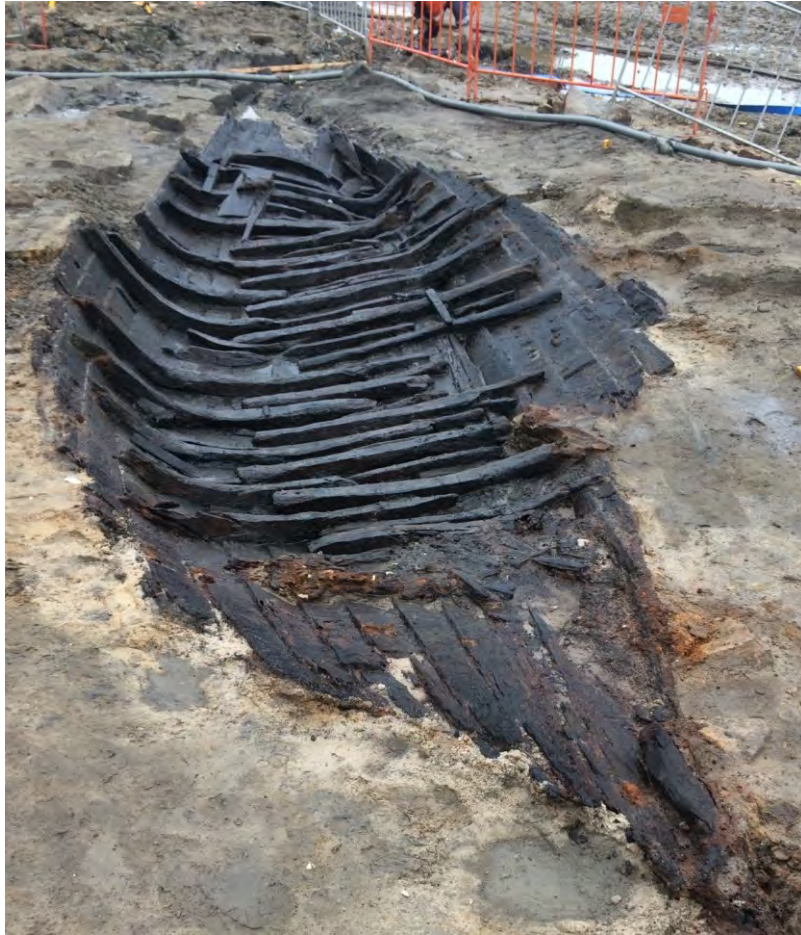
Figure 4.88: Hull framing as seen after removal of ceiling planks. Bow to stern shown front to back. (Source: AMBS).

The framing of UDHB1 was fitted after the planking was complete. Three main types of framing were identified in the vessel: floor, futtock and cant frames (Figure 4.88 and Figure 4.89).

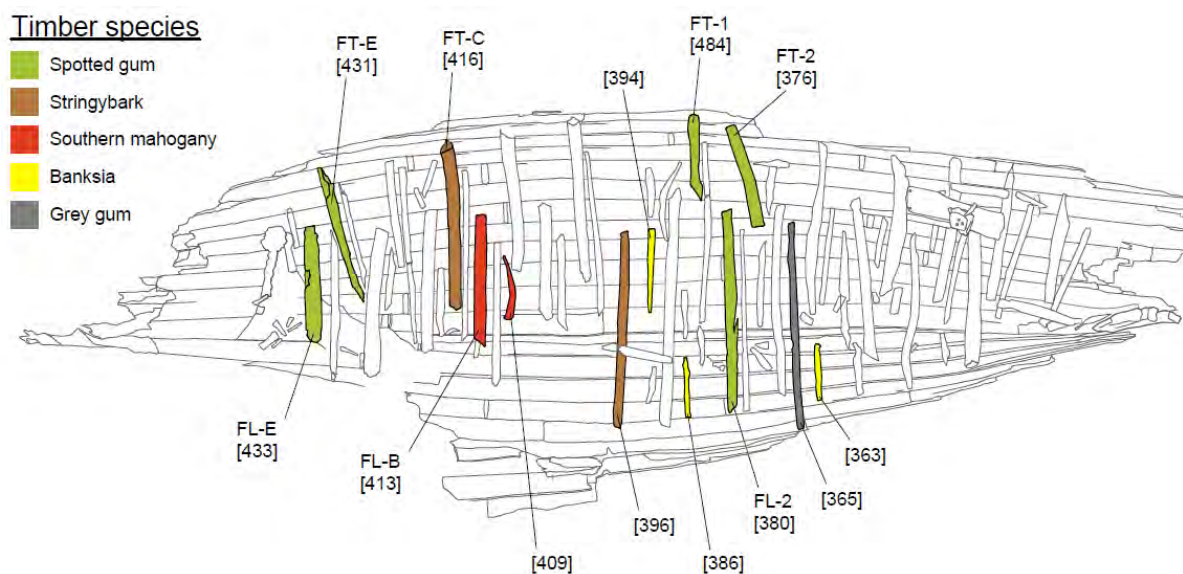
Figure 4.91: Timber species of framing. Spotted Gum – [376], [380], [484], [431], [433]; Stringybark – [396], [416]; Southern Mahogany – [409], [413]; Banksia – [363], [386], [394]; Grey Gum – [365]. (Source: Benjamin Wharton 2021 using base drawing: Plan16.W5 prepared by Casey & Lowe).

The majority of the primary floor and futtock frames sampled were identified as being Spotted Gum and Stringybark, while secondary framing timbers that were sampled were identified mostly as being Banksia, but also included Grey Gum, Stringybark and Southern Mahogany. It is likely that more primary frame timbers would be Spotted Gum, as it is known for its strength in these structural members (Figure 4.91).

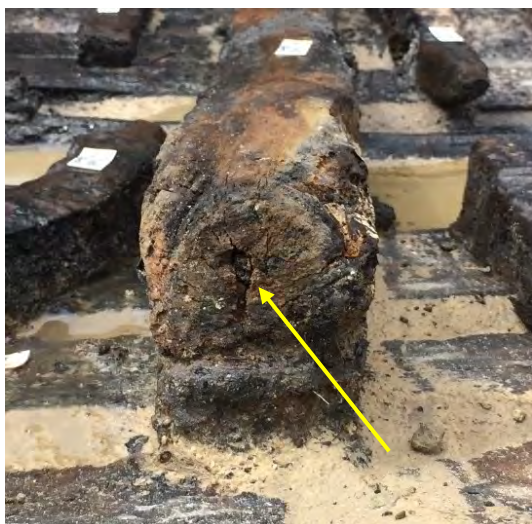
Figure 4.92: Runghead of [396] secondary to FL-O. Yellow arrow indicating the pith, or centre of branch and radius of branch circumference noticeable. (Source: AMBS)

Observations of some of the floor frames show that they have had minimal shaping to reach the finished dimensions as the pith is visible centred in the port-side rungheads and the radially curved edges of the original branch circumference is noticeable in cross-section (Figure 4.92 and Figure 4.93). Another example is on frames which exhibit the 'netting' pattern of the sapwood under the bark indicating that little-to-no material was removed after de-barking. Interestingly, branch collars, or pressure ridges, can also be seen on futtock frames at the chine such as [399] and [362], which are common on Spotted Gum trees (Figure 4.94 to Figure 4.95). These points indicate that the builder of the boat used timbers of the required sizings and angles, with minimal shaping.

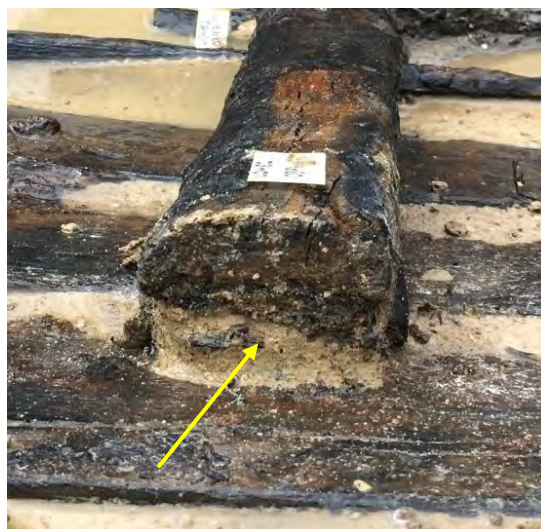
Figure 4.93: Runghead of [391] FL-01. Yellow arrow indicating the pith, or centre of branch and radius of branch circumference noticeable. (Source: AMBS)

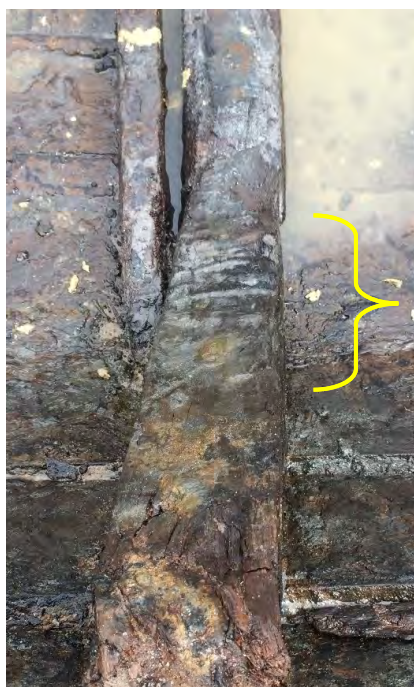
Figure 4.94: Branch collars on futtock frame [399] FT-A. (Source: AMBS)

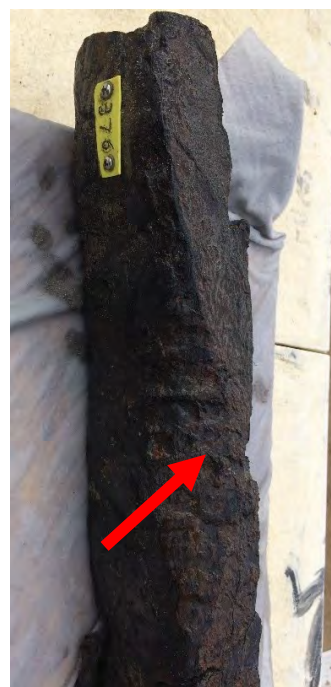
Figure 4.95: Branch collars (red arrow) on futtock frame [362] FT-3. (Source: AMBS).

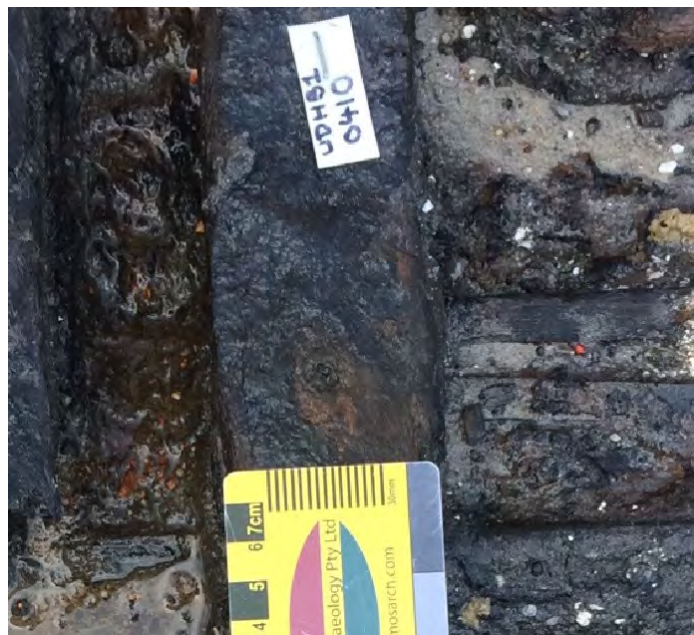
Figure 4.97: Dump spike fastening frame [410] to keel [055]. Spike measures approximately 10 mm ($\frac{3}{8}$ " in size. (Source: AMBS).

There were no complete fastenings in the framing to analyse; only ferrous concretions and small sections of fastening shanks remaining (Figure 4.97). However, from what remains, two types of fasteners were identified.

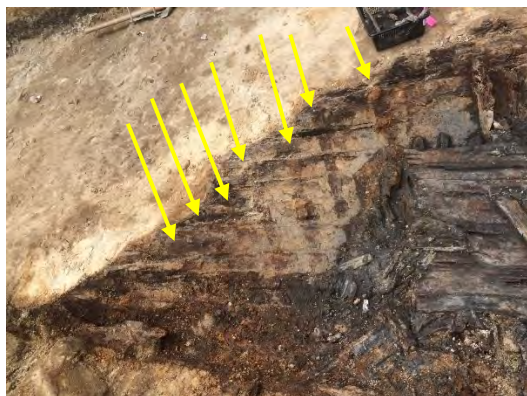
Figure 4.99: Ghost marks of cant frames in the bow. (Source: AMBS).

There were no remaining cant frames in the bow, however, during excavation seven ghost frames became apparent (Figure 4.99). Three after-cant frames remained in the stern, with the ghost mark of another further aft, given the frame ID 'AC-4' (Figure 4.100).

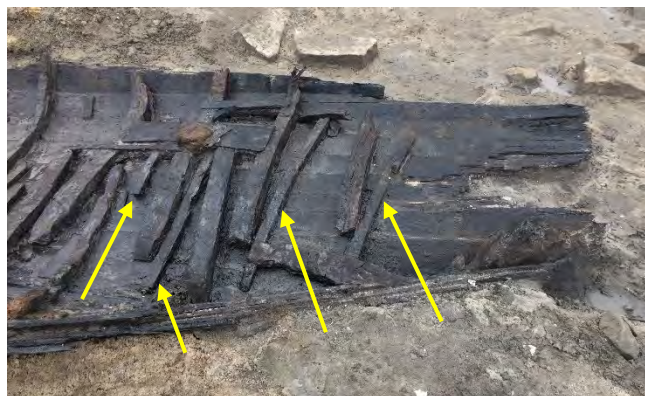
Figure 4.100: After-cant frames in the stern of the vessel. (Source: AMBS).

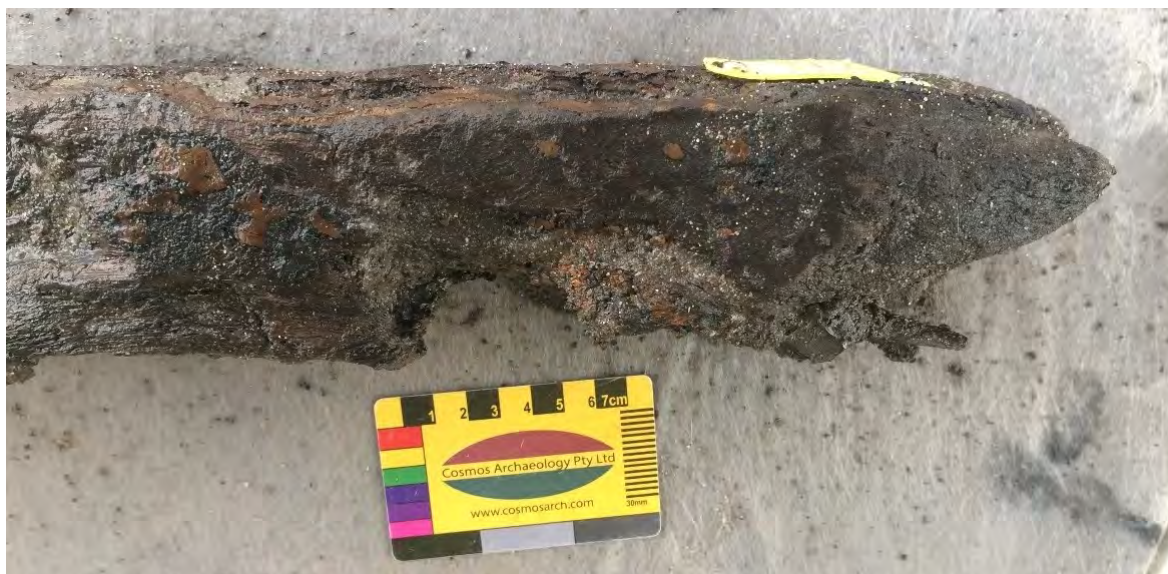
Figure 4.101: Floor frame [416 FT-C] with possible limber hole. (Source: AMBS).

A number of frames that were preserved well exhibit possible limber holes. Floor frame [416 FT-C] was one recorded as such (Figure 4.101). Further research would be required to investigate further examples.

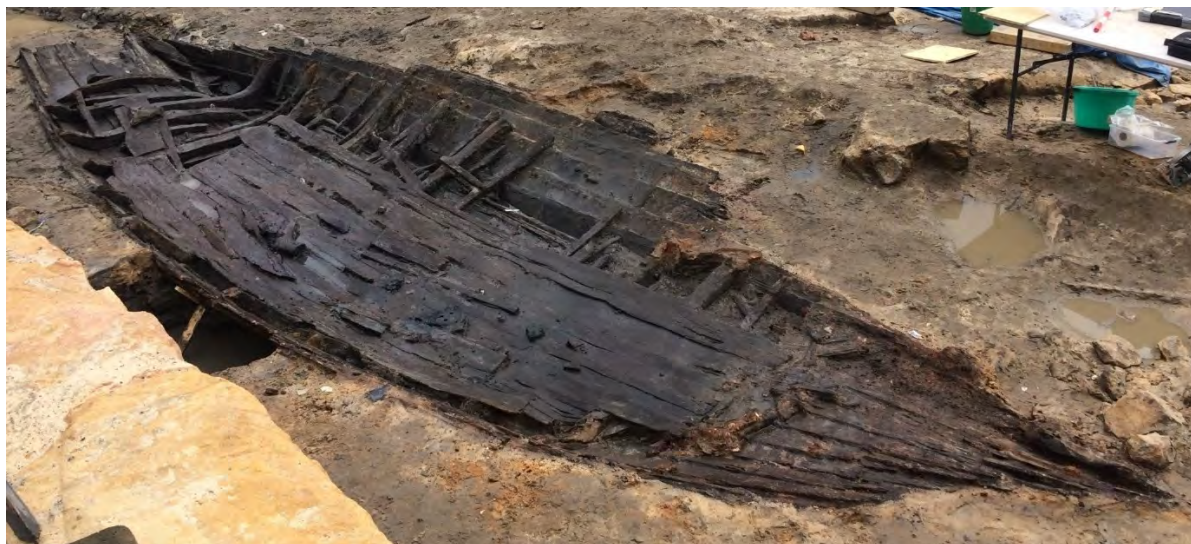
Figure 4.102: Ceiling planking in situ prior to removal. (Source: AMBS).

The inside of UDHB1 was lined with ceiling planks butted longitudinally edge-to-edge for complete coverage. All that remained at the time of the uncovering of the vessel were nine planks on the starboard side and none on the port side (Figure 4.102 and Figure 4.103).
