Sydney Metro Project Barangaroo Station UDHB1 'Barangaroo Boat'

Excavation Report VOLUME 2

Sydney Metro Project: Barangaroo Station

Excavation Report

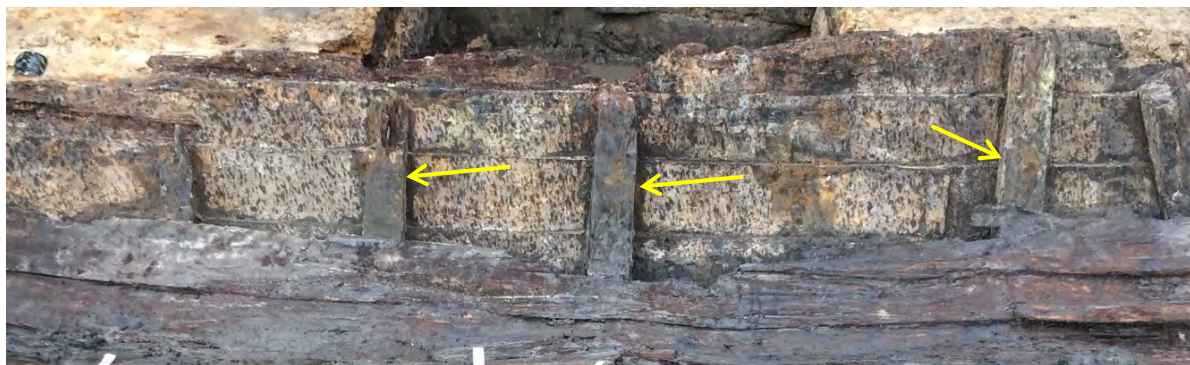
Figure 4.104: Starboard side ceiling planks futtock frames. Iron staining evident on frames suggest possibility of ceiling planks existing higher up the topside, or where a rising was fastened to. (Source: AMBS).

The remaining ceiling planks lined the inside of the hull from the garboard first strake up to the ninth; just above the bilge. It is unclear at this stage if they continued higher (Figure 4.104). There are indications of iron staining from fasteners higher up the topside, however, further examination and analysis is required to determine if these can be attributed to ceiling planking or a rising.

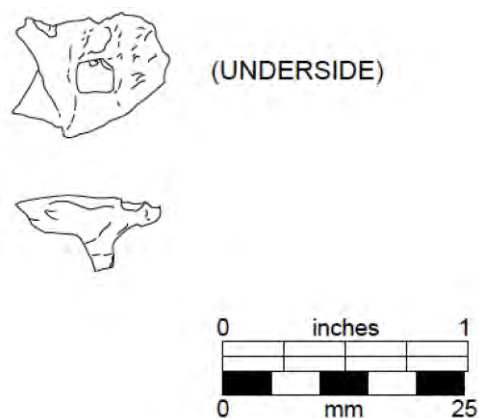
Figure 4.111: Copper alloy nail in copper sheathing from rider keel [551]. (Source: Benjamin Wharton 2020).

Below are various copper alloy nails recovered from the vessel during the conservation and cleaning phase (Figure 4.106 to Figure 4.109). The composition of the copper alloy nails and sheathing from the rider keel [551] were analysed by Dr. W. van Duivenvoorde from Flinders University (see Volume 6). Though the sample tested had no solid matter remaining and mainly consisted of corrosion products, it was possible to obtain satisfactory results. Two tacks were examined, one from the garboard shelf planks [539] and the other from the rider keel [551]. They were of a copper alloy comprising 80.14–85.58% copper, up to 4.55% zinc, 14.30% tin, and 3.04–4.7% lead.

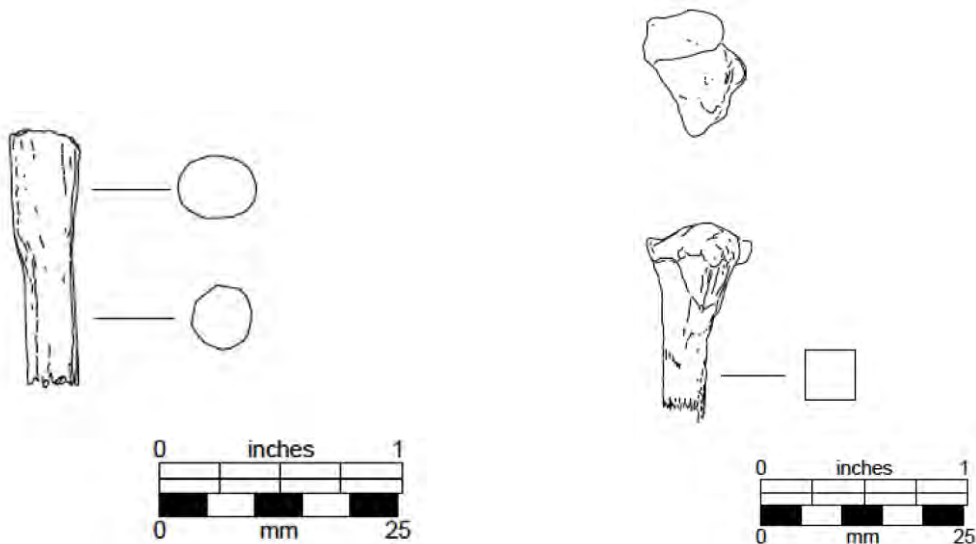
Figure 4.113: Treenail from plank [502 S-O-S9-M]. (Source: Benjamin Wharton 2020).

Selected drawings and cross sections of treenails are presented below (Figure 4.112 to Figure 4.116).

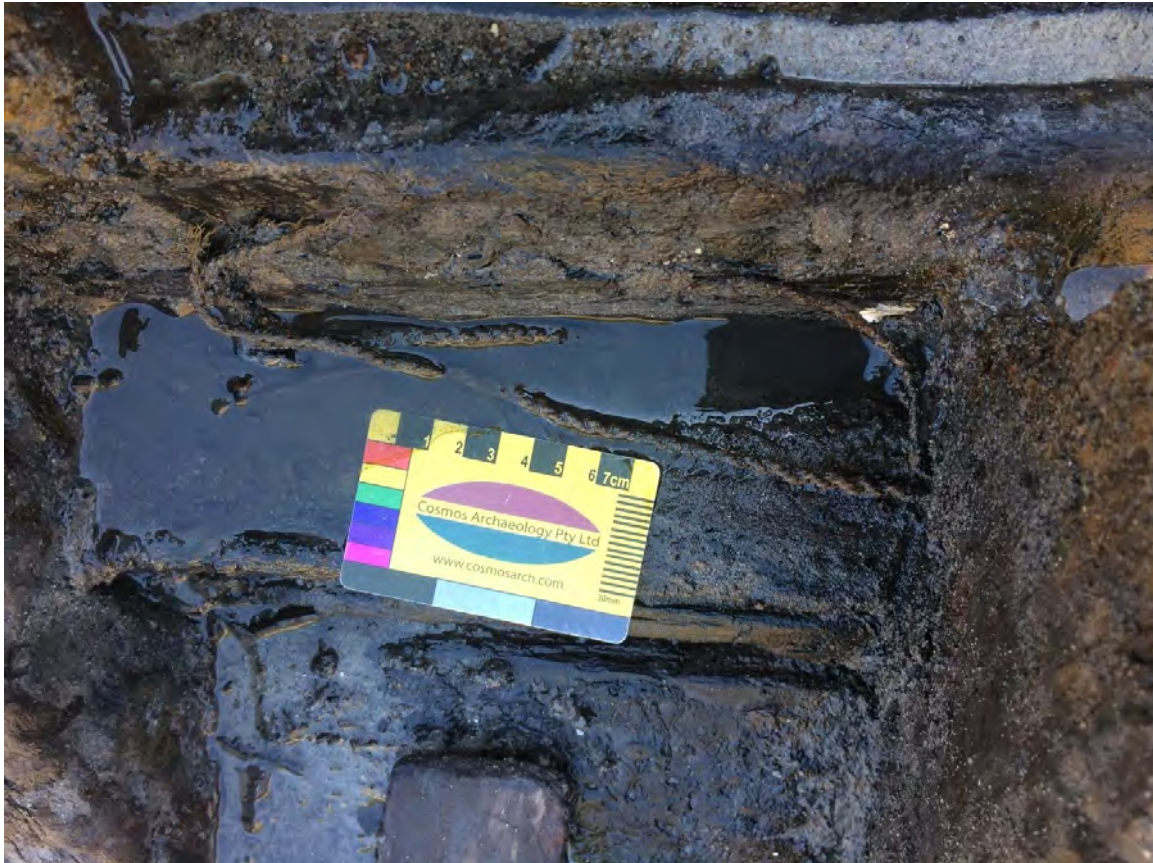
Figure 4.117: Cordage [490] in situ on keel [055]. Stern to the left of the photo. (Source: AMBS).

A length of cordage [490] 760 mm long was found within the aft end of the hull threaded under frame [347] over the keel [055]; possibly it was used for cleaning out the limber holes, or to tie something down. The cord has a right-hand lay and measures approximately 5 mm ($\frac{3}{16}$ "") in diameter. It consists of three strands made up of a rough fibrous yarn that is orange brown in colour and flat-shaped; possibly flax or hemp (Figure 4.117 to Figure 4.119).

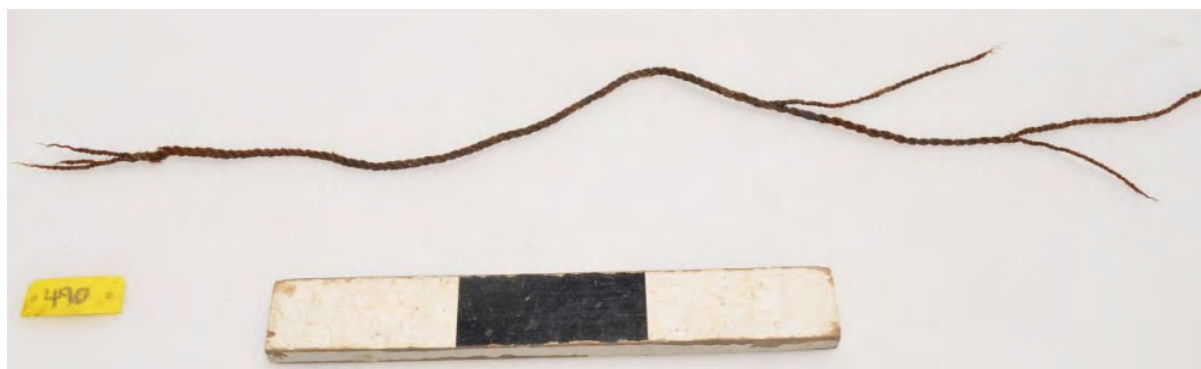
Figure 4.118: Cordage [490] overall length. (Source: Casey & Lowe).

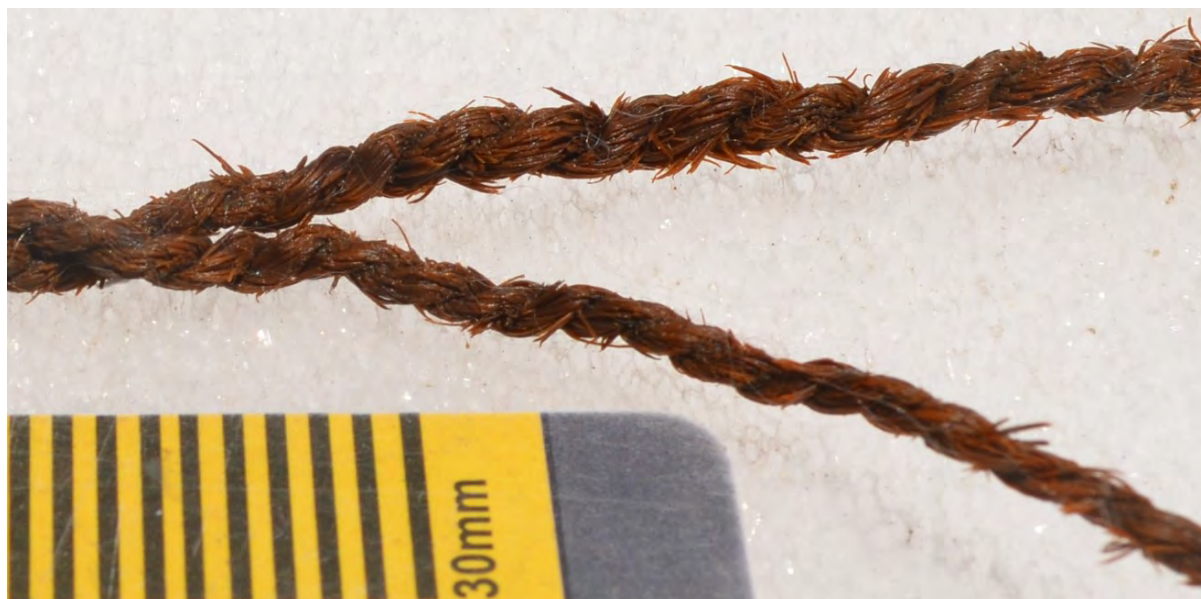
Figure 4.119: Cordage [490] close-up view of fibrous yarn. (Source: Casey & Lowe).

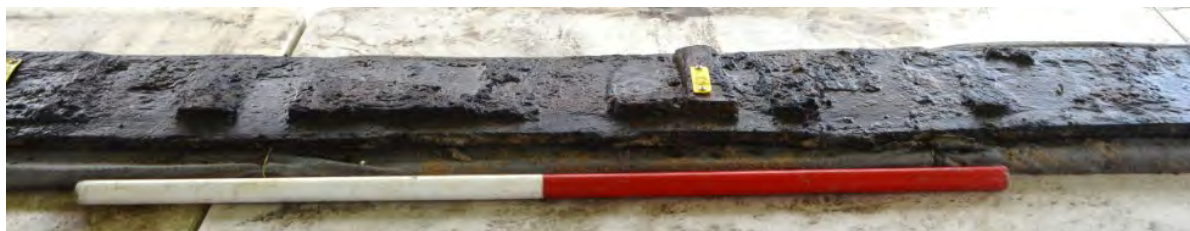
Figure 4.120: Pitch on internal side of Plank [495 S-I-S2-F]. Internally applied between framing as thick as the planking itself. (Source: Casey & Lowe).

The pitch was thickest at the lower parts of the hull in between the internal framing and on the outside, the pitch was thickest on the external surfaces of the keel assembly components (Figure 4.120 and Figure 4.121). Pitch was also observed on the outside of the inner planking, though this appeared inconsistent. Perhaps the hull was scrapped back before the chunam was applied and the second layer added.

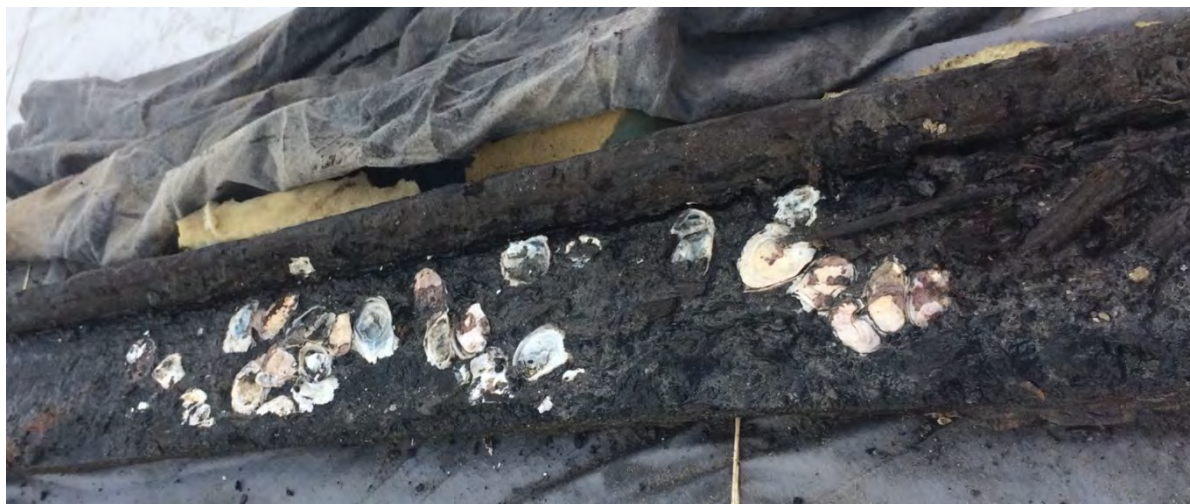
Figure 4.121: Pitch embedded with shells on garboard shelf [543]. (Source: AMBS).

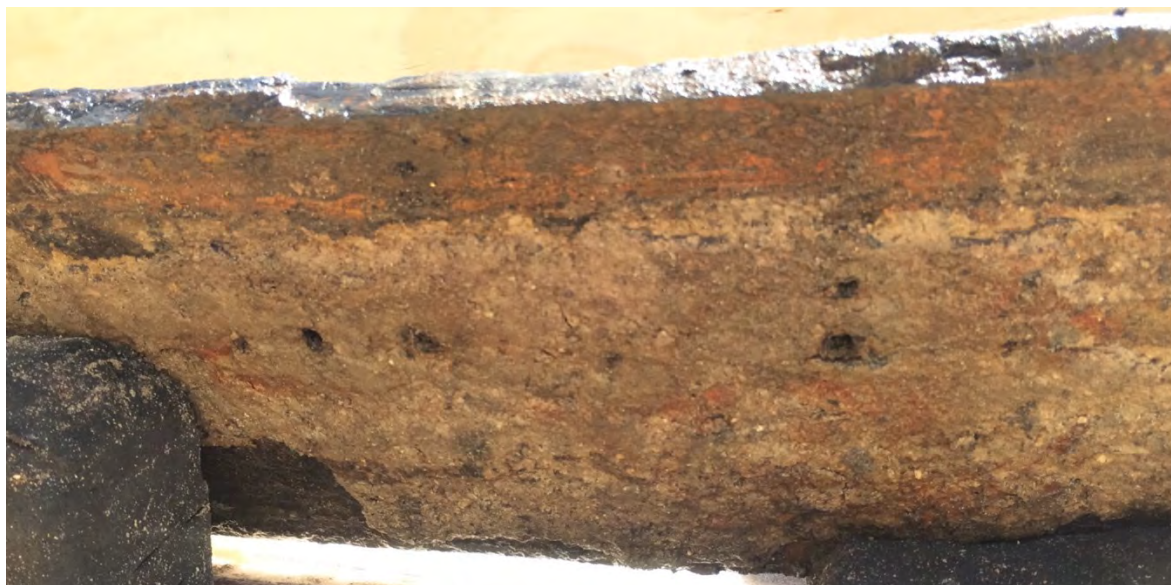
Figure 4.122: White putty between planking layers on outside of inner plank [311 P-I-S2-A]. Note also the fastener holes protruding through from the outer layer planking. (Source: AMBS).

Between the inner and outer layers of hull planking was a thick white putty substance much like chunam, or vernacularly '*schannam*,' which is a mix of lime and fish oil used between planking and sheathing materials on hulls (Figure 4.122 and Figure 4.123).⁷⁷ Samples of this material were also tested at the Sydney Analytical, Vibrational Spectroscopy Facility (see Volume 6). They were obtained from the inner planks [313 and 495] and one of the garboard

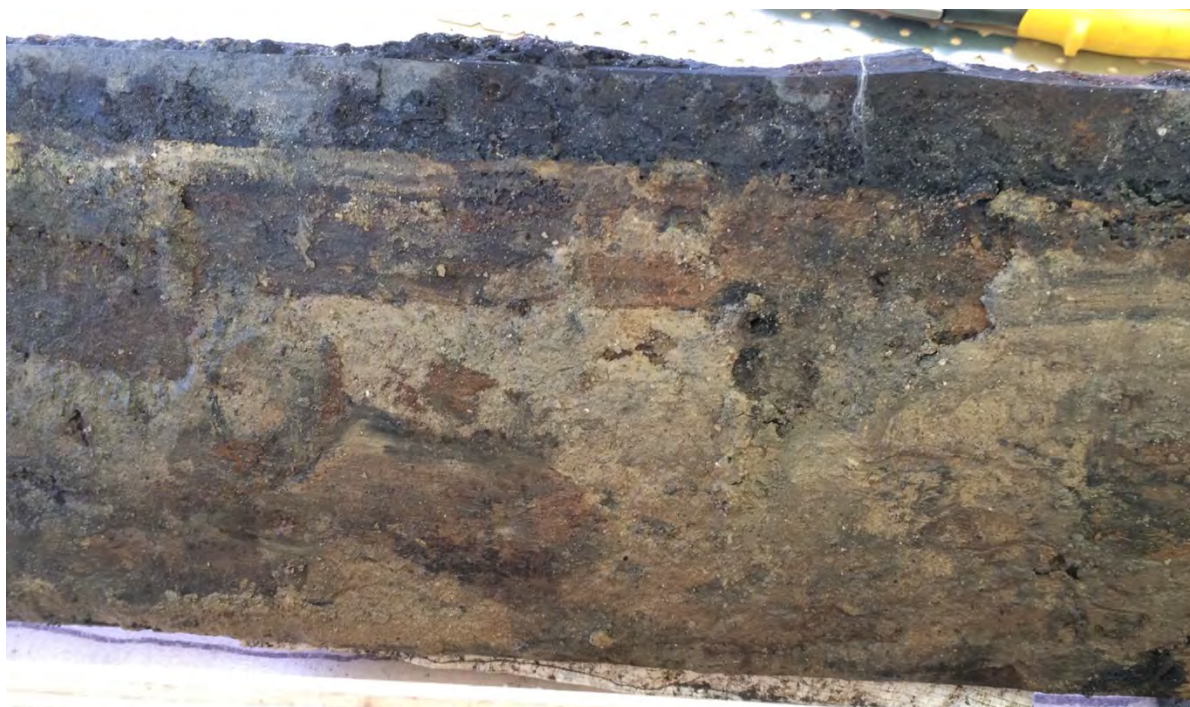
Figure 4.123: White putty between planking layers on outside of inner plank [313 S-I-S2-A]. (Source: AMBS).

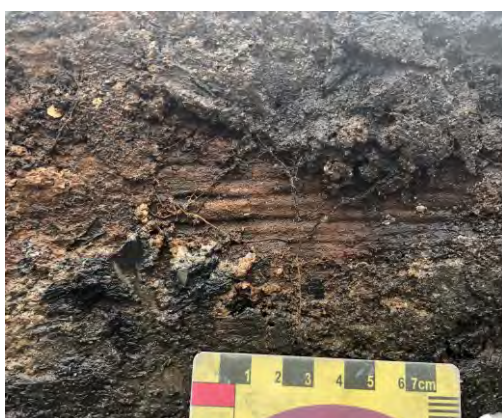
Figure 5.3: Wear and remains of pitch on exterior of inner plank [494], positioned on port side in the second strake.

The outside of the inner planking in places has surviving evidence of a coating of a resinous substance as well as marine borer damage. This indicates that the vessel once operated as a single hulled boat. Figure 5.3 shows the worn and coated exterior surface of inner plank 494 while the inner surface of the outer plank adjacent to inner plank [522] retains clear evidence of saw cuts (Figure 5.4). Figure 5.5 shows the remains of pitch under the chunam/white stuff on the outer side of inner plank [486].

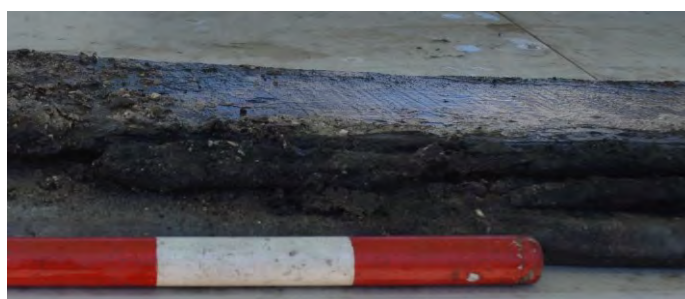
Figure 5.4: Saw marks observed on the inner surface of the outer plank 522 which was adjacent to inner plank [494]. (Source: Casey & Lowe)

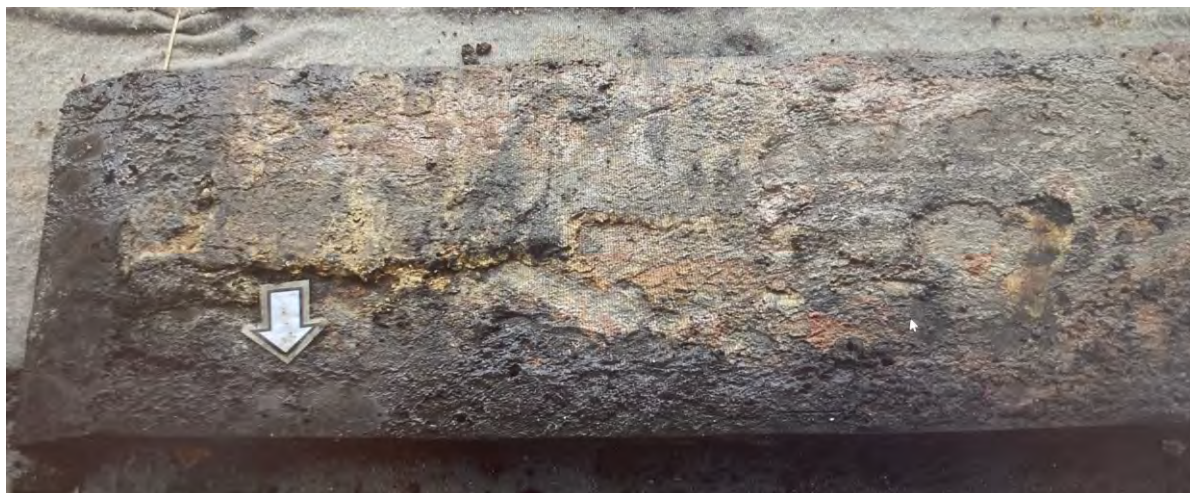
Figure 5.5 : Remains of pitch visible under chunam on outer side of inner planking [486]

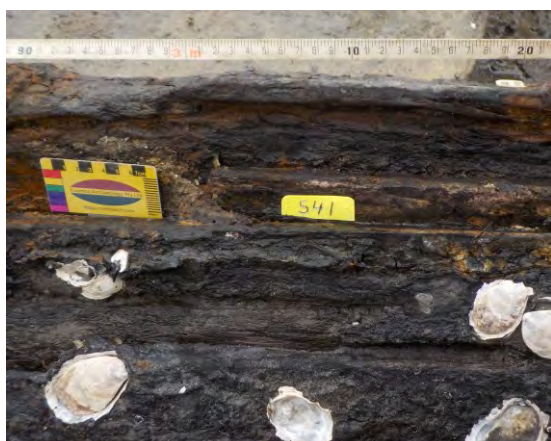
Figure 5.6: Around 30 mm of the filler plank [541] as indicated by the yellow tag. Abuts the keel [055] and is covered by the starboard garboard shelf plank [540] – which has oyster shell on its outer face.

The filler plank [541] attached to the starboard side of the keel at midships was a likely repair to the garboard strake rabbet, and shows evidence of wear as well as chunam and pitch on its exterior surface. This piece is mostly covered by the starboard garboard shelf plank [540] (Figure 5.6 and see Figure 4.7) for the outer planking. The evidence of wear indicates that the vessel underwent substantial repairs to the keel when it was still single hulled. This notion is further reinforced by the fact that the plank sat on the rider keel which is wider than the keel at this point, the saw cut clearly visible on the plank having been made when the scarfed rider keel pieces were attached to the keel (Figure 5.7).

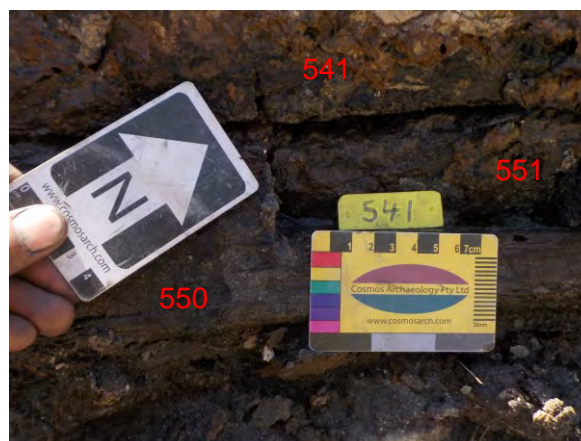
Figure 5.7: The cut (indicated by arrow) into the bottom of the filler plank [541] which lines up with the scarf cut where the two pieces comprising the aft section of the rider keel [550] and fore section [551] join.

The second event is that the aft section of the rider keel [550] is very likely a repair, scarfed onto the fore section of the rider keel [551] while still attached to the keel, as attested by the cut mark on the keel and filler plank [541] (see Figure 5.7). In this instance also there was no application of chunam and pitch on the repaired section.

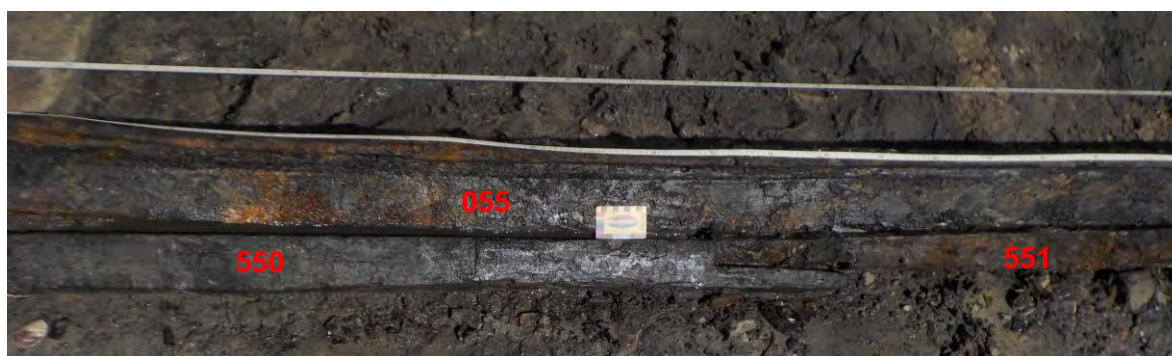
Figure 5.8: View of starboard side of keel [055] and rider keel aft [550] (left of image) with rider keel [551] fore to right of image.

The sided faces of the rider keel – fore [551] is covered by chunam overlaid with pitch similar to the exterior of the inner planking but shows no obvious wear, while rider keel - aft [550] has no applied chunam or pitch and also does not display wear or marine borer damage (Figure 5.8 and see Figure 5.7 as well as Figure 5.9). This observation points to two separate events. Firstly, that the rider keel was not exposed to water for an appreciable length of time, and that the garboard shelf planks [539, 540, 542, and 543] for the outer planking were placed around the same time as the rider keel. This indicates that the rider keel was added to the vessel to extend the depth of the keel to accommodate the garboard shelf planks which supported the outer layer of planking.

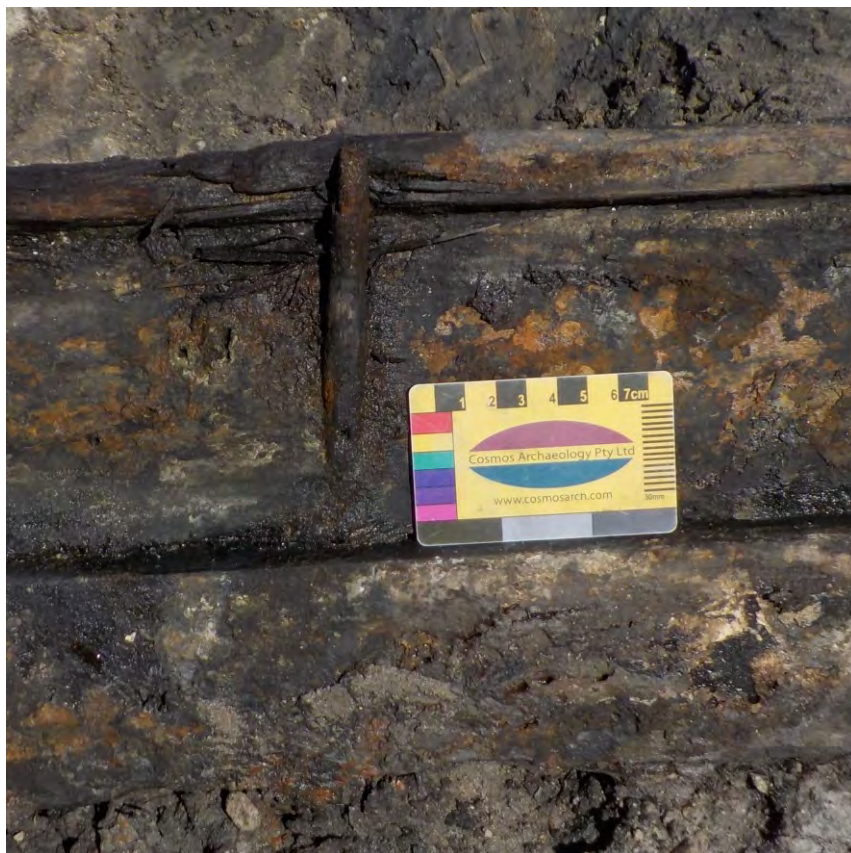
Figure 5.9: Trunnel [535] entering the starboard side of the keel [055] at an angle. Fore section of rider keel [551] below.

The angled trunnel [535] was inserted into the keel sometime after the filler plank [541] was added as it passed through the piece as well as the inner starboard garboard plank [400] (Figure 5.9). There was no corresponding floor frame above the trunnel and the top of the object was rounded, suggesting that the upper part had broken off or worn away.

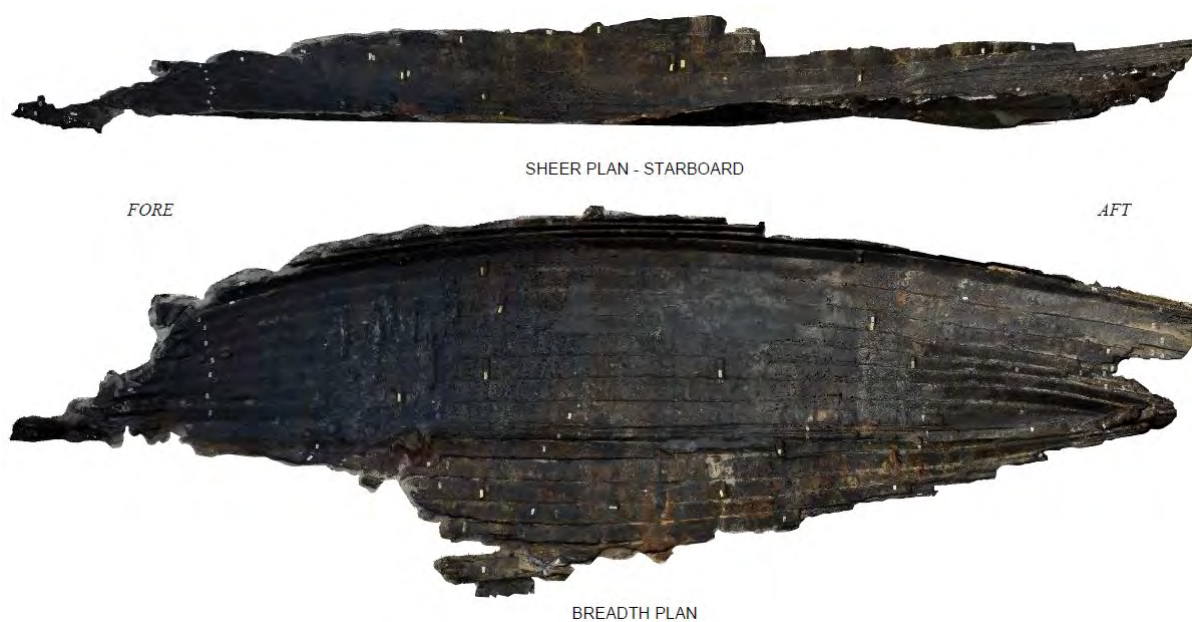
Figure 5.10: Photogrammetric model of UDHB1 after removal of the frames.

The hull had been distorted over time on the starboard side where it had been chocked with a sandstone block/ashlar (see Figure 3.3 and Figure 3.4). To correct this distortion, first, a photogrammetry model of the shell of the hull after the framing had been removed was processed into station, buttock, and waterlines to be able to adjust the lines where necessary (Figure 5.10 and Figure 5.11). Distortion is seen between Stations 2 and 3 and are most apparent in the breadth-plan in Figure 5.12. The lines were faired at this point.

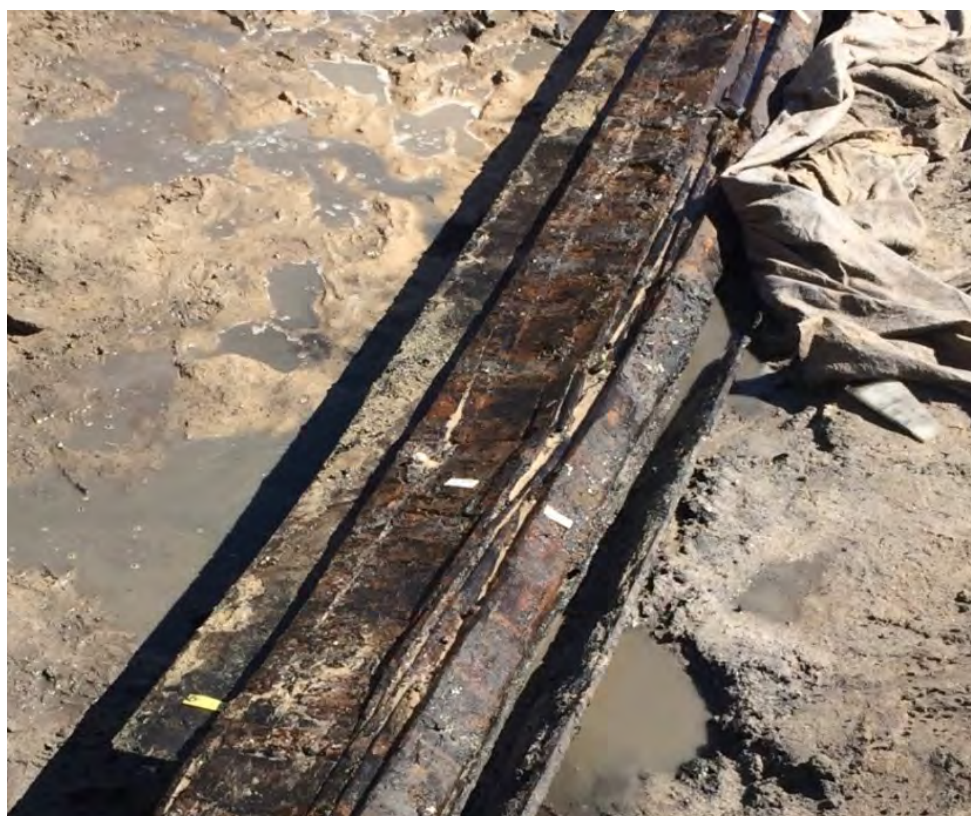
Figure 5.13: Garboard plank [437] pulled away from rabbet in keel [055]. Planks on the left of the photograph, keel on the right, looking towards the stern.

The stations from the photogrammetry hull model were extracted into CAD which represented the internal line of planking. The inner top edges of the planking were used to draw the hull station lines to represent the moulded, not planked, profile. This presented some challenges, as the garboard planks had shifted from the rabbet in the keel, which was corrected with a reconstruction of the keel and the plank dimensions (Figure 5.12 and Figure 5.13).

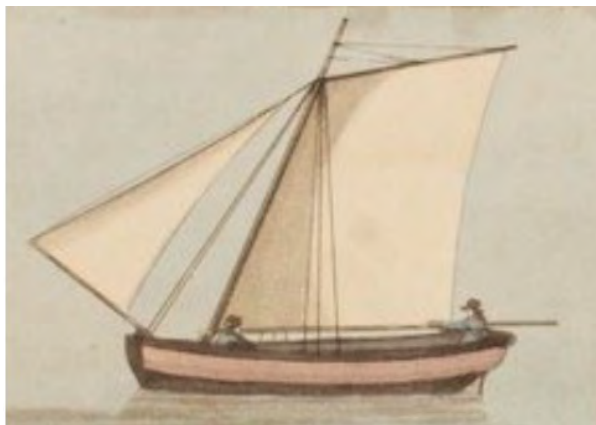
Figure 5.29: Detail from illustration of Sydney Cove viewed from the east. Gaff-rigged mainsail with headsail affixed to a bowsprit. Note the standing rigging required. No evidence has been found to date of standing rigging on UDHB1.

However, the cutter-style hull shape strongly suggests having been utilised for sail as well as by oar, as opposed to narrower oar-only propelled vessels. The rig of sail that could have been employed would be the gaff, lug, or sprit rig which appear for these sized vessels in the period in Port Jackson. However, the gaff rig requires more standing lines to support the mast, of which there were no recognisable remains of chain plates being fastened to the hull side, though there may have been a simple fixture not extending past the sheer strake and not preserved in the wreck. It could, however, be more likely that either lug or sprit sail were used, which do not rely on shrouds (standing lines) affixed to the hull sides. Figure 5.26 to Figure 5.28 are examples of a similar sized hull shapes with a lug mainsail.⁹⁵ Figure 5.29 demonstrates a gaff-rigged mainsail.⁹⁶

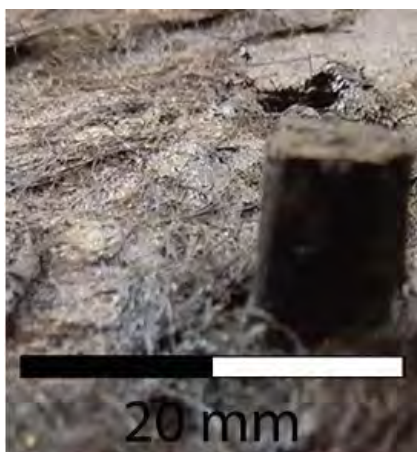
Figure 5.33: Old nail hole plugged with wooden plug. (Source: Fiedler, K., 2016)

recognisable in the Mönchgut 92 wreck (Figure 5.33 and Figure 5.34). It was noted that 'In several occasions old nail holes were plugged with wooden plugs.'¹²⁹

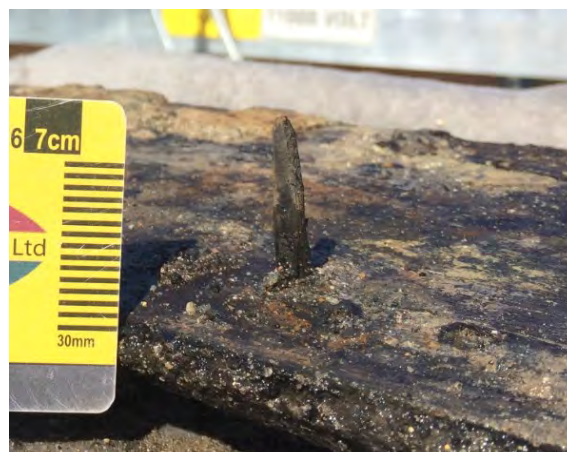
Figure 5.34: Treenail in plank [545 S-O-S3-F]. (Source: AMBS).

The first individual characteristic is the wooden plugs in nail holes (see Section 4.5.7). The repair wooden treenails used in UDHB1 to plug worn out iron nail holes are also

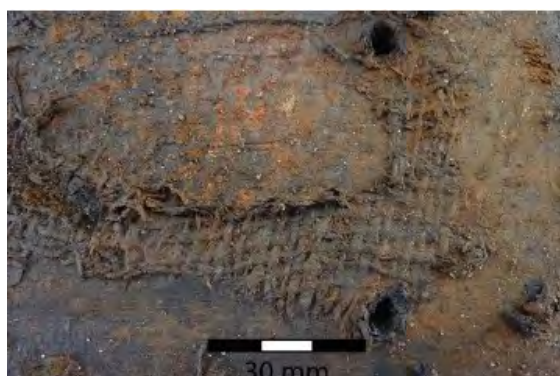
Figure 5.35: Textile used as caulking on the scarp between planks in the Mönchgut 92 wreck. (Source: Fiedler, K., 2016)

Another characteristic found comparative in the Mönchgut 92 wreck was the use of the textile caulking in between scarp joints (Figure 5.35). In comparison, it is coarser than that used on UDHB1 (Figure 5.36). Unfortunately, it is unknown what the Mönchgut 92 material is, as it was not conserved. However, the textile was described as:

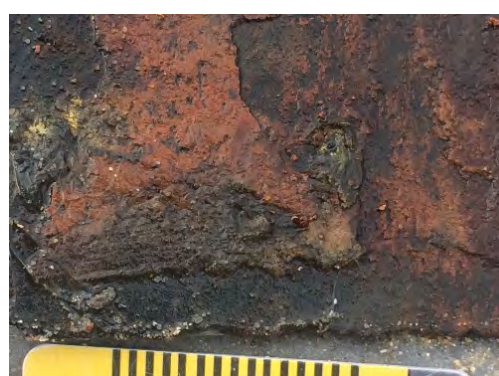
Figure 5.36: Scarph joint on aft end of portside plank [346] with textile caulking. (Source: AMBS).

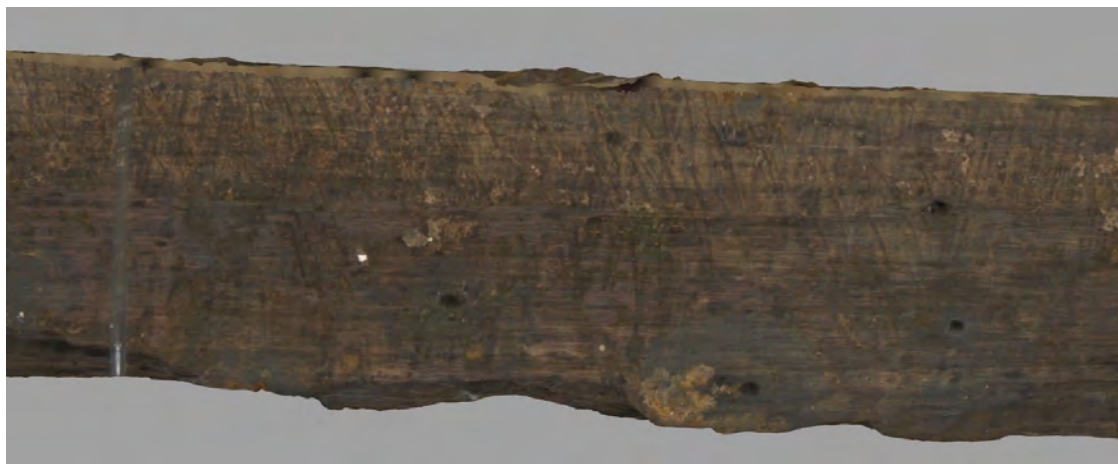
Figure 5.37: Scan of Plank [542] showing curved marks on part of the plank. (3D scans supplied by SWF)

While the majority of pit-saw marks on the planking are relatively uniform, there are some examples with anomalies, such as distinctly curved marks. It is not that these curved marks indicate the use of a circular saw, as it is important to note that these are dispersed within the prominent marks of straight pit-saw marks that are consistent across the length of the plank. They also are not characteristic of circular saw cut marks as they are not uniform in radius, and nor do the projected centres of the radii align (Figure 5.37 and Figure 5.38). Some of the curves when completed as a circle become smaller than the plank width itself, disputing any physical positioning of a circular saw blade and spindle in operation.

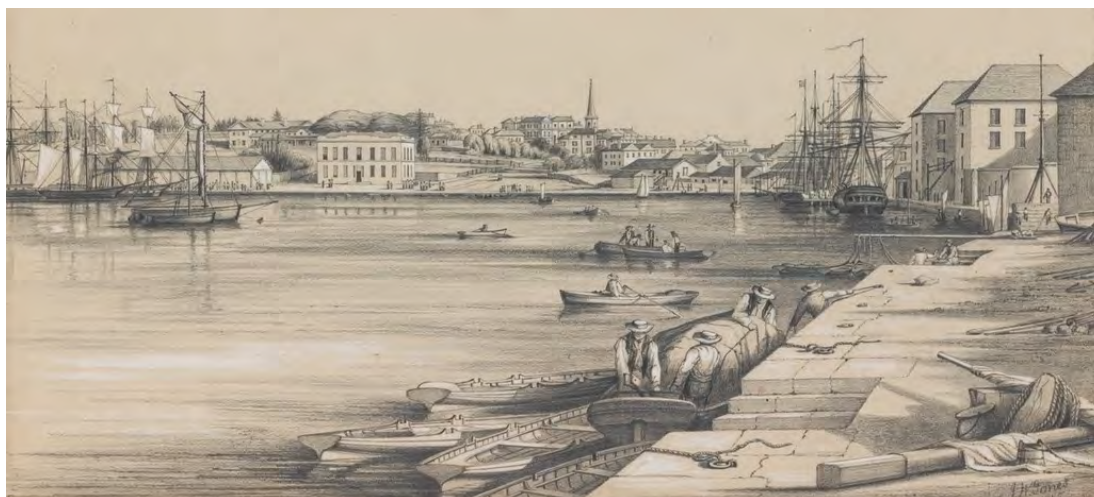
Figure 5.46: View in Sydney Cove, NSW, by Jacob William Jones 1845. Note the number of lighters operating and the two craft at base of image showing ceiling planking does not extend above the turn of the bilge.

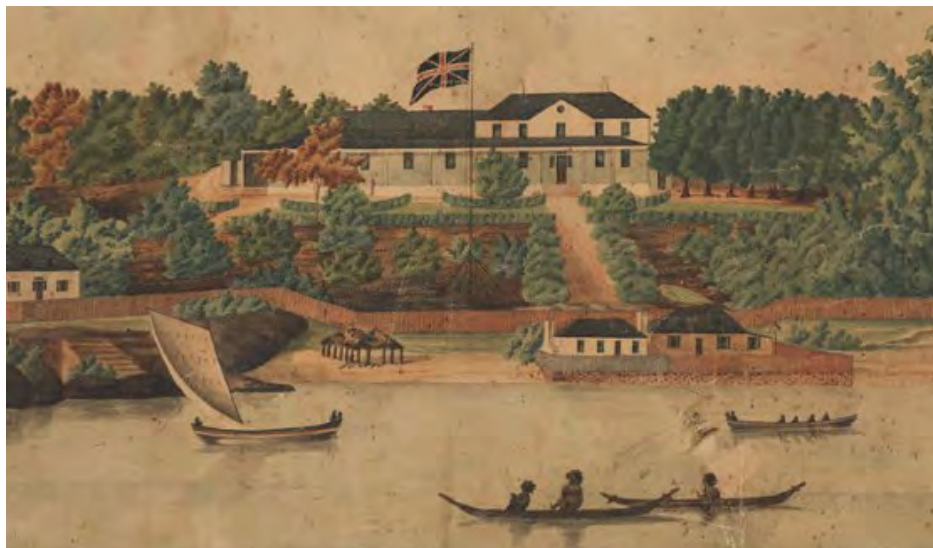
Figure 5.48: View of Government House, Sydney Cove by John Eyre ca. 1807. Note how far forward the mast sits in the boat on the left with no standing rigging.

Although a mast-step was not located with the hull, there are other indications that the vessel may have had a single mast (that may or may not have been removable as circumstances dictated). Single-masted vessels of the period are usually referred to as being rigged as 'cutter', 'yaw' or 'sloop' types (Figure 5.48).¹⁷⁰ Mast and sail propulsion would have been essential if the vessel travelled any distance, either within Port Jackson/Sydney Harbour or along the New South Wales coast, or even in Bass Strait, as demonstrated by the 14 ton sloop *Raven* (see Section 5.4.1). While the size of UDHB1 somewhere between 10 to 15 tons may seem relatively small, the coastal fleet sailing out of Sydney and along the coast did contain a number of vessels of this size as they were easier to operate where cargo loading places were difficult to approach and needed only a few crew (two or three men). They were also far nimbler in satisfying the demands of the local trade where cargoes may

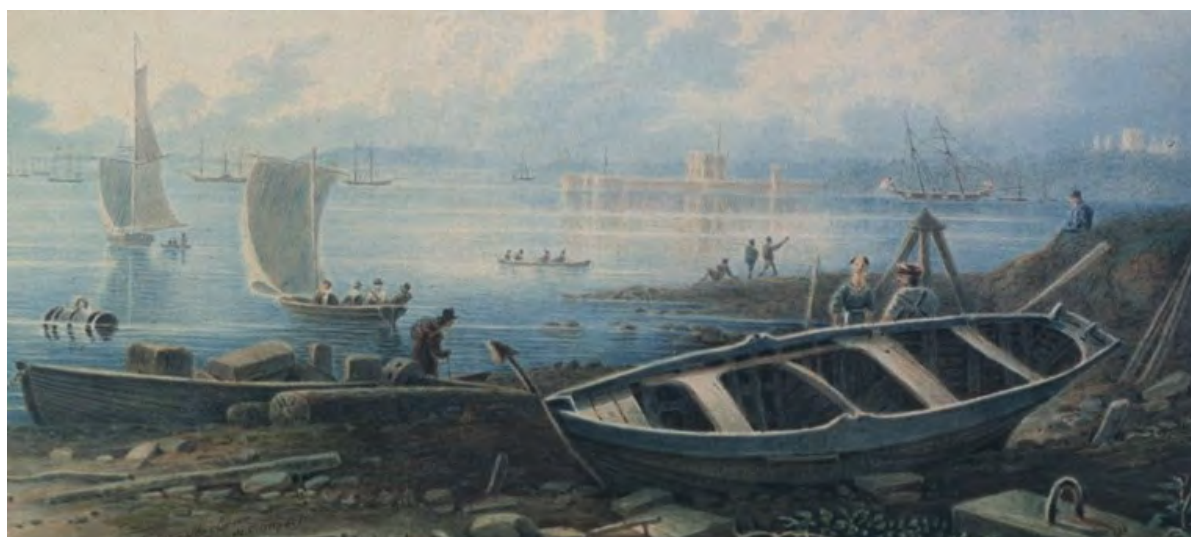
Figure 5.49: Sydney Harbour in the 1840s showing small craft around the foreshore. Note the square sterned boat, with rudder, its foremast bearing a square sail, smaller in size than UDHB1.

not have been large or needed to be transported quickly, and did not require a large financial investment to own and operate (Figure 5.49).¹⁷¹

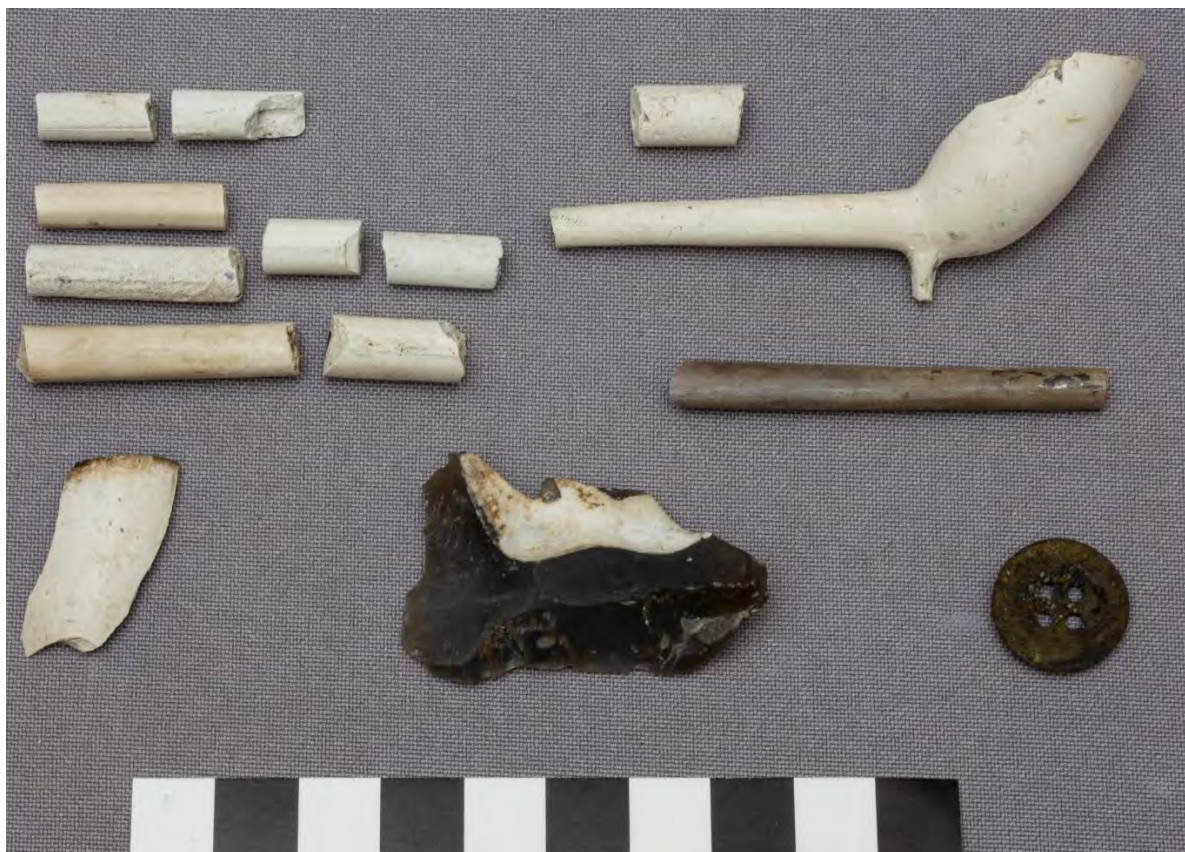
Figure 5.50: Artefacts from the mid ship area of UDHB1, below ceiling planks (l-r). Top row: pipe stems: 154/#20187 (2), 158/#20191, near whole pipe 154/#20188. Second row: pipe stems 158/#20190 (6), glazed/stained stem #158/#20192. Bottom row: pipe bowl 158/#20193, flint/strike-a-light #158/#20194, brass 4-hole button #158/#20195. 100mm scale. IMG_3834. Source: R. Workman.

A circular brass button found in 158 is the same japanned black style as buttons found in 152, 246 and 249, suggesting someone had a stash of buttons, possibly a tailor, or a whole garment had been thrown away (see Figure 5.50).

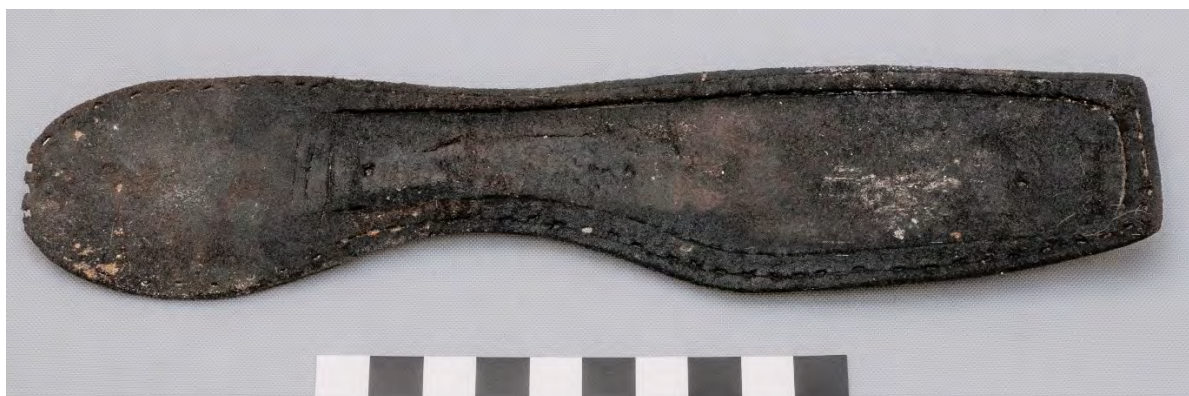
Figure 5.51: Outsole of turned shoe (158/#25579). 100mm scale. Img_5383. Source: R. Workman.

Within 158, one whole turned sole with a square toe was found (Figure 5.51). Turned shoes have the upper stitched directly to the sole inside out before being turned. This technique was mainly used for indoor shoes and slippers, and was commonly used on children's shoes even after the introduction of welted manufacture. These shoes are dated until ca.1860 when new technology changed the way shoes were made. This piece is likely to have floated into the bilge when the boat was ashore and awash at the higher tides.

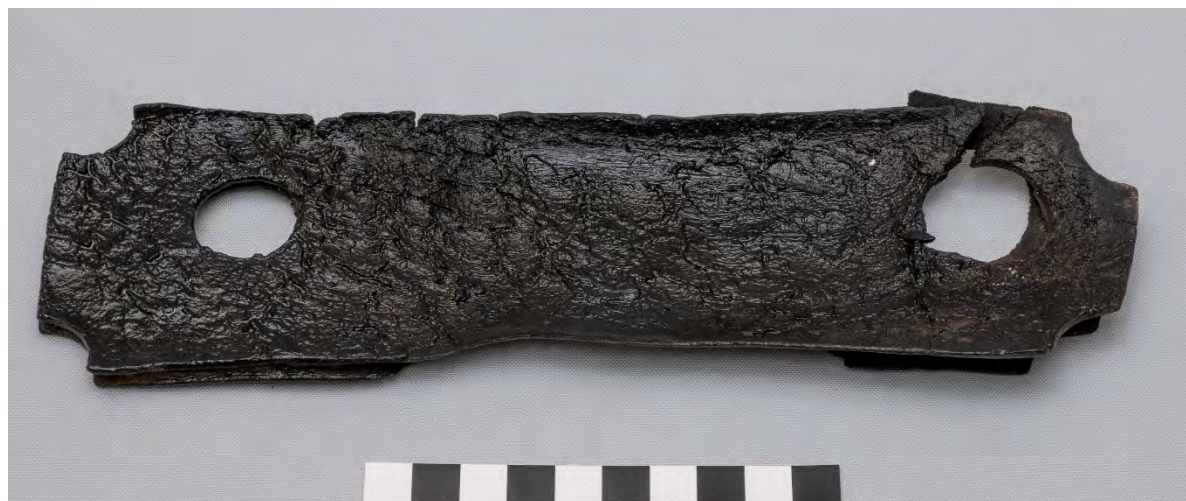
Figure 5.52: Unidentified piece of leather (158/#25585). 100mm scale. Img_5387. Source: R. Workman.

An unidentified piece of leather found in 158 appears to be a gasket and may have been associated with a pump (Figure 5.52). It is a flat rectangular piece of thick leather with inverted corners and two large circular holes at each end. There are wear and cut marks in the centre. This object may have formed part of a fitting on UDBH1.

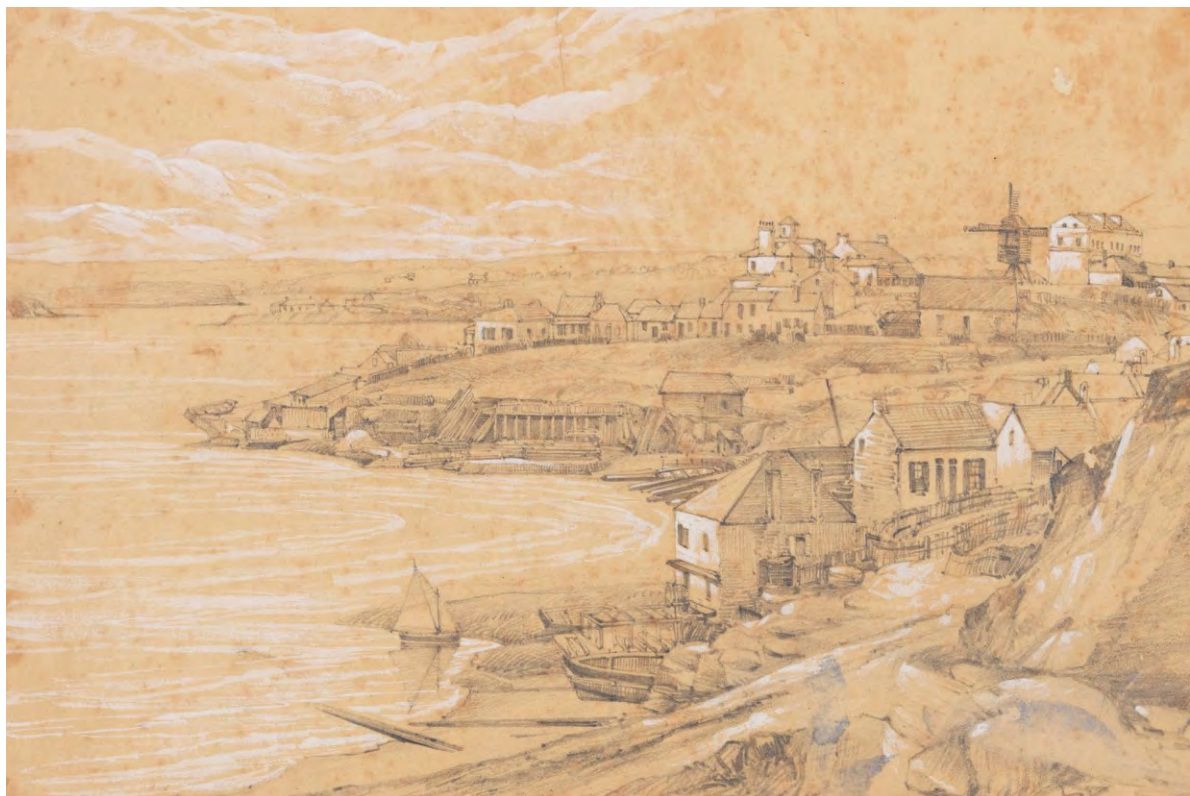
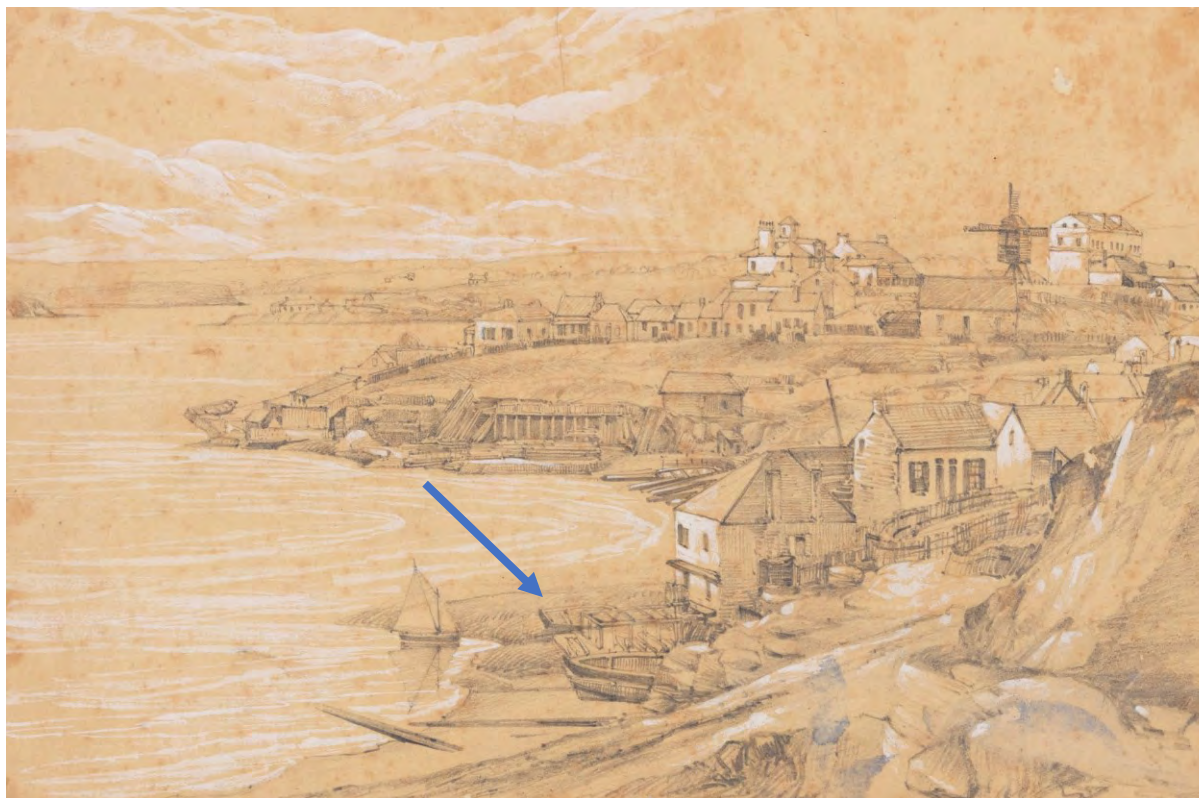
Figure 5.53: View overlooking Langford's Boatyard ca. 1854. Note the boat of similar dimensions to UDHB1 (blue arrow) dragged up in front of Langford's house.

A series of sketches and watercolours from the mid-1800s that incorporate Langford's boatyard give an informative glimpse into the arrangement of the waterfront at that time and the vessels associated with the establishment (see Figure 1.9 and Figure 3.8). Two images produced by Samuel Elyard provide a tantalizing possibility of the incidental depiction of UDHB1 (Figure 5.53 and Figure 5.54).¹⁷⁸ The sketch, dated to around 1854, shows a number of boats dragged ashore in front of and adjacent to Langford's boatyard, as well as to the west where Cuthbert's shipyard had become established by that time (Figure 5.53).

Of interest is the small boat situated in front of Langford's house. The heel of the vessel, to starboard, and its size mimics UDHB1. However this depicted vessel is not UDHB1. This is because it sits in front of the building and there is higher, dry ground to the west of it. When this drawing was made in the 1850s, there was no reclamation or higher ground to the west of the wreck (compare Figure 3.5 and Figure 3.9). A watercolour dated a decade later but seemingly based on the aforementioned sketch, shows the boat from a slightly different angle (Figure 5.54). In this image the boat is on the same elevation as the ground entrances to Langford's building. The location of UDHB1 places it in the intertidal zone to the north west of the building on the seaward side of reclaimed land (see Figure 3.14). The base of the boat would have been around 2 m below the threshold for the ground entrance to the building.
