Sydney Metro Project Barangaroo Station UDHB1 'Barangaroo Boat'

Excavation Report VOLUME 2

Sydney Metro Project: Barangaroo Station

Excavation Report

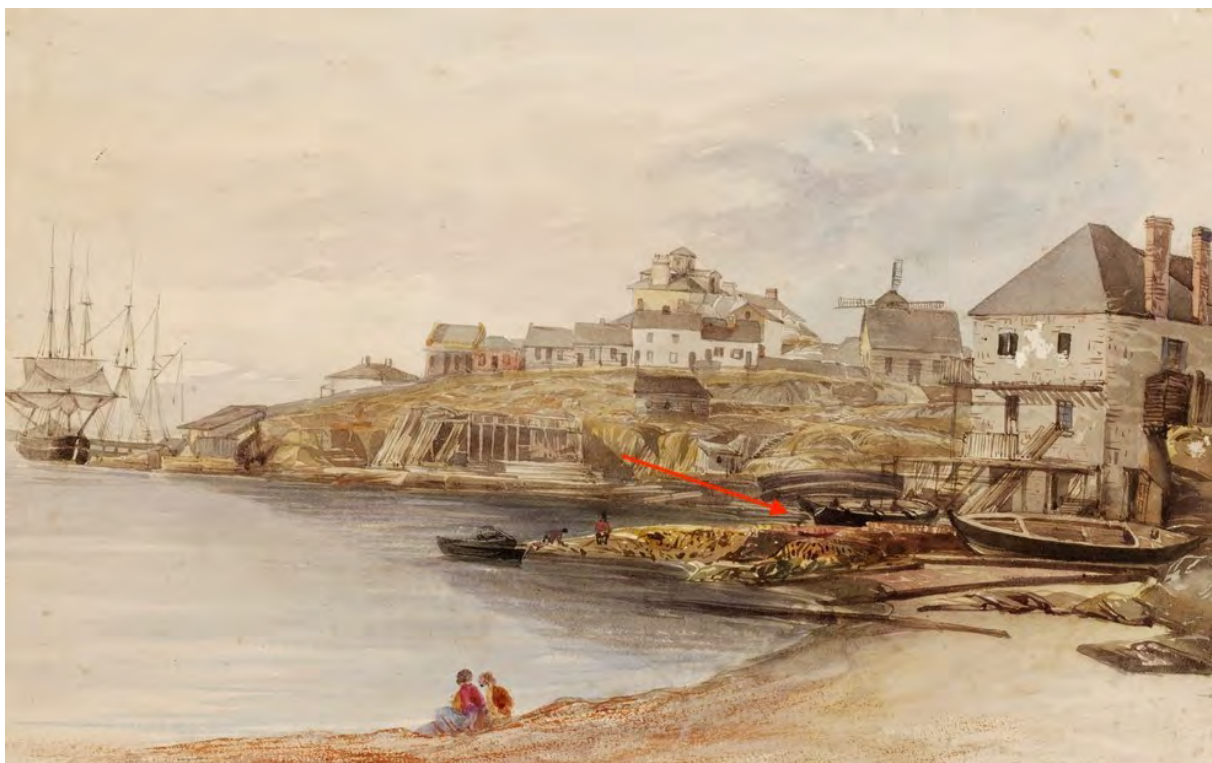
Figure 5.54: View of Millers Point/Darling Harbour showing the Langford boatyard (right) with beaches on either side dated from 1862 to 1873 but likely based on sketch from previous decade (see Figure 5.53). The black hulled boat (red arrow) is heeled to starboard and of a similar length to UDHB1. It appears to lay in front of Langford's house at ground level.

The similarities between where the boat was discovered and a similar type of vessel sitting on reclaimed land in front of Langford's house could lead to the speculation that the vessel in the aforementioned images was in fact UDHB1, and that it was eventually moved to the intertidal zone after these images were created. If this took place after the mid-1850s, it would mean that it broke down, with the remains largely buried by marine sediments, in a relatively short period of time. This scenario is actually less plausible, because the vessel was abandoned at an establishment which regularly built vessels of a similar size. The vessel depicted in Samuel Elyard's drawing and painting from the mid-1850s is extremely likely to have been just one of the many boats built by the Langfords. However, the boats shown in these images influenced the interpretation of the appearance of UDHB1 (see Section 5.3).

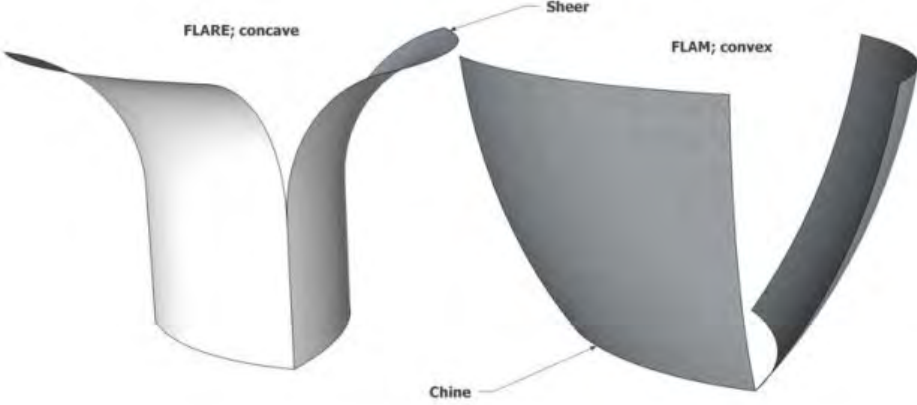
<p>Fairing</p>	<p>Making ship lines even and smooth with a uniform curve without hollows or bumps.</p>
<p>Flam</p>	<p>Similar to flare or flair, the sides of the bow of a vessel curving gradually outward from the base. If the curve is concave, the vessel is said to “flare”, if it is convex, the vessel is said to “flam”.</p>

<p>The diagram shows two cross-sections of a ship's hull. The left one is labeled 'FLARE; concave' and shows a hull that curves inward towards the centerline as it rises. The right one is labeled 'FLAM; convex' and shows a hull that curves outward. Labels include 'Sheer' at the top edge and 'Chine' at the bottom edge of the hull.</p>
<p>Floors</p>	<p>Frames on the bottom planking up to the eighth strake at the bilge before the upturn to the topside planking. They were spread from port to starboard sides evenly over the keel.</p>

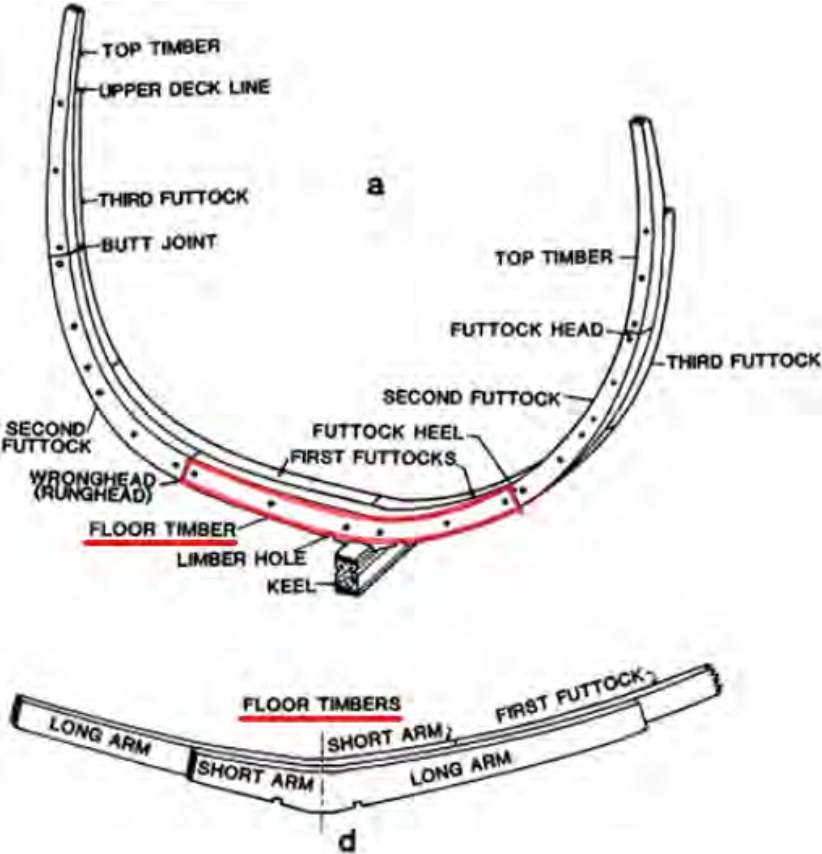
<p>The diagram shows a cross-section of the hull's bottom structure. It is divided into two parts: 'a' and 'd'. Part 'a' shows the upper hull structure with labels: TOP TIMBER, UPPER DECK LINE, THIRD FUTTOCK, BUTT JOINT, TOP TIMBER, FUTTOCK HEAD, THIRD FUTTOCK, SECOND FUTTOCK, FUTTOCK HEEL, and FIRST FUTTOCKS. Part 'd' shows the lower hull structure with labels: FLOOR TIMBERS, LONG ARM, SHORT ARM, and FIRST FUTTOCK. Other labels include WRONGHEAD (RUNGHEAD), FLOOR TIMBER, LIMBER HOLE, and KEEL.</p>

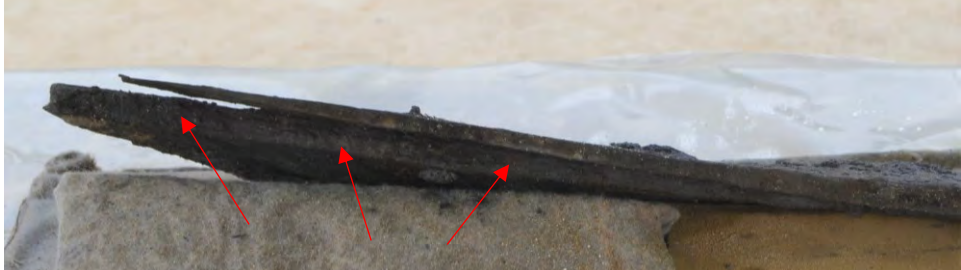
<p>Gerald rabbet</p>	<p>Also, jerrold, chase, or gain; a rabbet cut into the top edge of the forward hood of a clinker planked vessel to enable the hemming plank above it to sit flush. See UDHB1 timber id: 341 (picture of Gerald below).</p>

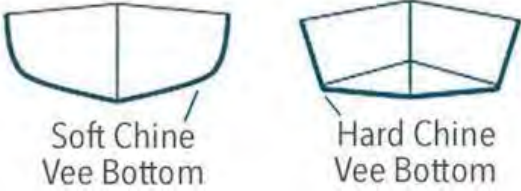
<p>Grown</p>	<p>Timber which is either part of a trunk where a branch grew; or a branch with the required angle bend in it. Other terms used are <i>crooked</i> or <i>compass</i>.</p>
<p>Hard bilge</p>	<p>Also referred to as a hard chine. Where the bottom part of the hull (bilge) meets the upper hull. If the meeting point is more angular than round, it is called a hard bilge.</p> <div style="text-align: center;">

<p>Soft Chine Vee Bottom Hard Chine Vee Bottom</p> </div>
<p>Hood end</p>	<p>Also hood or hooded ends; the length of the ends of the skin planks that lay against the apron or inner stem or sternpost.</p> <div style="text-align: center;">

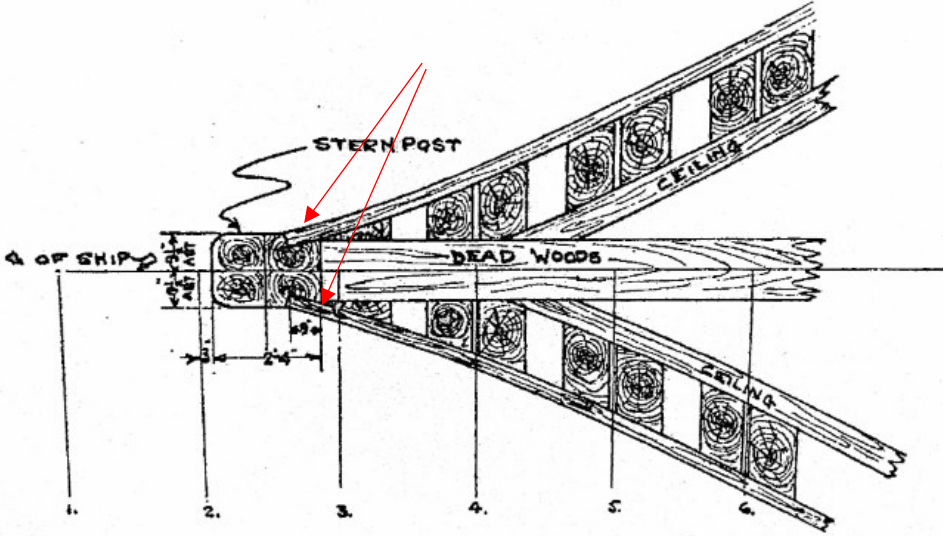
<p>Fig. 34—Sectional plan view of stern showing planking rabbeted into stern-post and deadwood; also cant frames and ceiling.</p> </div>
<p>Inwale</p>	<p>A longitudinal secondary main structural timber fitted inside the heads of the frames or timbers and under the capping to form the vessel's gunwale.</p> <div style="text-align: center;">

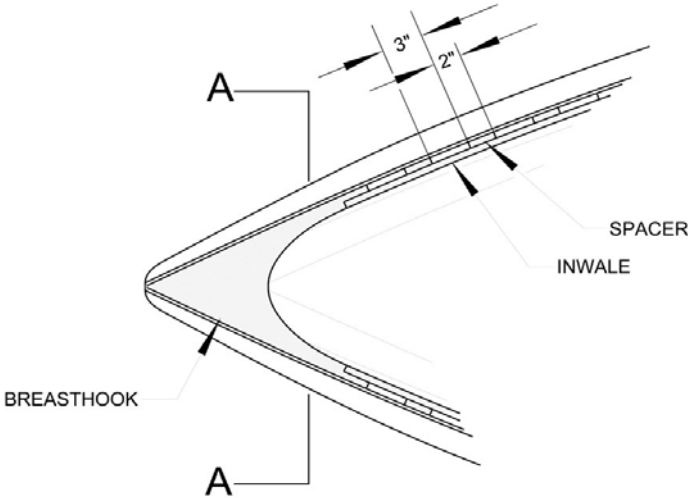
<p>BREASTHOOK SPACER INWALE</p> </div>

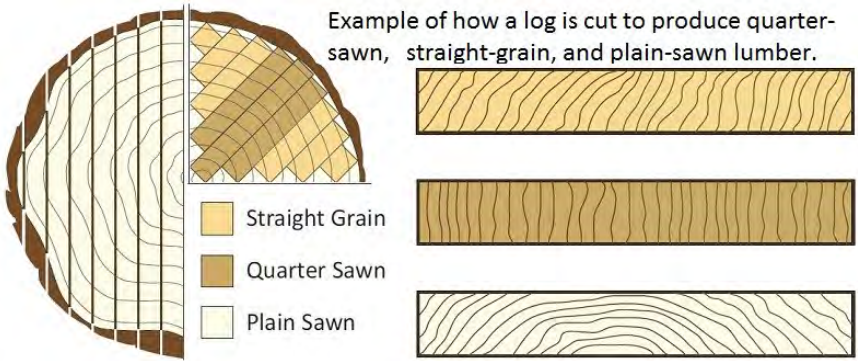
<p>Example of how a log is cut to produce quarter-sawn, straight-grain, and plain-sawn lumber.</p>

<ul style="list-style-type: none"> Straight Grain Quarter Sawn Plain Sawn
<p>Rabbet</p>	<p>A depression or channel in a piece of timber cut for the purpose of receiving and securing the edge and hood ends of bottom and side planking, for example, the rabbet of the keel and deadwood to receive the garboard strake.</p>
<p>Rider Keel</p>	<p>One or more additional keels bolted to the bottom of the main keel to increase its strength. In the circumstance of UDHB1 the rider keel was added to support the outer layer of planking. It should not be confused with a false keel, whose primary purpose was to protect the keel's lower surface.</p>
<p>Ripped or rip cut</p>	<p>A ripped frame is a bent frame partly sawn longitudinally to make it easier to bend.</p>
<p>Riser</p>	<p>Also rising, riser timber or rising timber. A horizontal longitudinal non-structural timber on the inside of the side frames or timbers of a wooden hull to form a ledge for thwarts.</p>

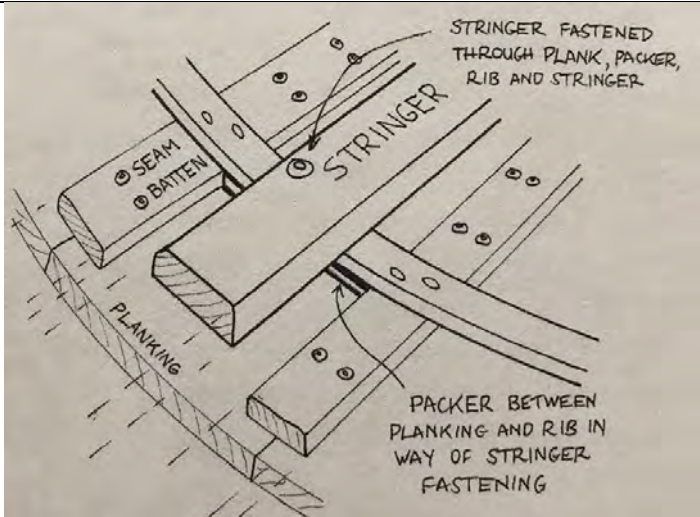
Seam batten

A strip of wood or metal fastened over a flush joint or seam to prevent leakage or for strengthening purposes; also known as a *welt*. In the context of planking, a longitudinal member that reinforces the joint between rows of planking, placed between the frames and the planking.

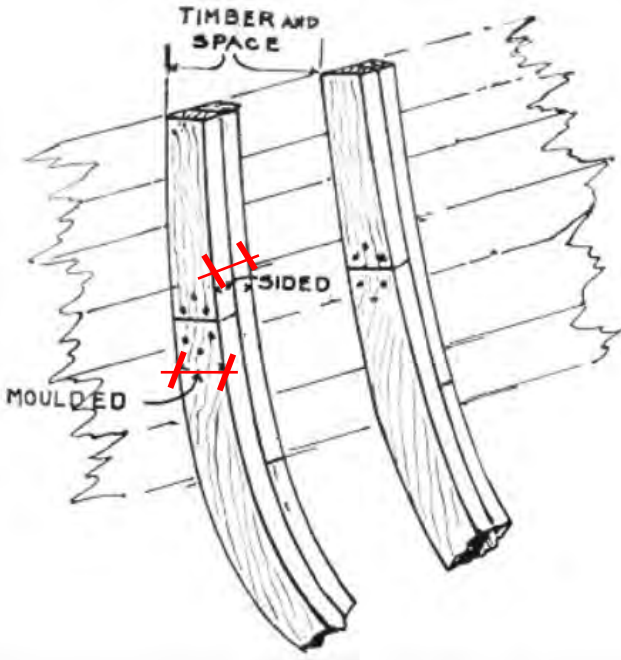
<p>Sided</p>	<p>The dimension of an un moulded surface; the distance across an outer frame surface, the forward or after surface of a stem or sternpost, or the upper surface of a keel or keelson.</p>

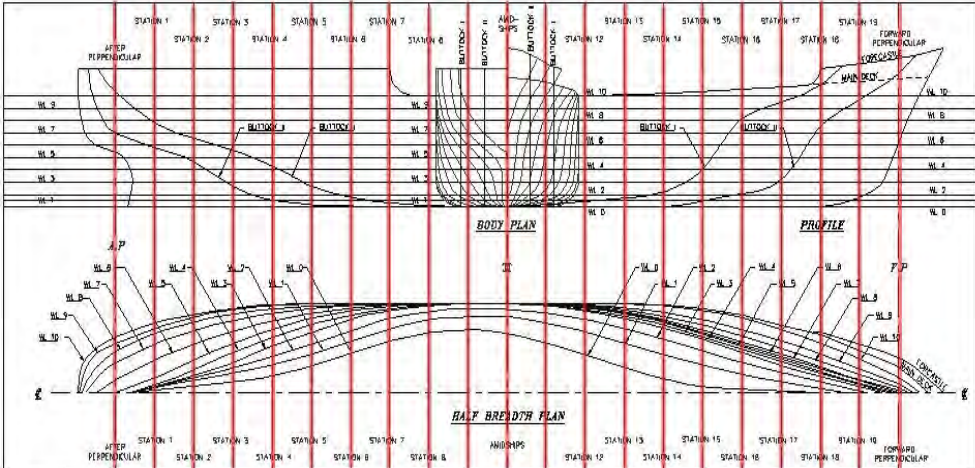
<p>Station</p>	<p>One of a series of equally spaced transverse cross-section slices of the hull as shown in the lines drawing.</p>

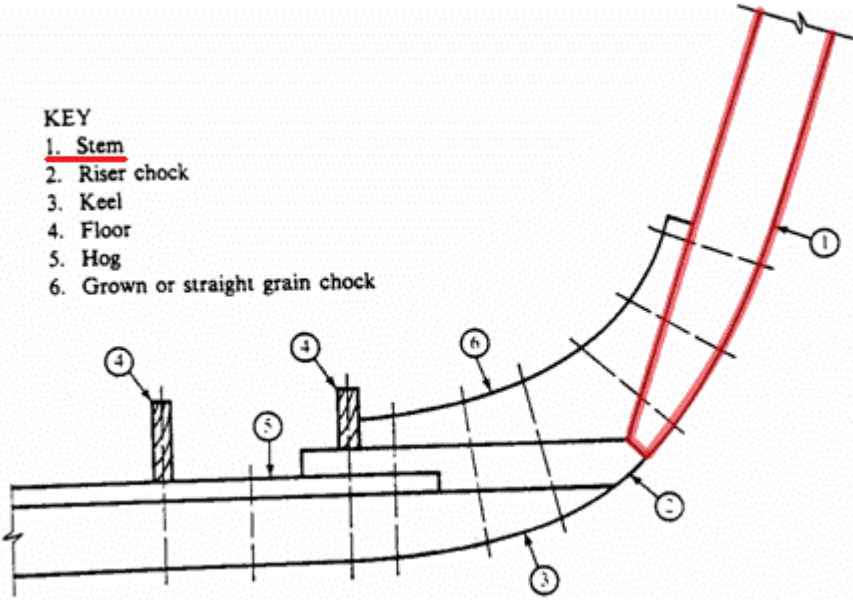
<p>Stem</p>	<p>A heavy timber forming the extreme bow of the ship extending from the keel to the forecastle deck. The forehood planking terminates at the rabbet and is firmly fastened to the stem.</p>

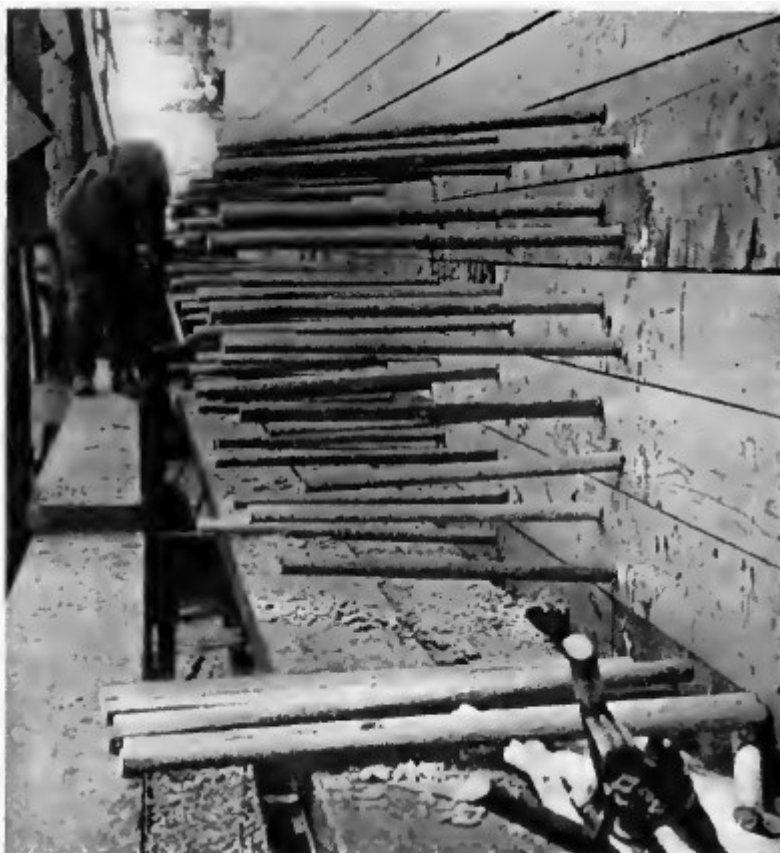
Tree nail

Timber dowell used to fasten timbers *in lieu* of metallic nails. Also called *treenail* and *trunnel*.

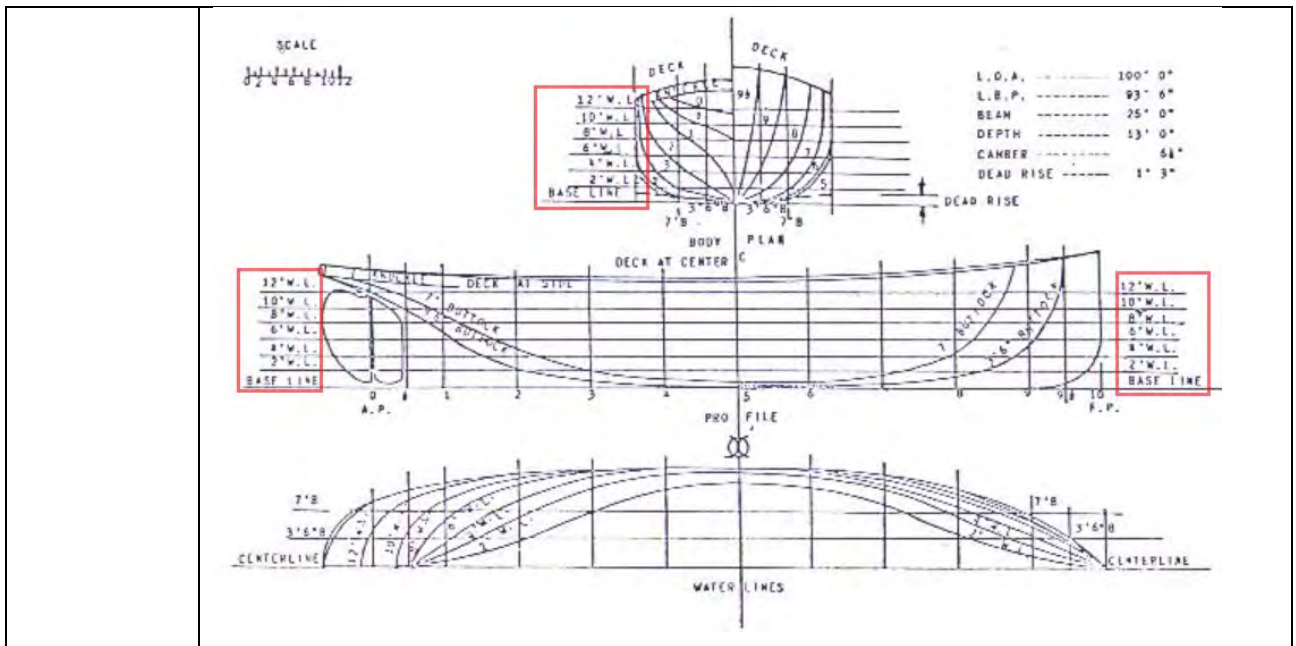
Waterlines Lines on a hull drawing representing the horizontal sections of the hull. These are horizontal lines intended to represent the surface line of the water on the sides of a ship.
