Pre-Construction Minor Works Approval Form

Part 1: Application	
Contractor:	METRON T2M
Project:	Southwest Metro Design Services (SMDS)
Application Title: (e.g. Smith St trenching works)	Utility and Sanitary Pipe Investigations at Belmore and Lakemba stations precinct.
Application Number:	SMDS-PCMWW-007
Application Date:	Rev00:16.04.2020 Rev01:28.04.2020
Planning Approval:	<ul style="list-style-type: none"> Sydney Metro City and Southwest – Sydenham to Bankstown – Environmental Impact Statement (EIS) Sydney Metro City and Southwest – Sydenham to Bankstown – Submissions and Preferred Infrastructure Report (SPIR) Sydney Metro City and Southwest Infrastructure Approval SSI-8256
Minor Works Categories: <ul style="list-style-type: none"> Highlight as applicable. If Items 4, 8 or 11 are applicable, this form must be endorsed by an Environmental Representative. 	<ol style="list-style-type: none"> Survey, survey facilitation and investigation works (including road and building dilapidation survey works, drilling and excavation). Treatment of contaminated sites. Establishment of ancillary facilities (excluding demolition), including construction of ancillary facility access roads and provid

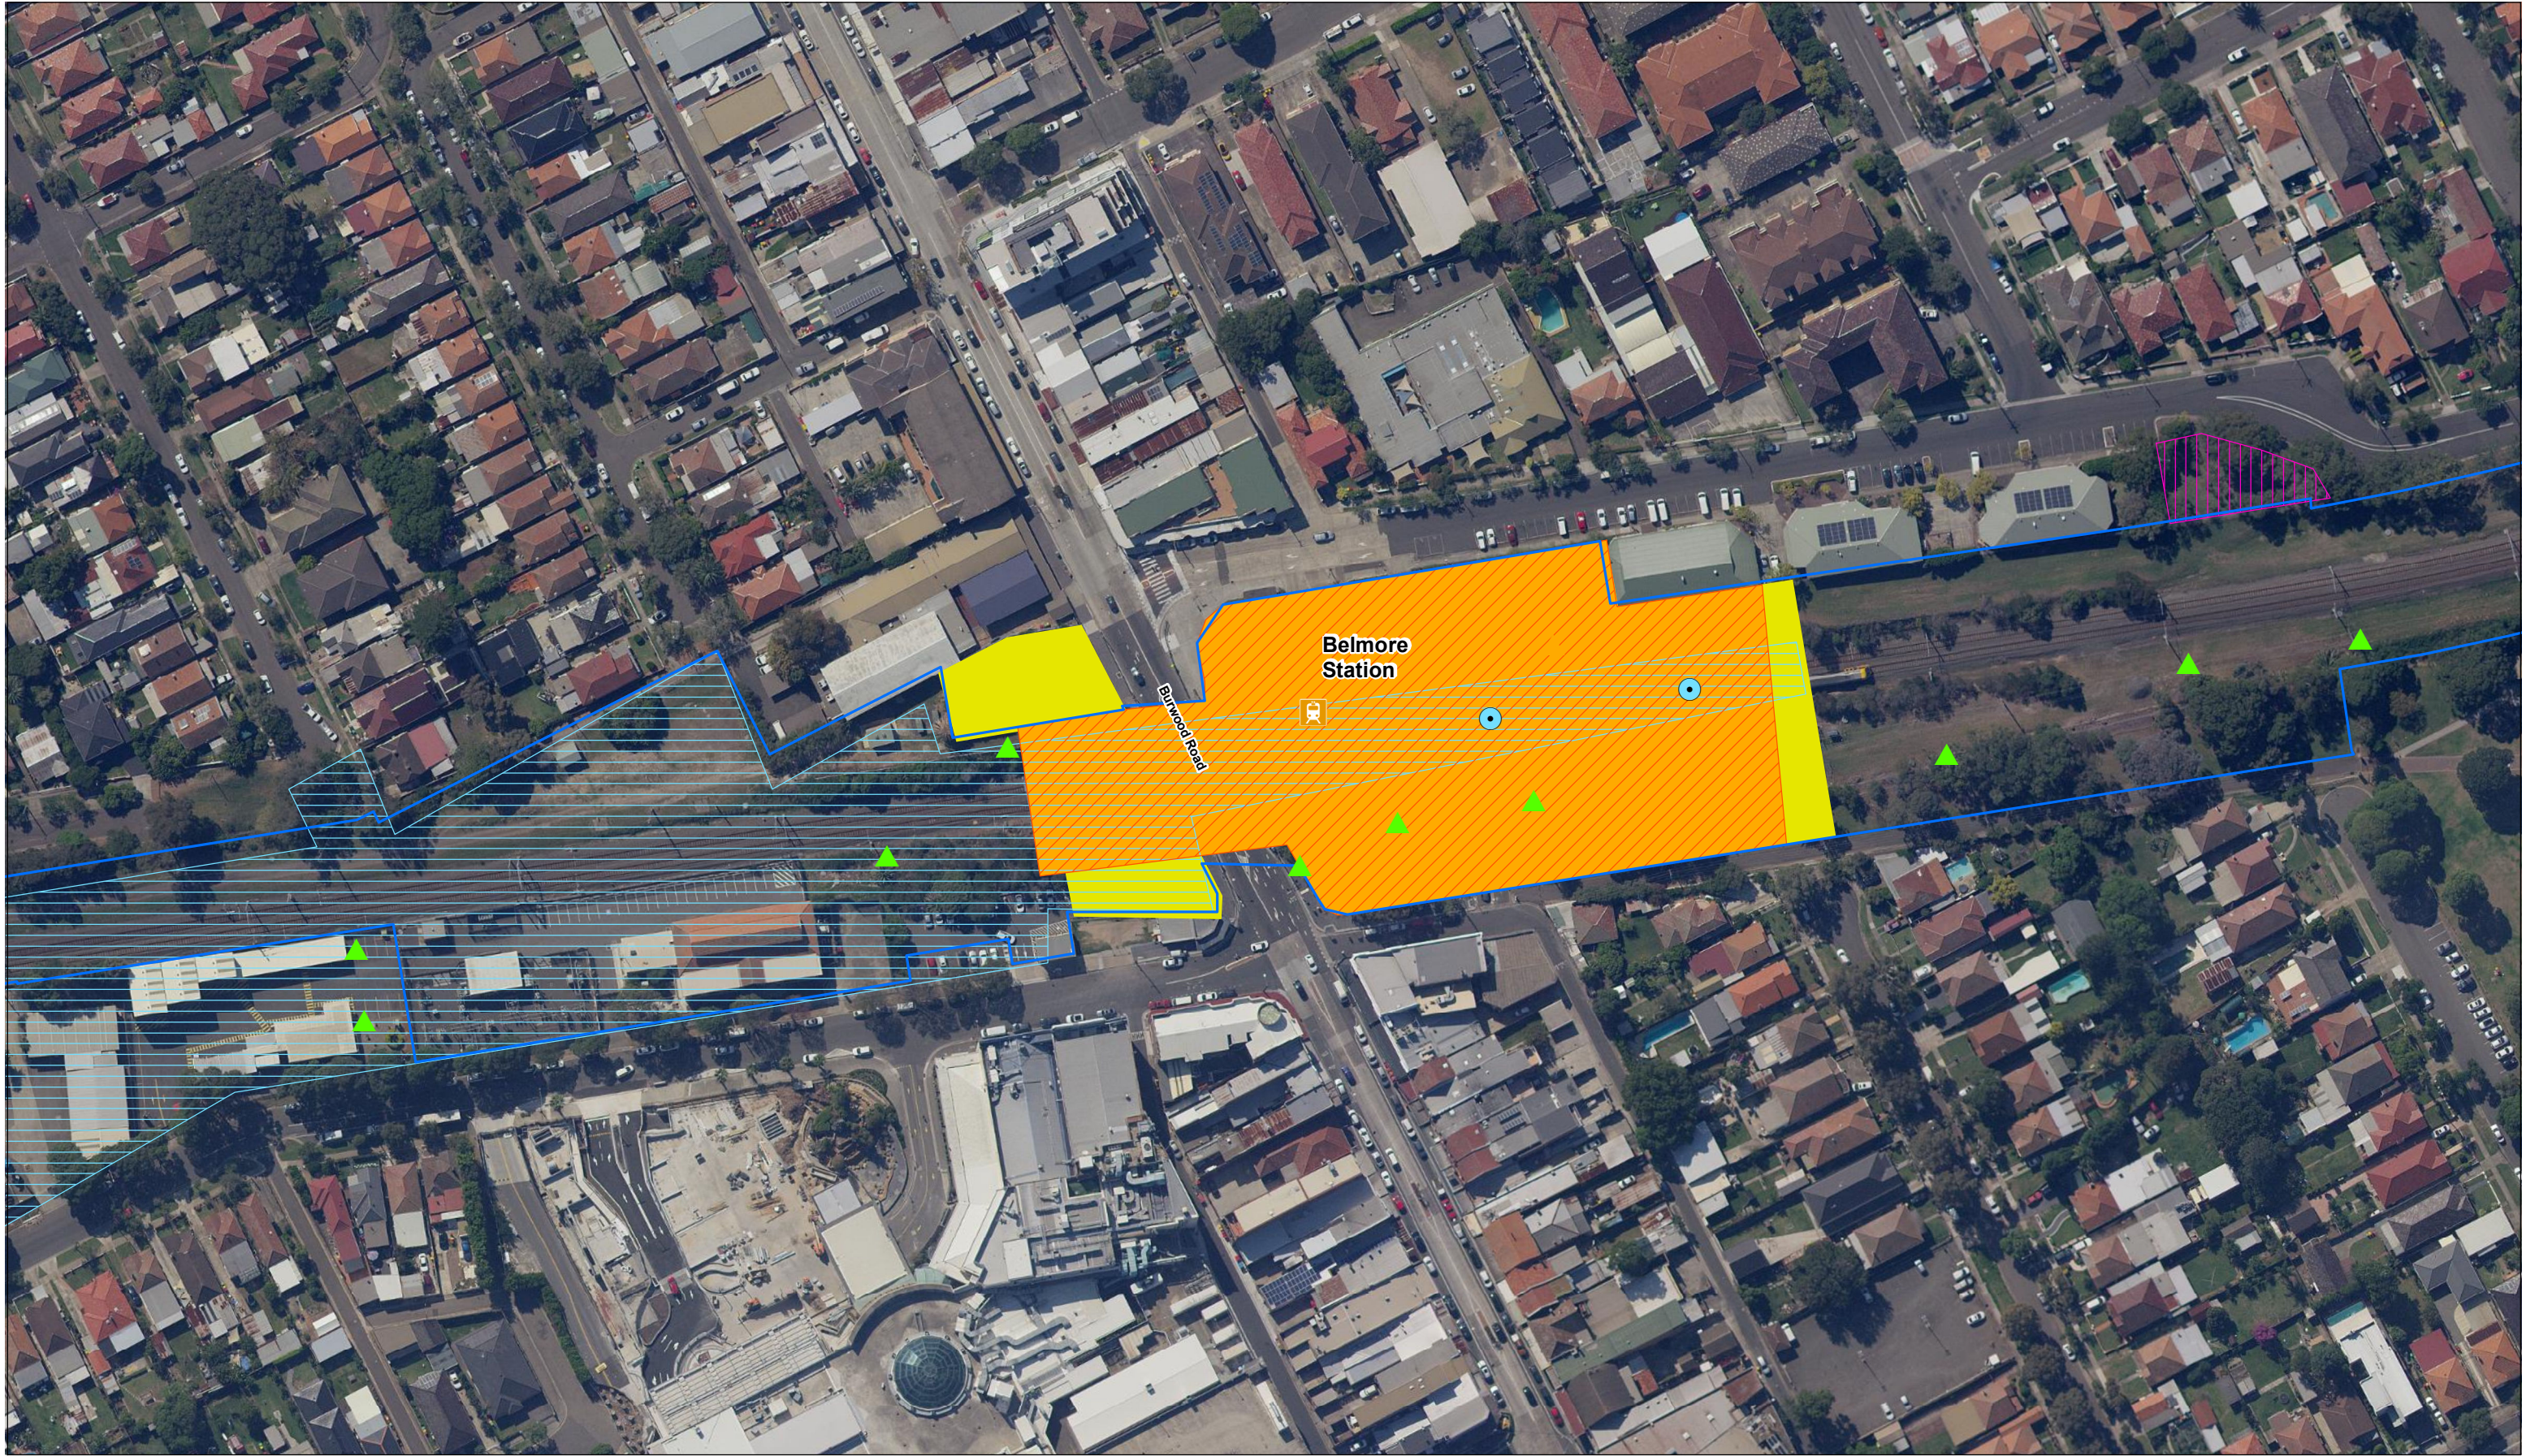
- Stations
- Corridor Boundary
- Potholes (approx. locations)
- AGJV Contamination (approx. locations)**
- General solid waste
- General solid waste w asbestos
- Restricted solid waste

- GHD 2017 Contamination (approx. locations)**
- General solid waste
- General solid waste w asbestos
- Hazardous waste
- Restricted solid waste
- Not completed
- Threatened Species Sightings**
- Grey-Headed Flying-Fox

- Local Heritage
- Conservation Areas
- Threatened Ecological Community**
- Broad-leaved Ironbark - Grey Box - Melaleuca decora grassy open forest (ME004, Moderate/good)
- Degraded Turpentine - Grey Ironbark open forest on shale (ME041, Moderate/good-poor)
- Turpentine - Grey Ironbark open forest on shale (ME041, Moderate/good-medium)

1 cm = 15 meters
 GDA 1994 MGA Zone 56
 28/04/2020

Sanitary pipe investigation minor works would essentially involve potholing works at Belmore Station. Indicative individual pothole locations proposed for each station is shown in the environmental control maps provided at Appendix 1.

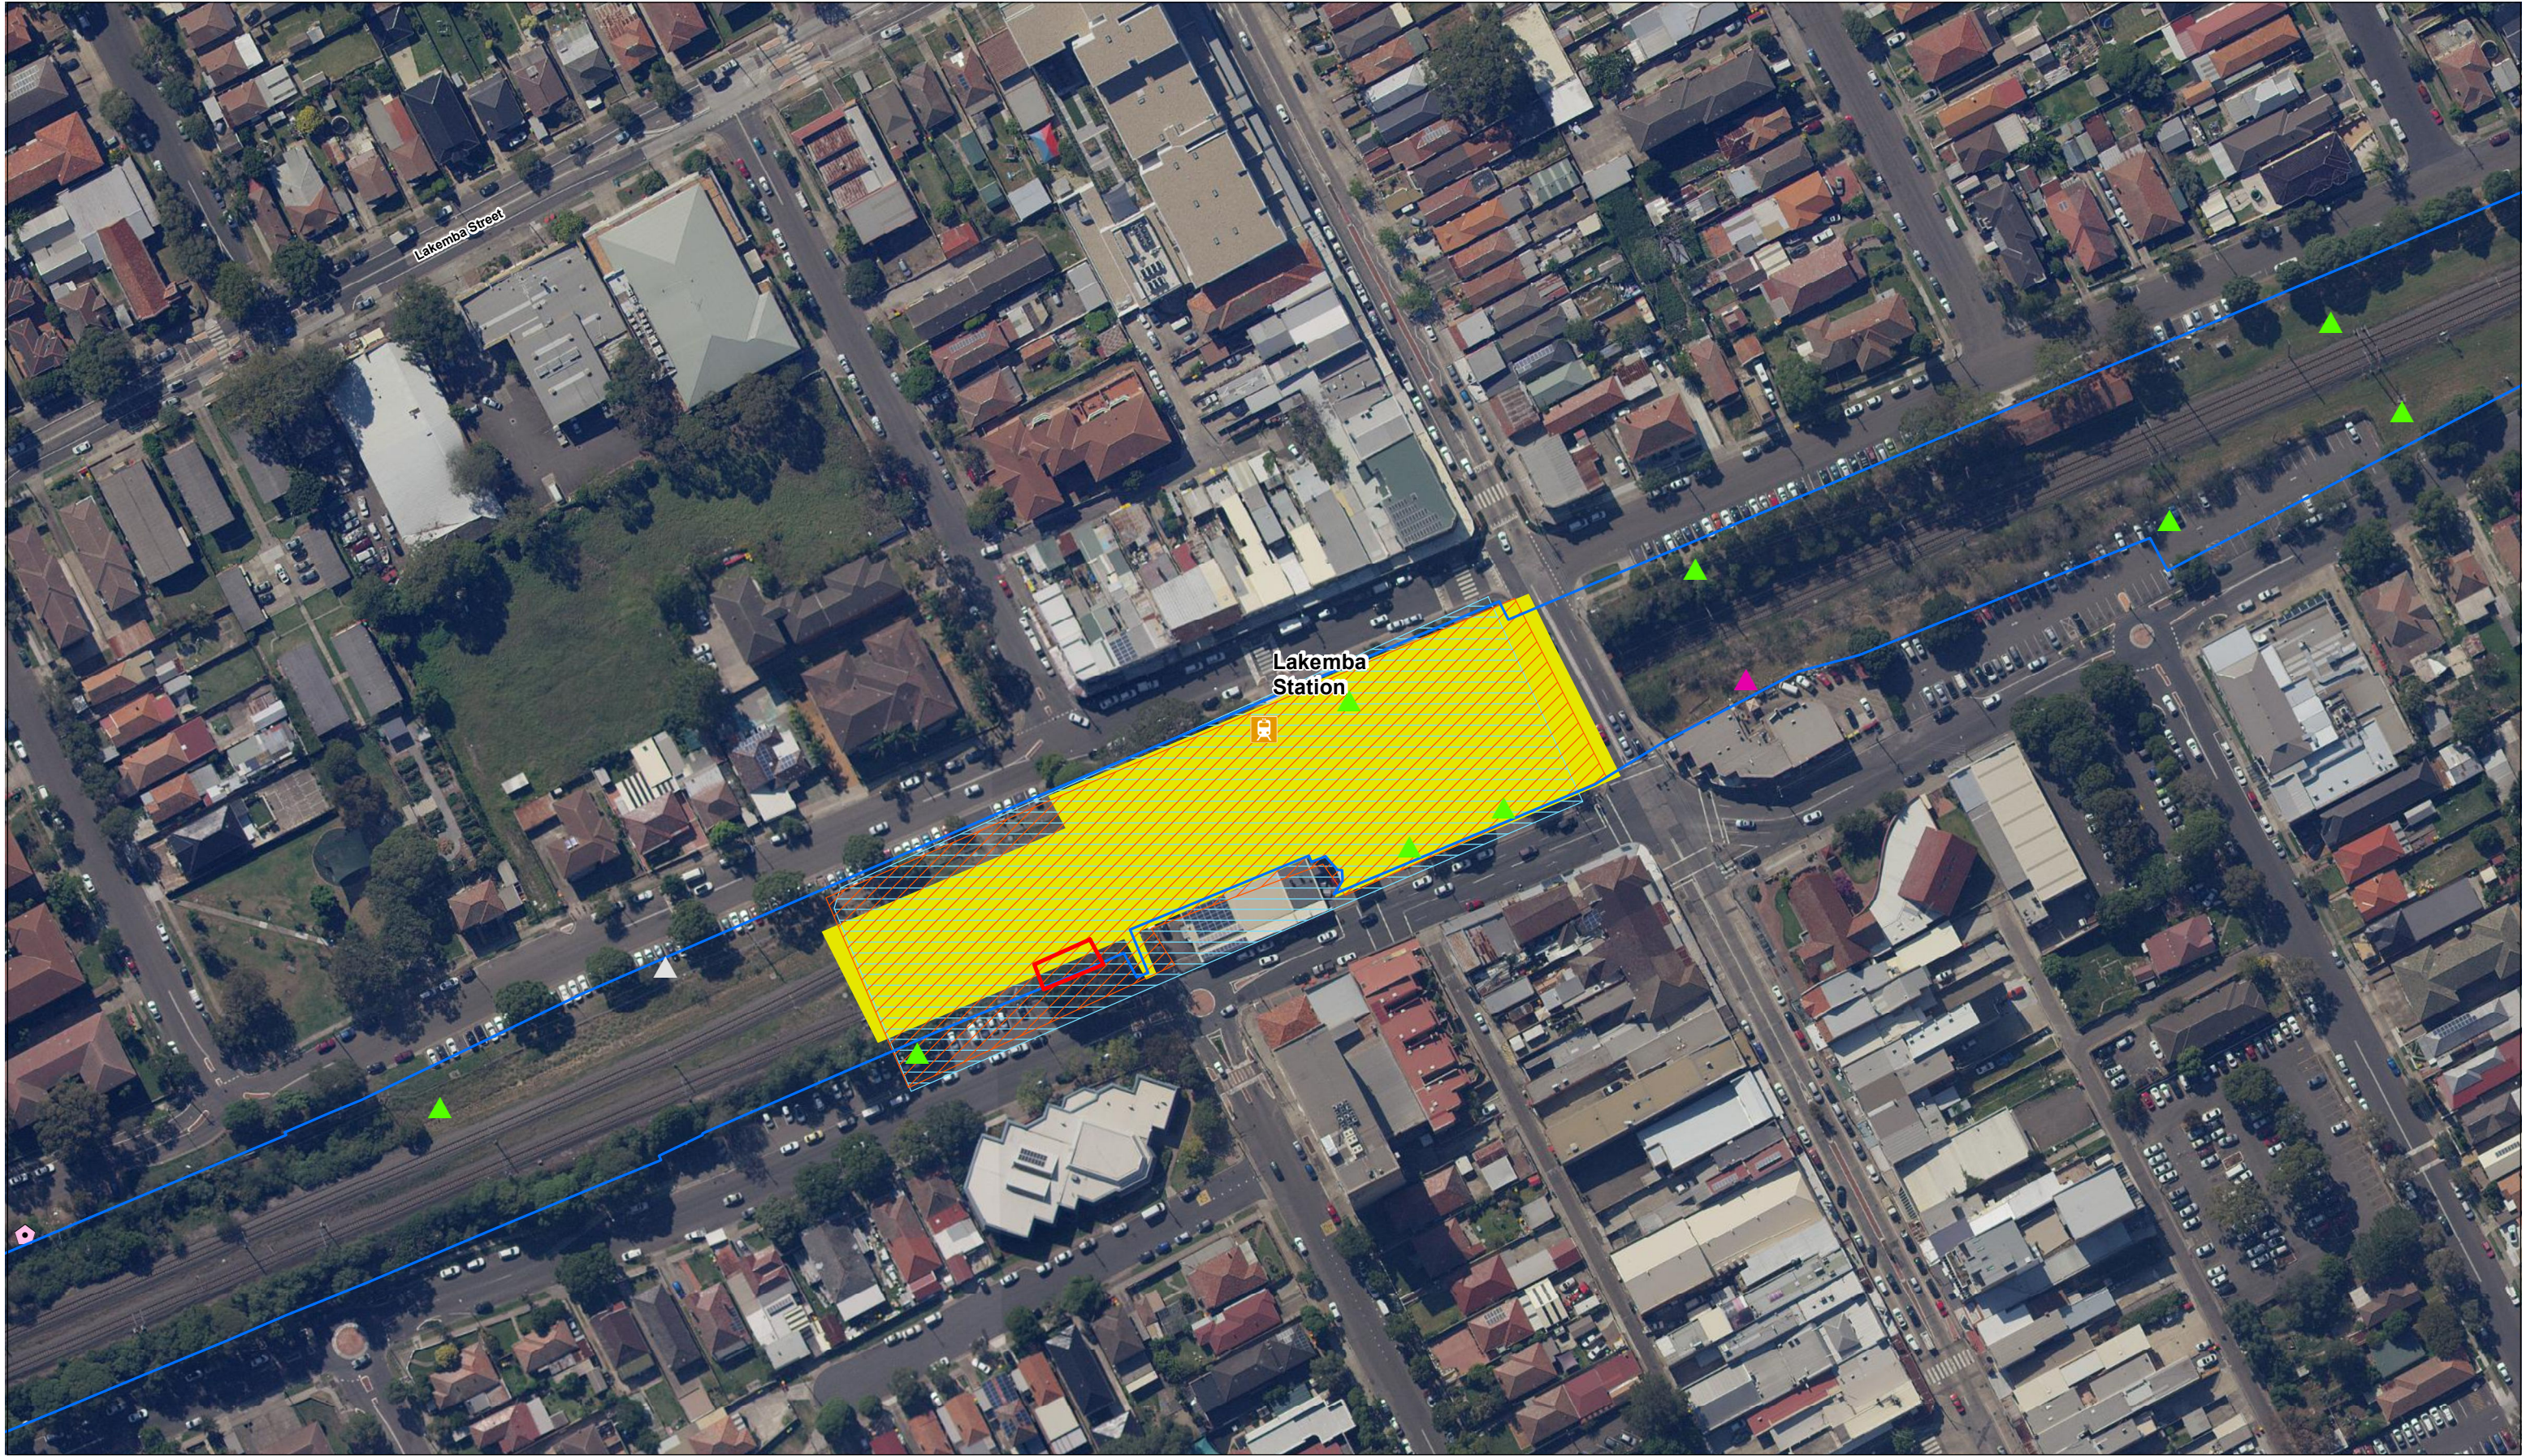
Southwest Metro Design Services
Environmental Sensitivities: Minor Works Map

- Stations
- Corridor Boundary
- Utilities (approx. locations)
- AGJV Contamination (approx. locations)**
- General solid waste
- General solid waste w asbestos
- Restricted solid waste

- GHD 2017 Contamination (approx. locations)**
- General solid waste
- General solid waste w asbestos
- Hazardous waste
- Restricted solid waste
- Not completed
- Threatened Species Sightings**
- Grey-Headed Flying-Fox

- Local Heritage
- Conservation Areas
- Threatened Ecological Community**
- Broad-leaved Ironbark - Grey Box - Melaleuca decora grassy open forest (ME004, Moderate/good)
- Degraded Turpentine - Grey Ironbark open forest on shale (ME041, Moderate/good-poor)
- Turpentine - Grey Ironbark open forest on shale (ME041, Moderate/good-medium)

<p>Utility investigations</p> <p>Utility investigations would involve intrusive potholing works within the rail corridor boundaries at Lakemba station, within indicative locations outlined within sensitivity mapping in Appendix 1. The following works procedure would likely be undertaken:</p> <ul style="list-style-type: none"> • A certified locator will identify utilities locations by using the non-invasive methods (e.g. GeoScan) prior to commence the potholing (excavation) works. This will eliminate a risk of damage to utilities which potentially could be located close to target test locations • Road to be cut (if necessary). Not all potholes will be undertaken on the road, some are planned in the corridor hence a road saw will not be necessary • The excess spoil soils will be assessed for contamination by qualified ADE Environmental Consultant and will be disposed off-site appropriately. • NDD potholing plant to safely expose utilities • Utilities to be surveyed to G73 standard • Reinstatement of all excavations will include a combination of excavated materials and stabilized sand to asset owners' specifications and compacted to ensure solid foundation. Bitumen will be reinstated with cold mix to match the existing pavement thickness. The removed asphalt at all stations will be replaced to pre-existing conditions (to match existing asphalt surface). <p>The following equipment would likely be used:</p> <ul style="list-style-type: none"> • Hand digging equipment (e.g. shovels, crowbar, trowel) • Survey hand tools • Concrete saw • Plate compactor or whacker packer • Vacuum truck • Supporting vehicles. <p>Working Hours</p> <p>The proposed works will be undertaken predominately during standard construction hours: <i>Monday to Friday between 7am and 6pm and Saturday between 8am and 6pm.</i> Work outside of standard working hours will be managed under the Out of Hours Works Approval and in accordance with the Sydney Metro City & Southwest Out of Hours Work Protocol.</p>

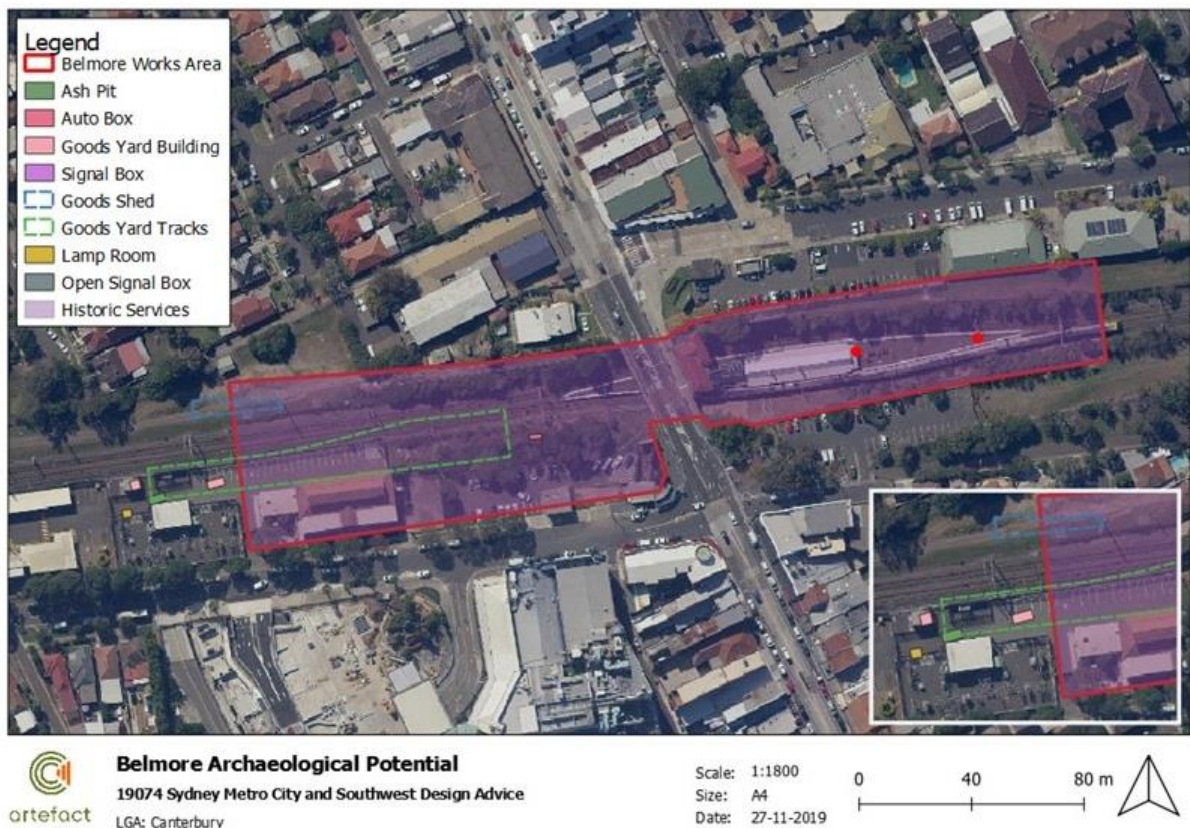
Figure 3. Archaeological potential at Belmore Station (pothole locations in red)

The proposed potholing works would take place within an area of predicted significant archaeological potential associated with the construction and use of the station between 1880 and 1930. The SPIR ARD report defined the following remains may be located within the area of potholing at Belmore Station:⁵

These potholing works would take place within an area identified as Management Zone 2 within the SPIR ARD report. Ground disturbing works in this area would have to adhere to methodologies provided in a work specific AMS, which is provided at the end of this report.

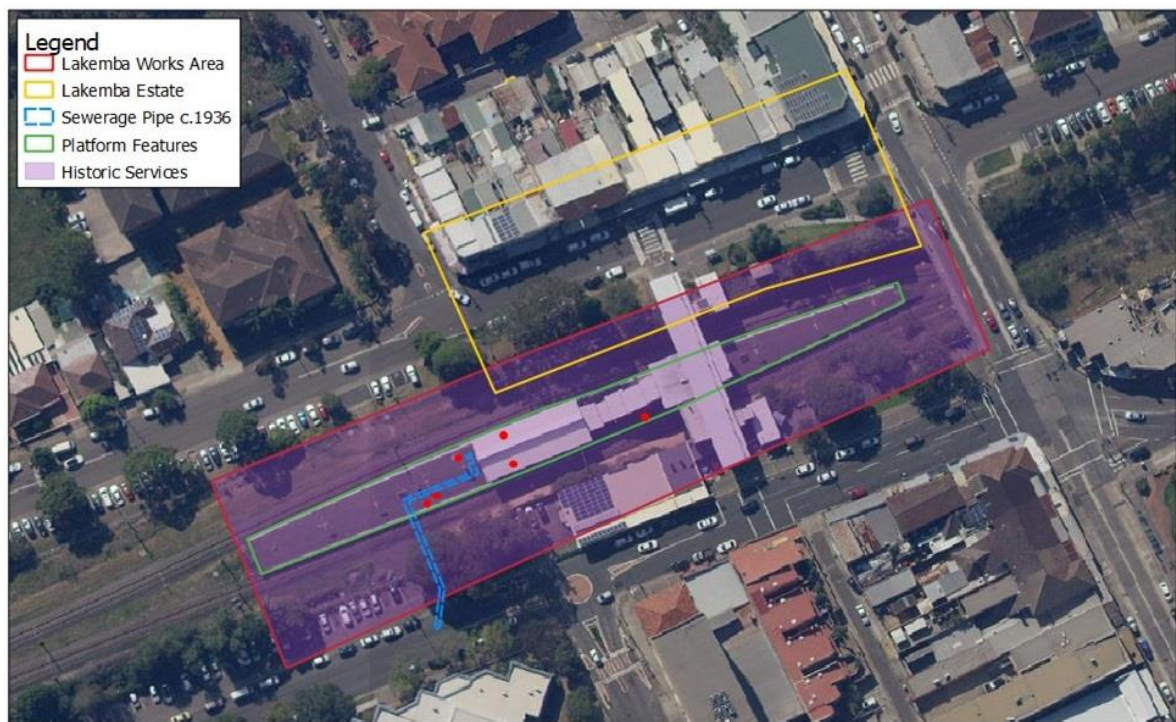
Figure 4. Archaeological potential at Lakemba Station (pothole locations in red)

**Lakemba Archaeological Potential**
19074 Sydney Metro Southwest Design Advice
LGA: Canterbury

The proposed potholing works would take place within an area of predicted significant archaeological potential associated with the construction and use of the station between 1909 and 1919. The SPIR ARD report defined the following remains may be located within the area of potholing at Lakemba Station:⁶

These potholing works would take place within an area identified as Management Zone 2 within the SPIR ARD report. Ground disturbing works in this area would have to adhere to methodologies provided in a work specific AMS, which is provided at the end of this report.

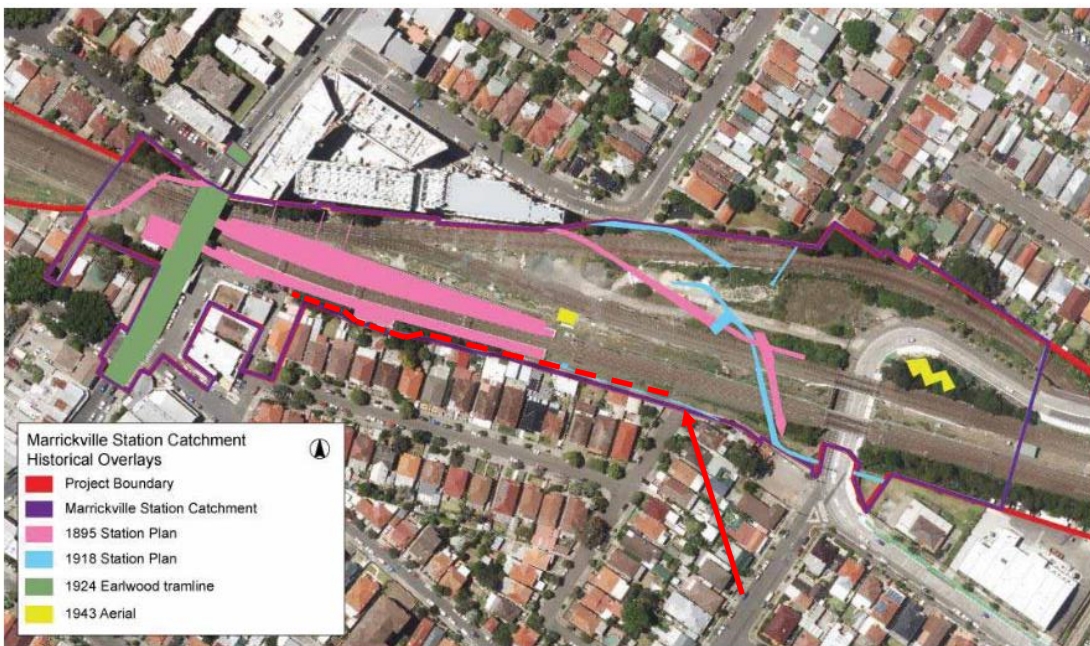
Figure 1. Areas of archaeological potential at Marrickville Station, location of potholing shown as a red dashed line / red arrow

The proposed potholing works are located on the southern edge of the rail corridor at Marrickville Station, and would be conducted to identify the location and integrity of an existing sewer line in this location. Potholing in this area would be conducted at approximately every 20 metres over a length of ground approximately 160 metres in extent.

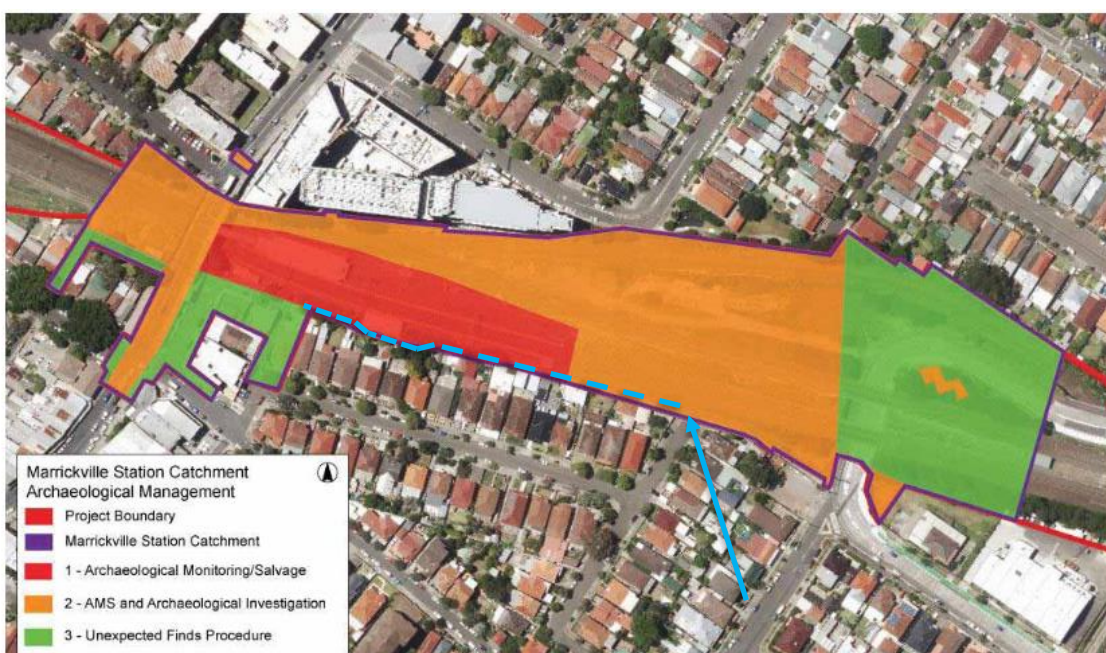
Figure 2: Marrickville Station Catchment archaeological management zones, location of potholing shown as a blue dashed line / blue arrow

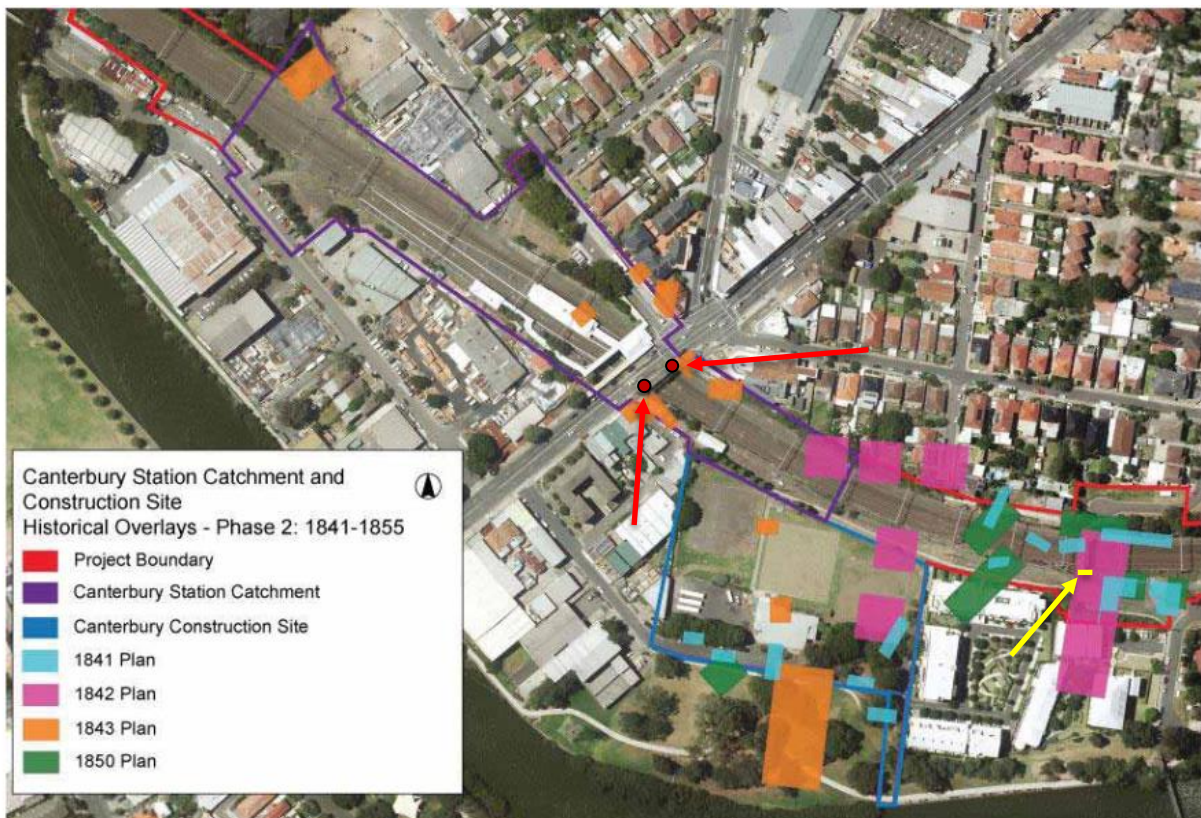
Figure 3. Archaeological Potential at Canterbury Station, location of potholing shown as red circles / red arrows. The location of the potholing between Church Street and Dutton Street (assessed separately below) is shown as a yellow line / yellow arrow

The proposed potholing would be limited to the Canterbury Road overbridge. This area has been assessed as having nil to low potential to contain archaeological remains associated with pre-rail structures and occupation. However, the investigation locations are situated on the current Canterbury Road overbridge over the rail corridor, in an area where all archaeological remains would have been removed during the construction of the railway line in the 1890s.

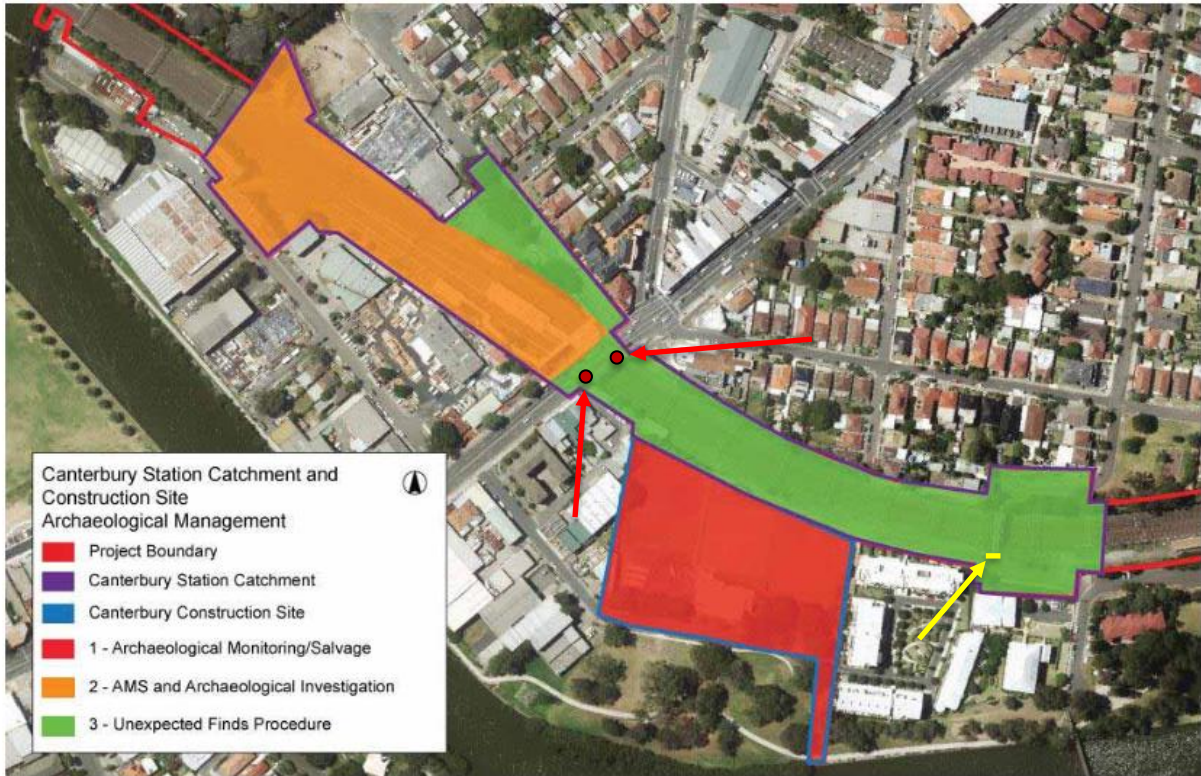
Figure 4: Canterbury Station Catchment archaeological management zones, location of potholing shown as red circles / red arrows. The location of the potholing between Church Street and Dutton Street (assessed separately below) is shown as a yellow line / yellow arrow
