Pre-Construction Minor Works Approval Form

Part 1: Application	
Contractor:	METRON T2M
Project:	Southwest Metro Design Services (SMDS)
Application Title: (e.g. Smith St trenching works)	Intrusive Utility Investigations - Marrickville
Application Number:	SMDS-PCMW-009
Application Date:	Rev00:04.06.2020 Rev01:30.06.2020
Planning Approval:	<ul style="list-style-type: none"> Sydney Metro City and Southwest – Sydenham to Bankstown – Environmental Impact Statement (EIS) Sydney Metro City and Southwest – Sydenham to Bankstown – Submissions and Preferred Infrastructure Report (SPIR) Sydney Metro City and Southwest Infrastructure Approval SSI-8256
Minor Works Categories: <ul style="list-style-type: none"> Highlight as applicable. If Items 4, 8 or 11 are applicable, this form must be endorsed by an Environmental Representative. 	<ol style="list-style-type: none"> Survey, survey facilitation and investigation works (including road and building dilapidation survey works, drilling and excavation). Treatment of contaminated sites. Establishment of ancillary facilities (excluding demolition), including construction of ancillary facility access roads and providing facility utilities. Operation of

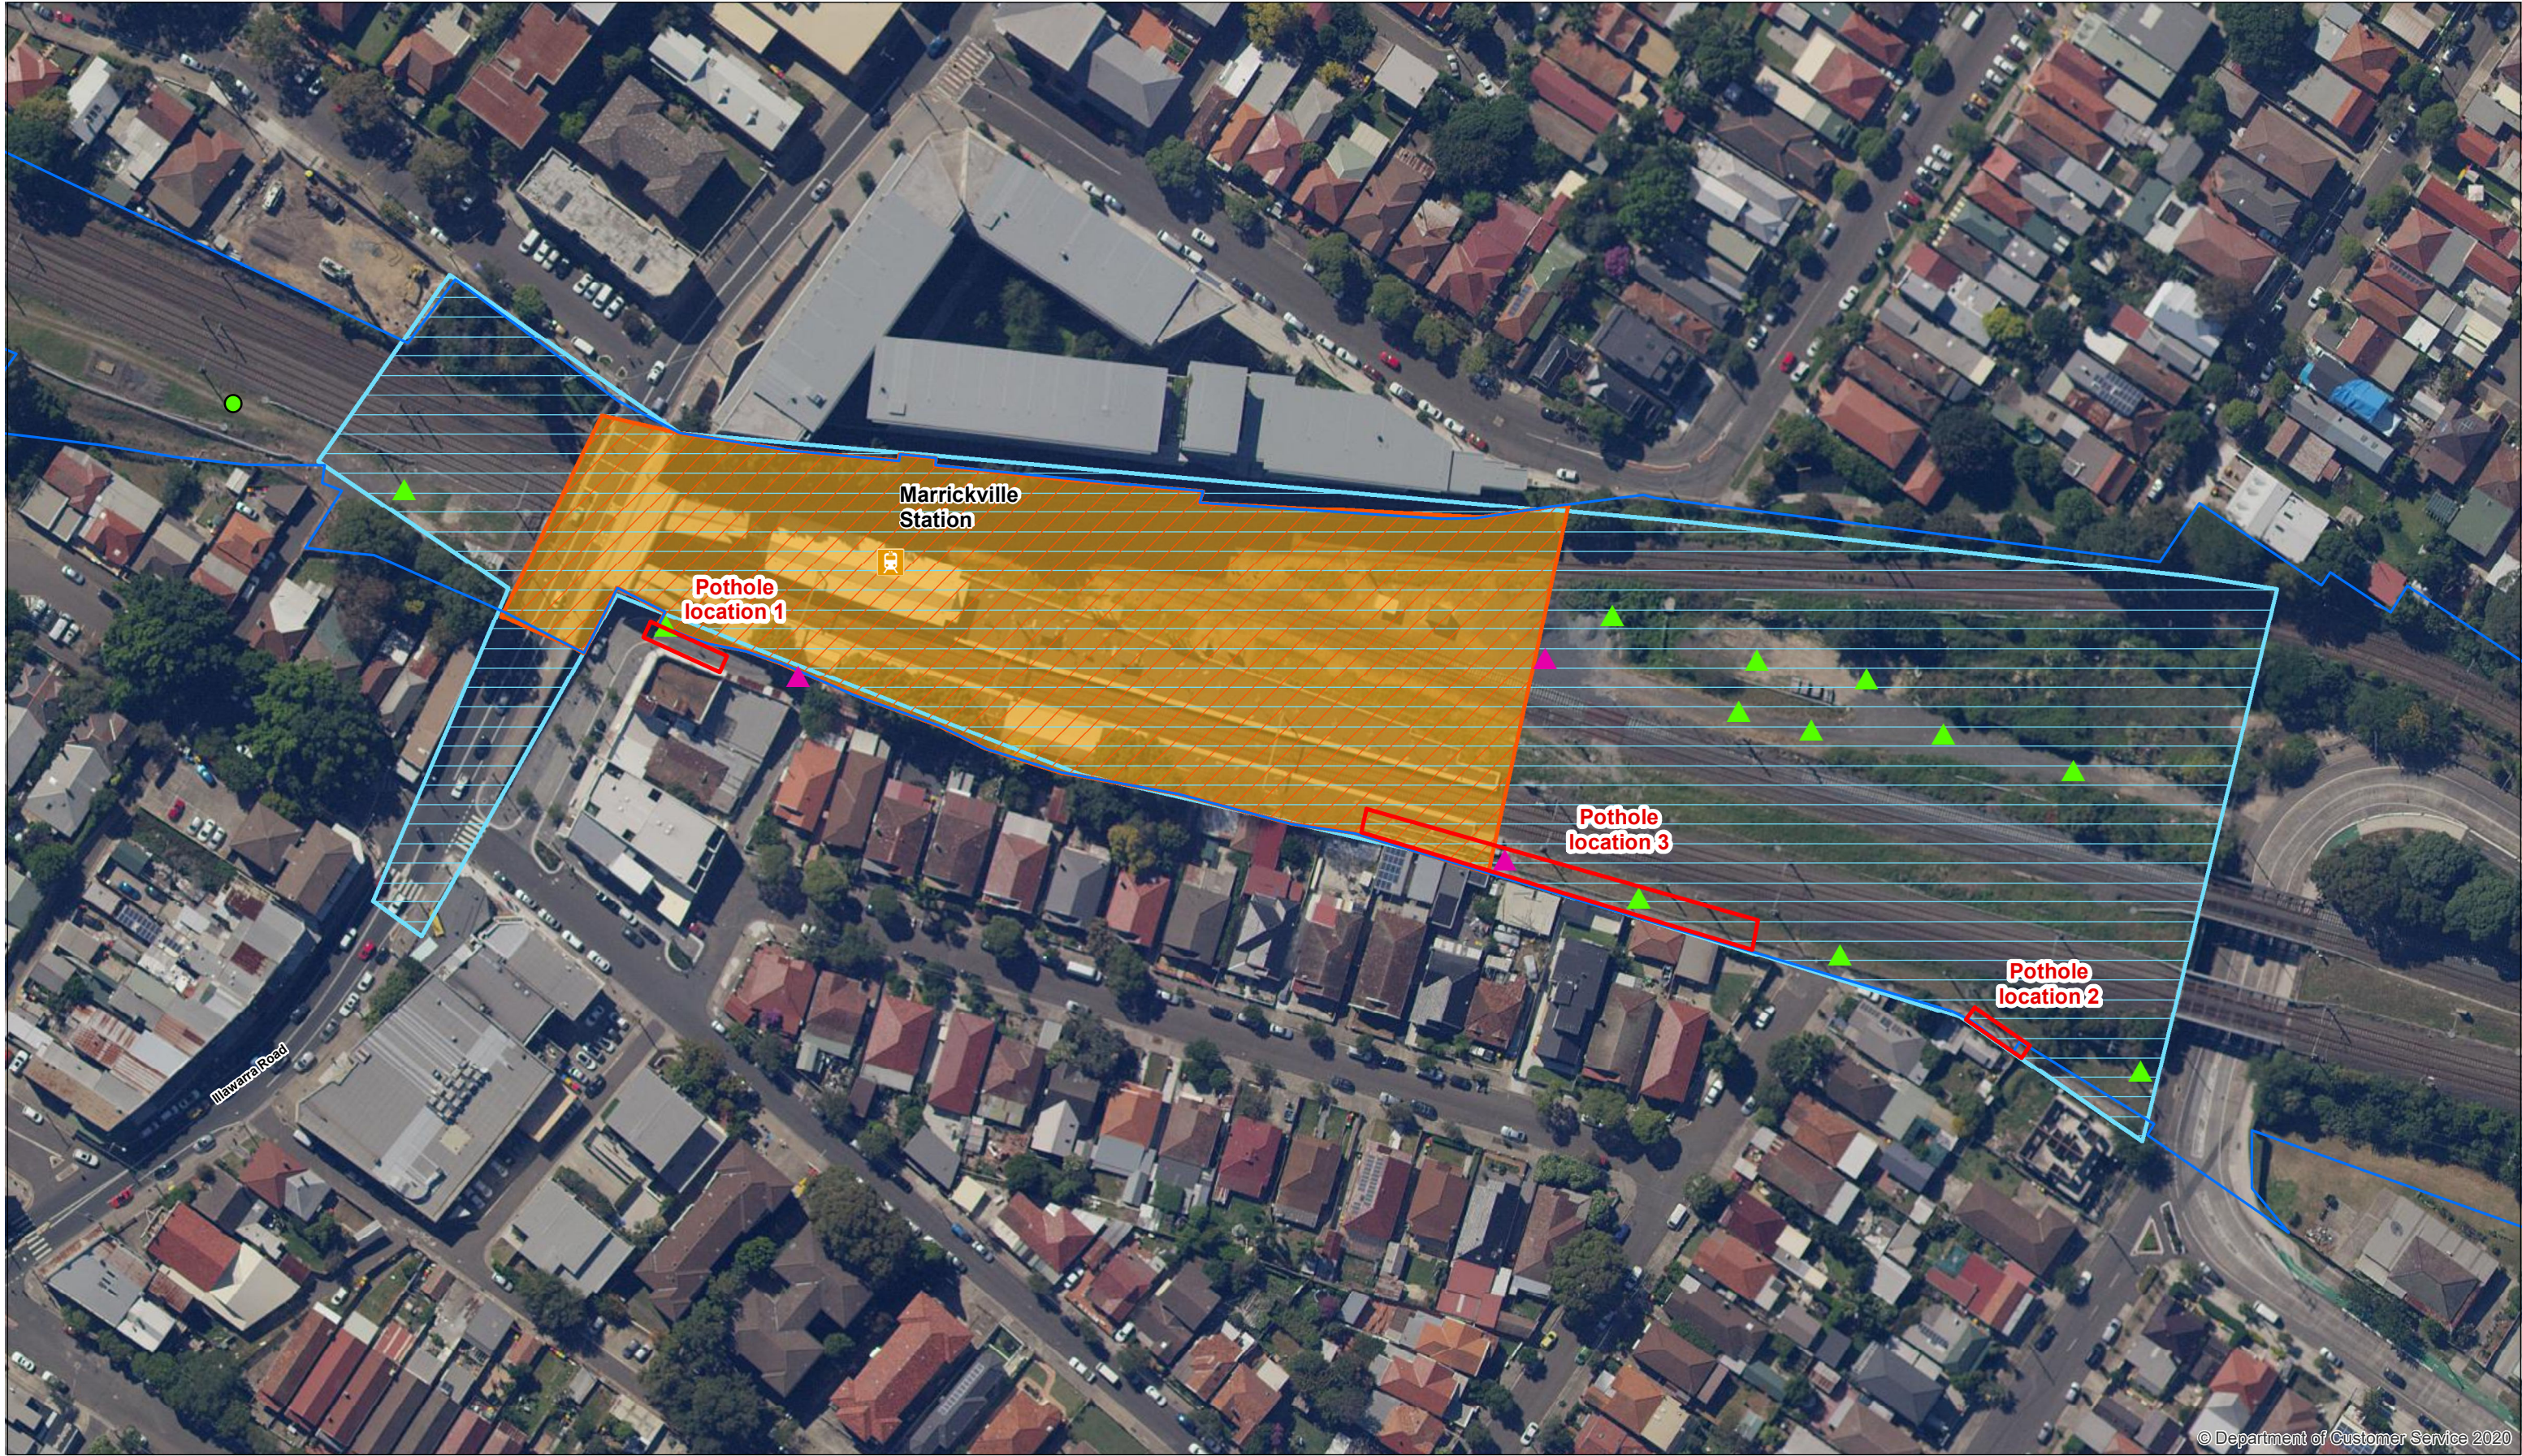
The proposed works are not located in areas of threatened species, populations or endangered ecological communities as shown in the Environmental Sensitive Receivers Map in Appendix 1. No vegetation clearing is required for the works.

A map showing the local sensitivities discussed in Part 2 will be provided to the survey teams to ensure impacts are avoided. The map is provided in Appendix 1. The mitigation measures developed as part of the environmental risk assessment (provided in Appendix 1) will be provided to survey teams as part of the pre-survey induction.

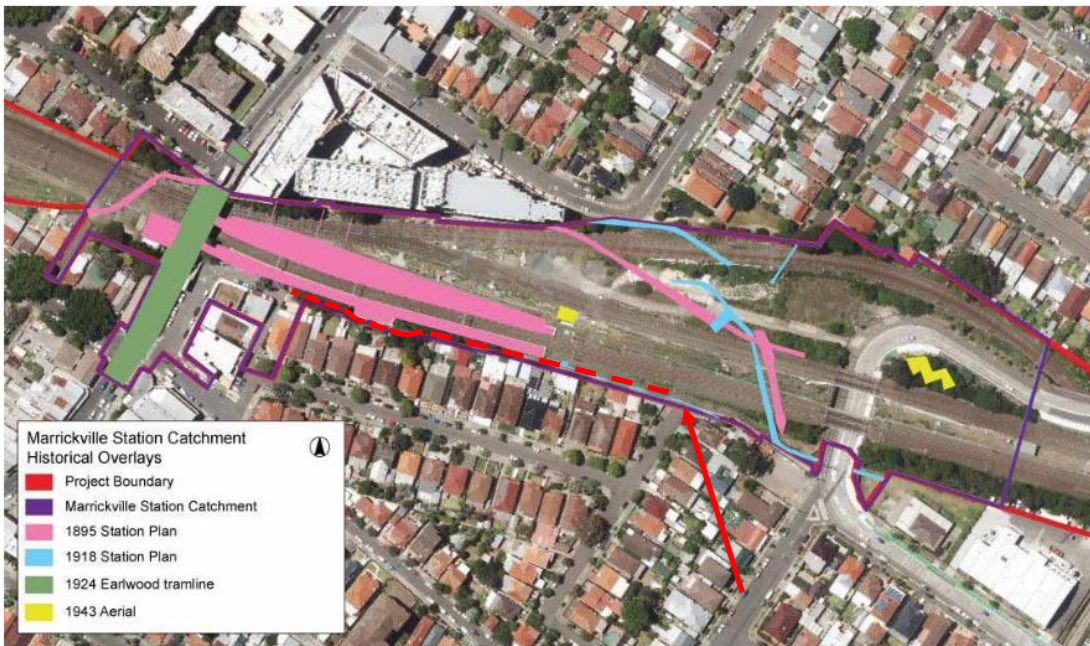
Figure 1. Areas of archaeological potential at Marrickville Station, location of potholing shown as a red dashed line / red arrow

The proposed potholing works are located on the southern edge of the rail corridor at Marrickville Station, and would be conducted to identify the location and integrity of an existing sewer line in this location. Potholing in this area would be conducted at approximately every 20 metres over a length of ground approximately 160 metres in extent.

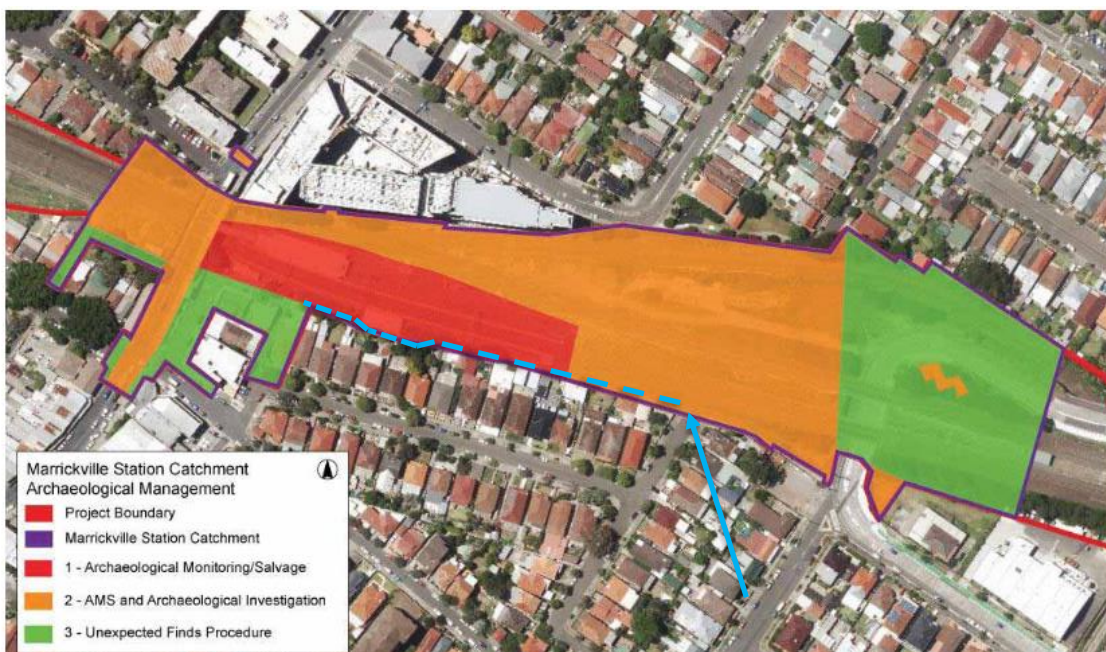
Figure 2: Marrickville Station Catchment archaeological management zones, location of potholing shown as a blue dashed line / blue arrow

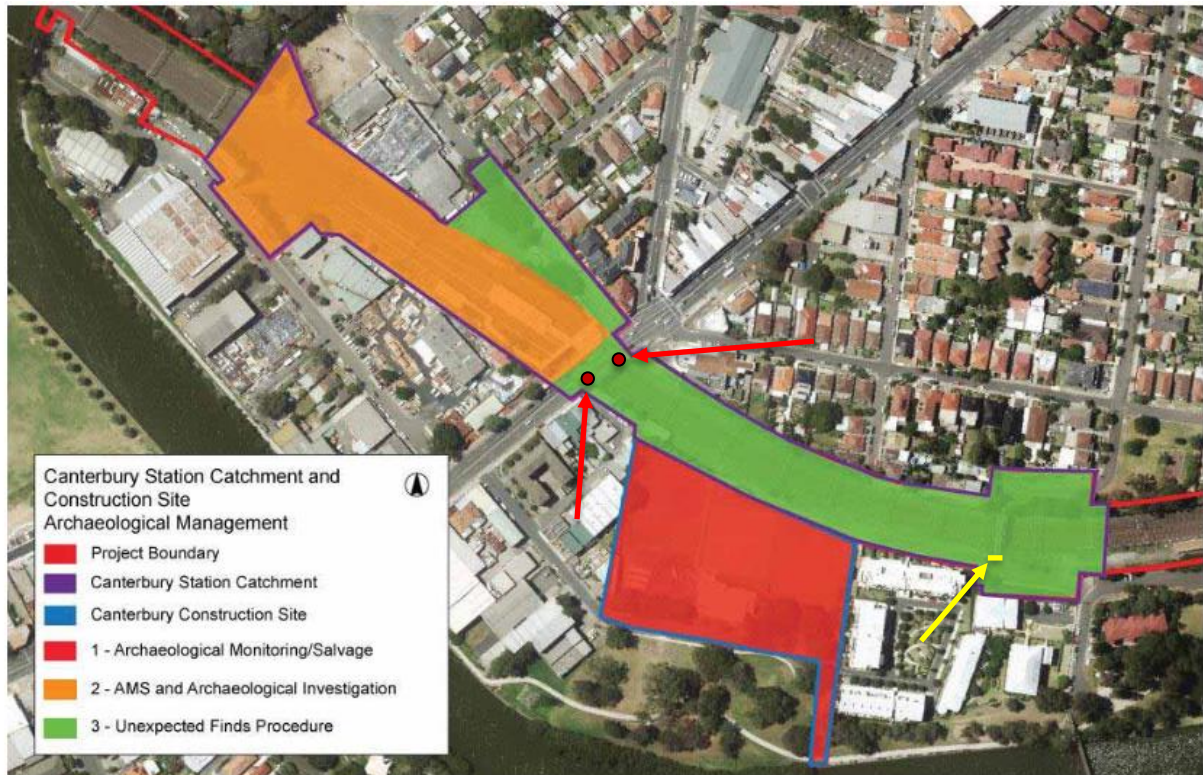
Figure 4: Canterbury Station Catchment archaeological management zones, location of potholing shown as red circles / red arrows. The location of the potholing between Church Street and Dutton Street (assessed separately below) is shown as a yellow line / yellow arrow

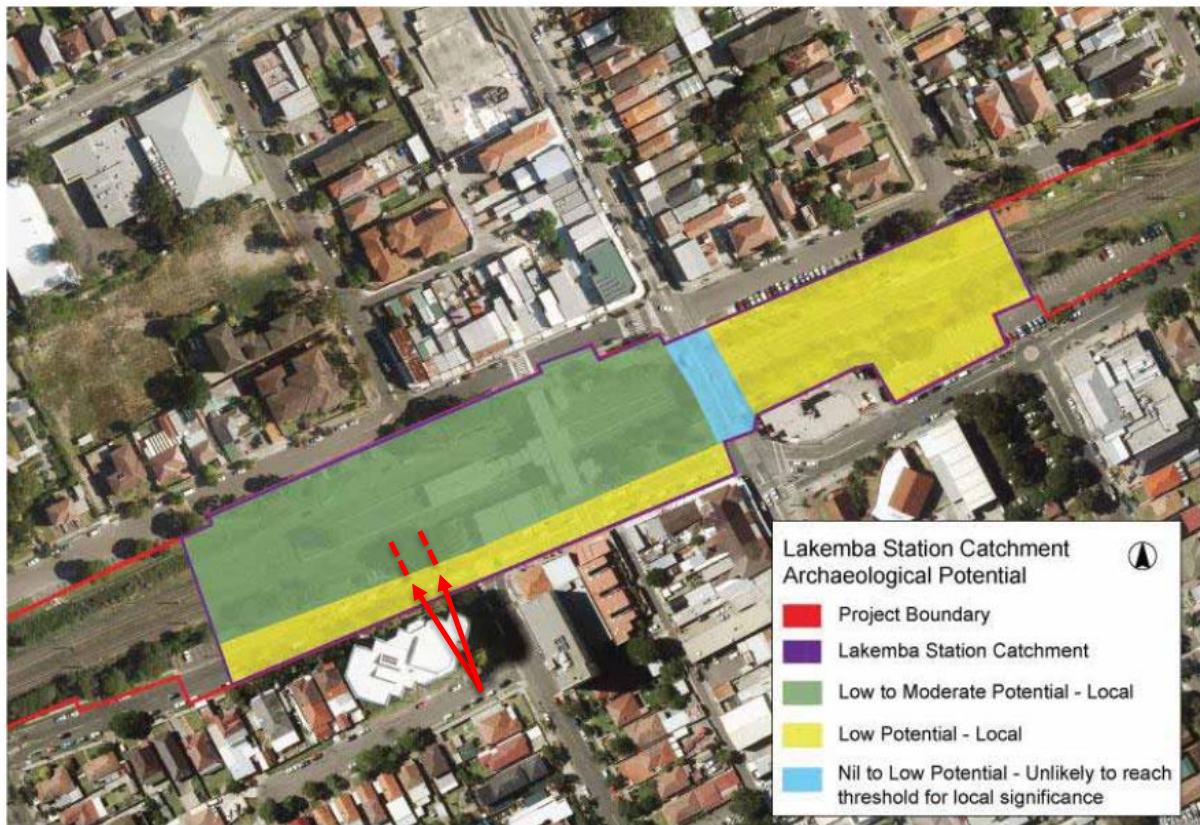
Figure 5. Archaeological potential at Lakemba Station (pothole locations in red)

The proposed potholing would be limited to the embankment to the south of the rail corridor. This area is located on the opposite side of the rail corridor as the platform, which is the main area of archaeological potential, and no specific archaeological features were identified within the embankment. Furthermore, the potholing works would be located in areas where existing utility pipes are suspected to be located, and as such, archaeological deposits or features are more likely to have been disturbed and/or removed in these localised areas. In addition, the ground disturbance caused by the potholing works would be limited in size and the use of a vacuum truck and manual excavation would further reduce the risk of archaeological impacts to archaeological remains even if they were predicted to be located within this area.

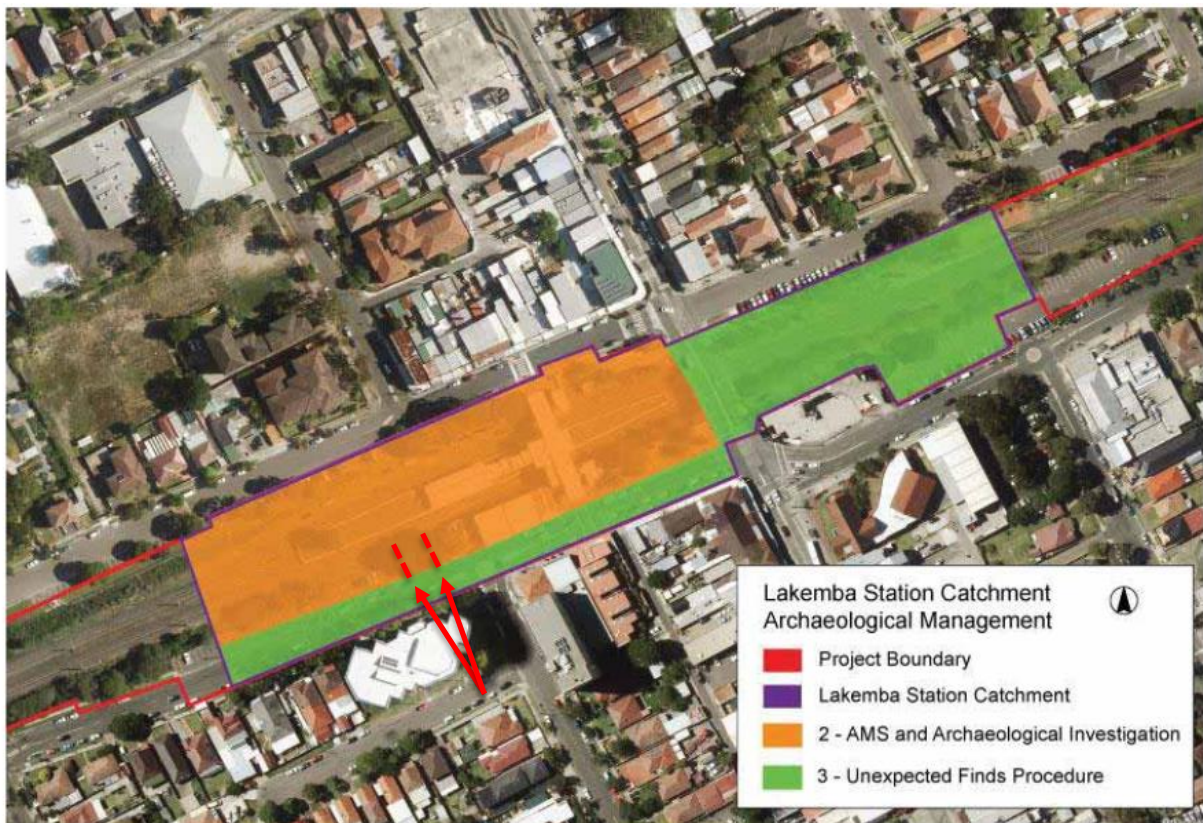
Figure 6: Lakemba Station Catchment archaeological management zones, location of potholing shown as red dashed lines / red arrows

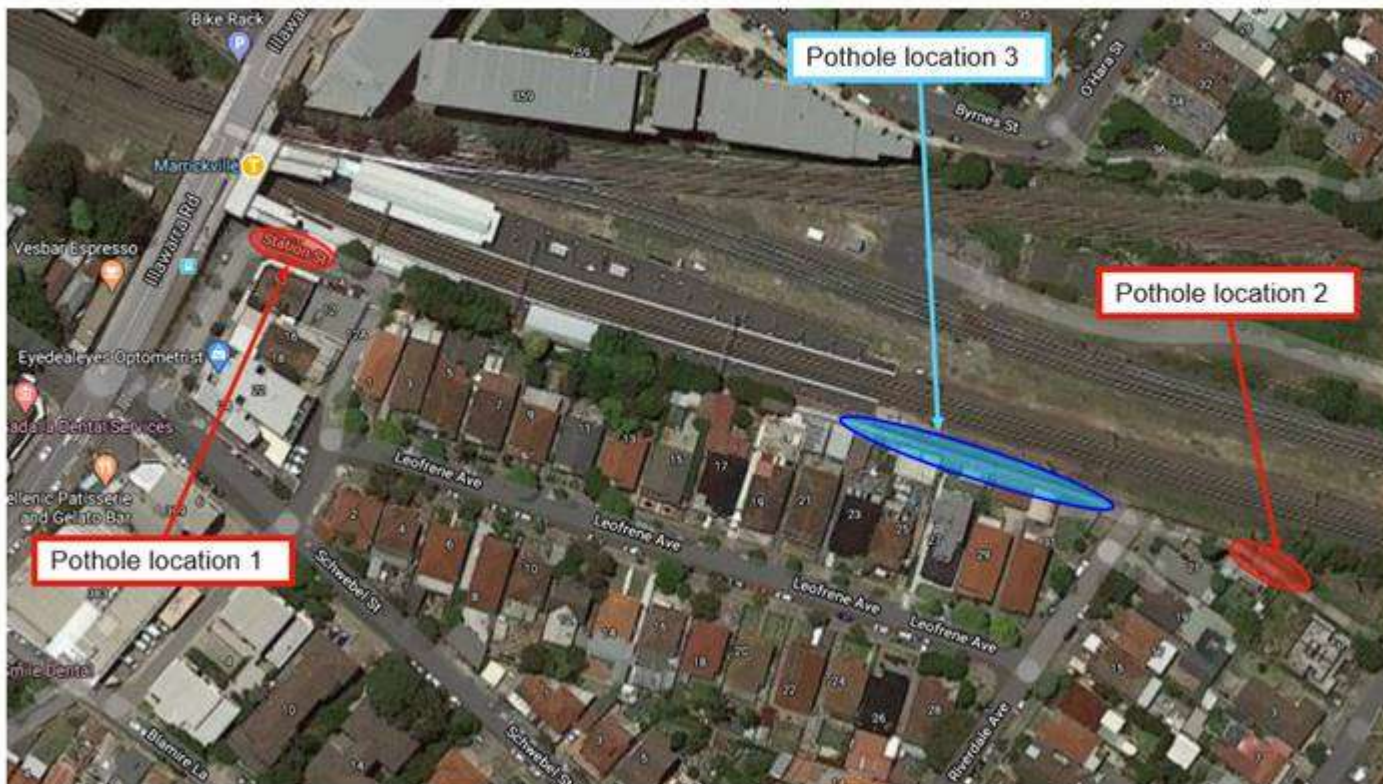
Marrickville – Intrusive Utility Survey

Three potholing locations are proposed at Marrickville – shown in the figure below.

- Pothole location 1 – is located within the Station Street area to the south of Marrickville Station. This area is designated as Archaeological Management Zone 3 – and no significant archaeological remains have been identified to be located in this area. Ground disturbing works in this area would not require any further active archaeological investigation, and unexpected finds would be managed under the Sydney Metro Unexpected Finds Policy.

- Pothole location 3 – this location is within the area already approved in the low impact activity HIA and requires no further assessment or approval. These works are also located in Archaeological Management Zone 2. Management recommendations and the AMS prepared in the HIA would apply to works in this area.

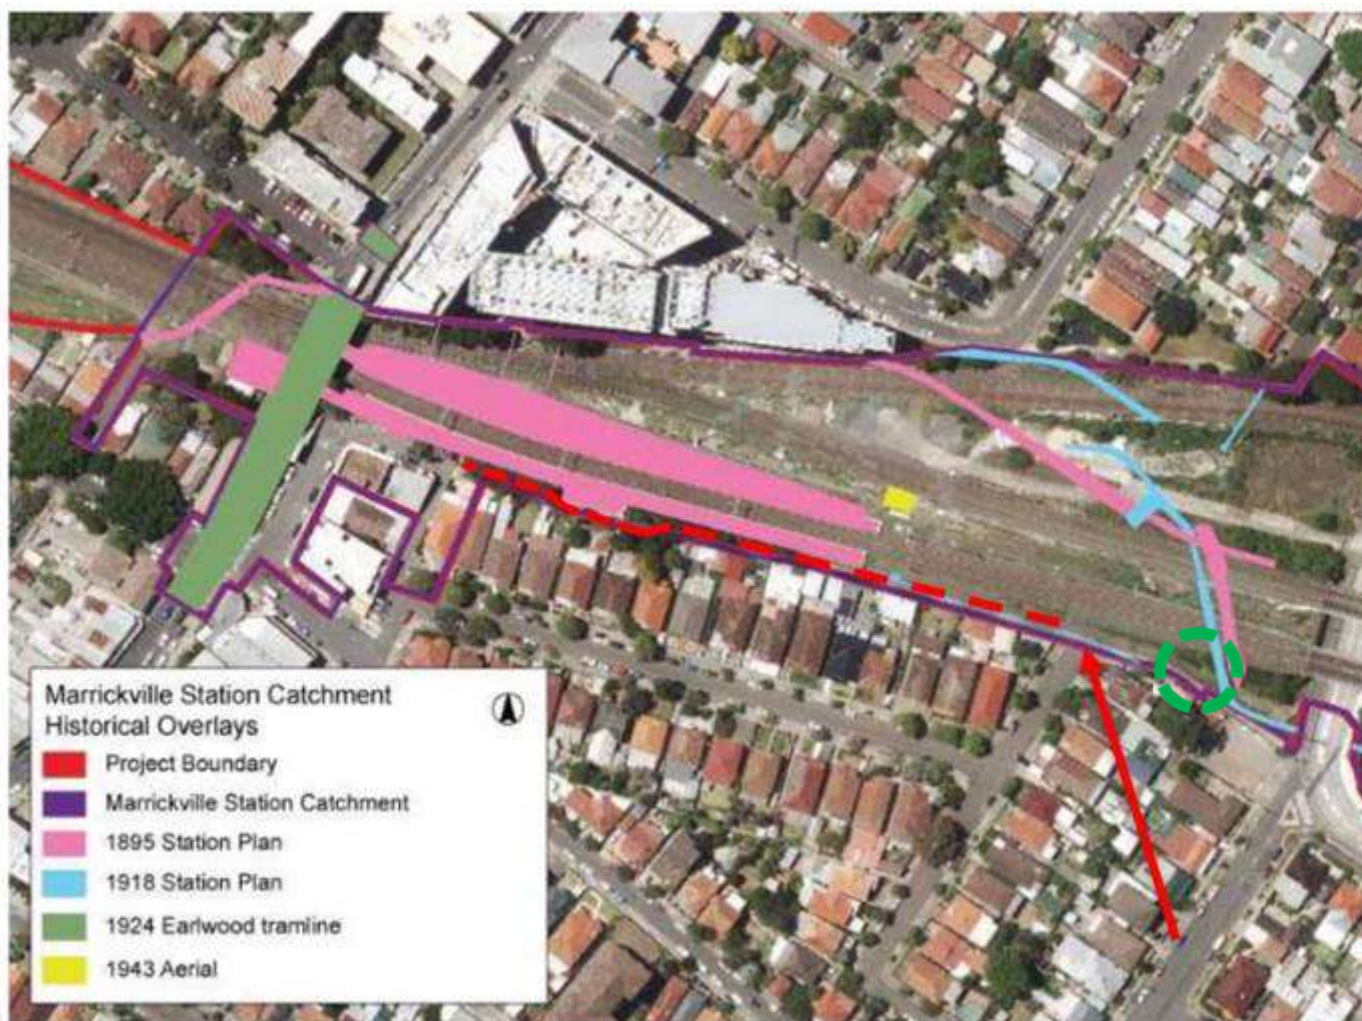
These works are located in proximity to brick drainage culverts identified in a 1918 station plan, which have been classified as potentially locally significant in the SM AARD report. Due to the broad level of detail of potholing investigation locations, it cannot be confirmed whether potholing works would occur directly over the location of the former culvert, although it is expected that works would be conducted within 10 metres of the suspected location of the culvert. The approximate location (shown in the green dotted circle) of the pothole 2 location excavation area in relation to archaeological potential overlay mapping from the AARD is shown below.

It is considered that high pressure water and vacuum suction (vacuum truck) excavation would be unlikely to physically impact the robust brick and/or concrete structures of the culvert and that the assessed degree of archaeological impact from potholing in this location would be negligible. However, work crews must avoid excavating or impacting the item during works when making their final excavation selection location.
