# Appendix D Report 610.15897R2

Train Passby Noise and Vibration Measurements

### Appendix E Report 610.15897R2

#### Construction Airborne Noise Contours

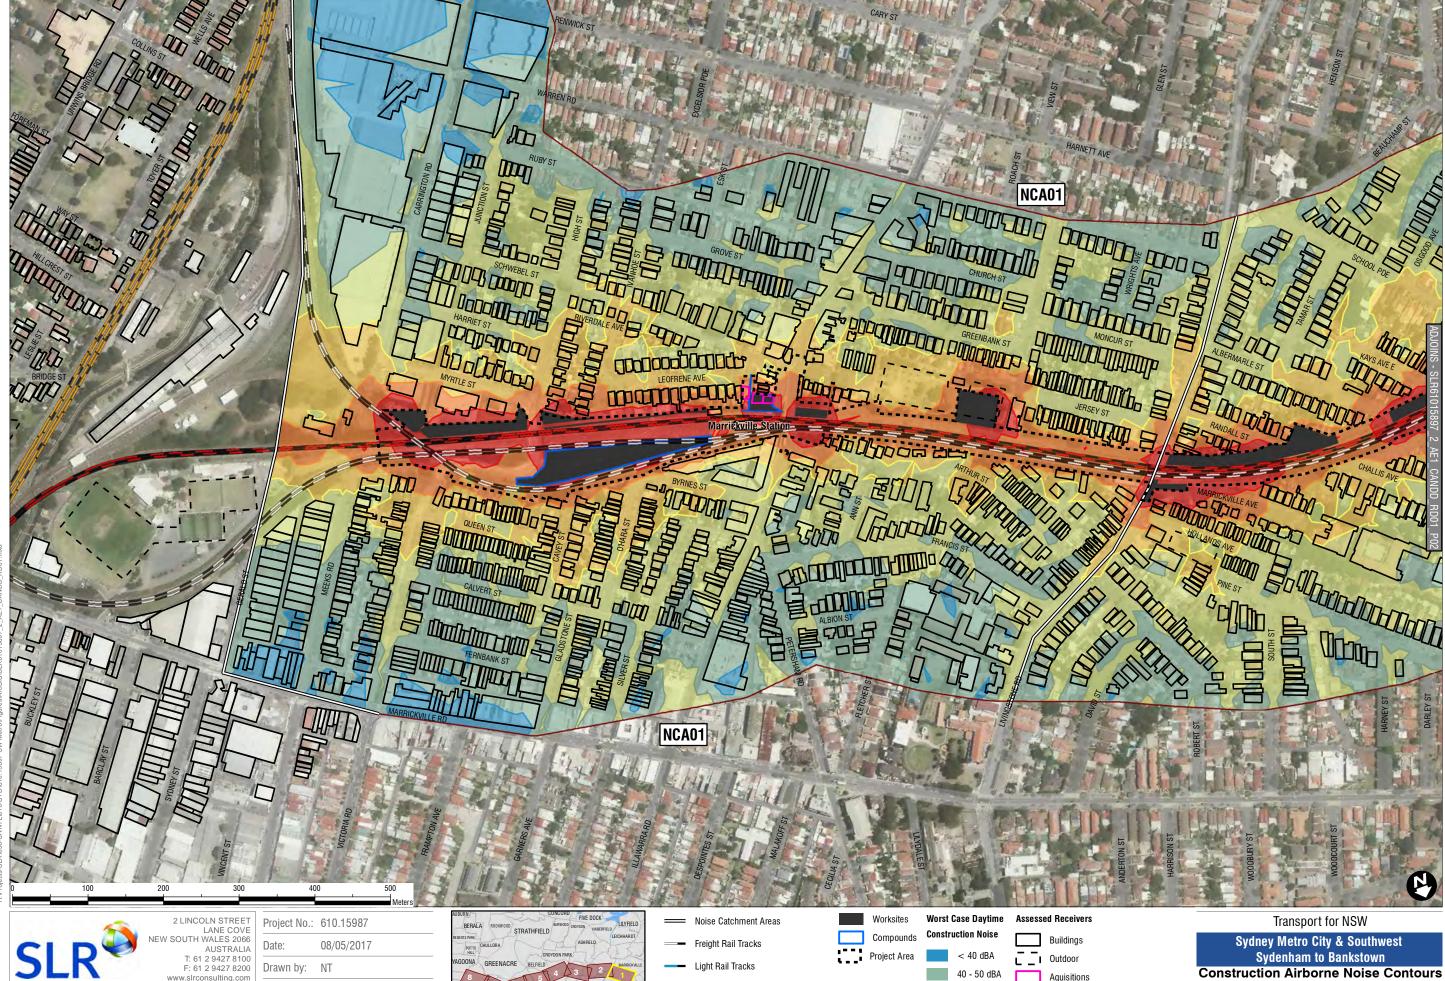
**Worst-case Daytime Construction Noise Predictions** Page 1 of 8

Construction Airborne Noise Contours	- Worst-Case Daytime LAeq(15hr) (	Construction Noise Predictions

\*Noise contours are indicative and represen the worst-case noise levels predicted for all scenarios operating in the period.

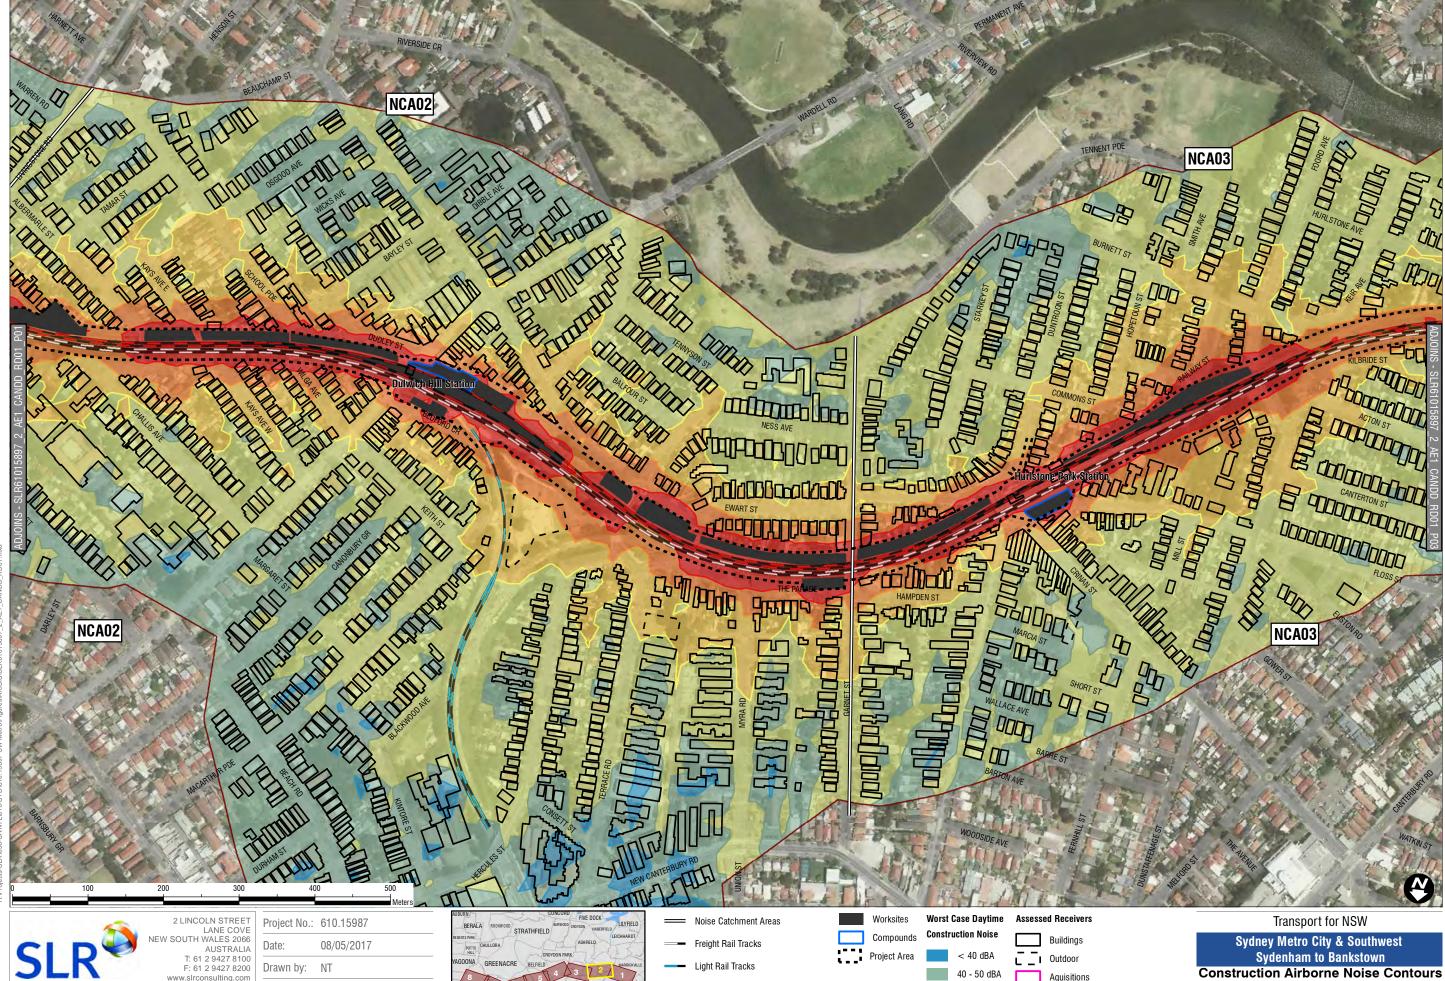
**Worst-case Daytime Construction Noise Predictions** Page 2 of 8

\*Noise contours are indicative and represer the worst-case noise levels predicted for all scenarios operating in the period.

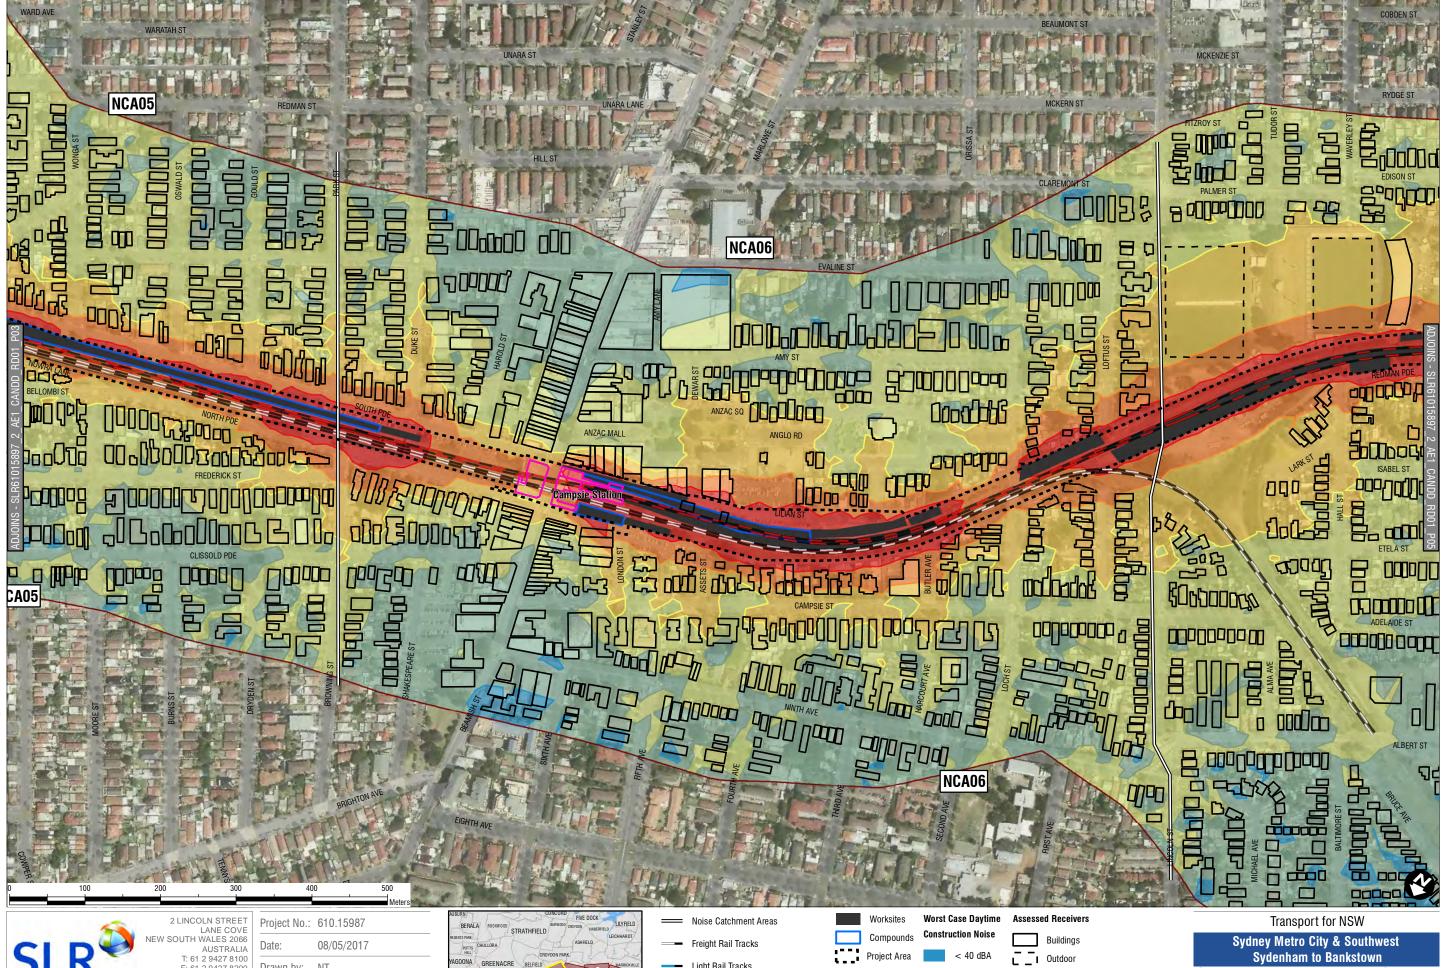
Page 4 of 8

\*Noise contours are indicative and represen the worst-case noise levels predicted for all scenarios operating in the period. **Construction Airborne Noise Contours Worst-case Daytime Construction Noise Predictions**

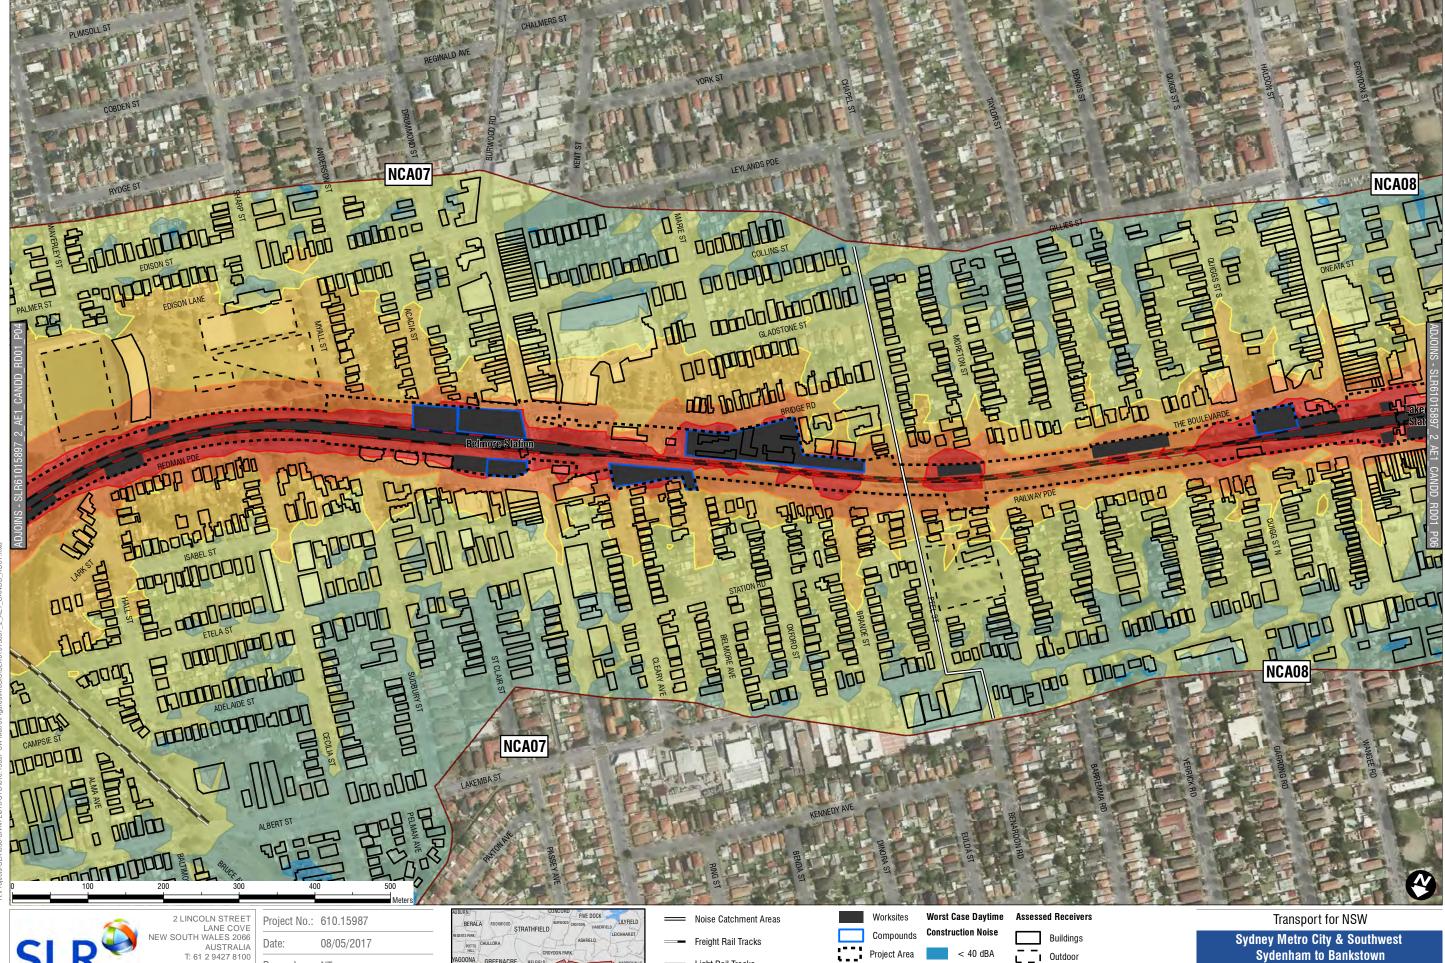
Page 5 of 8

**Construction Airborne Noise Contours Worst-case Daytime Construction Noise Predictions**

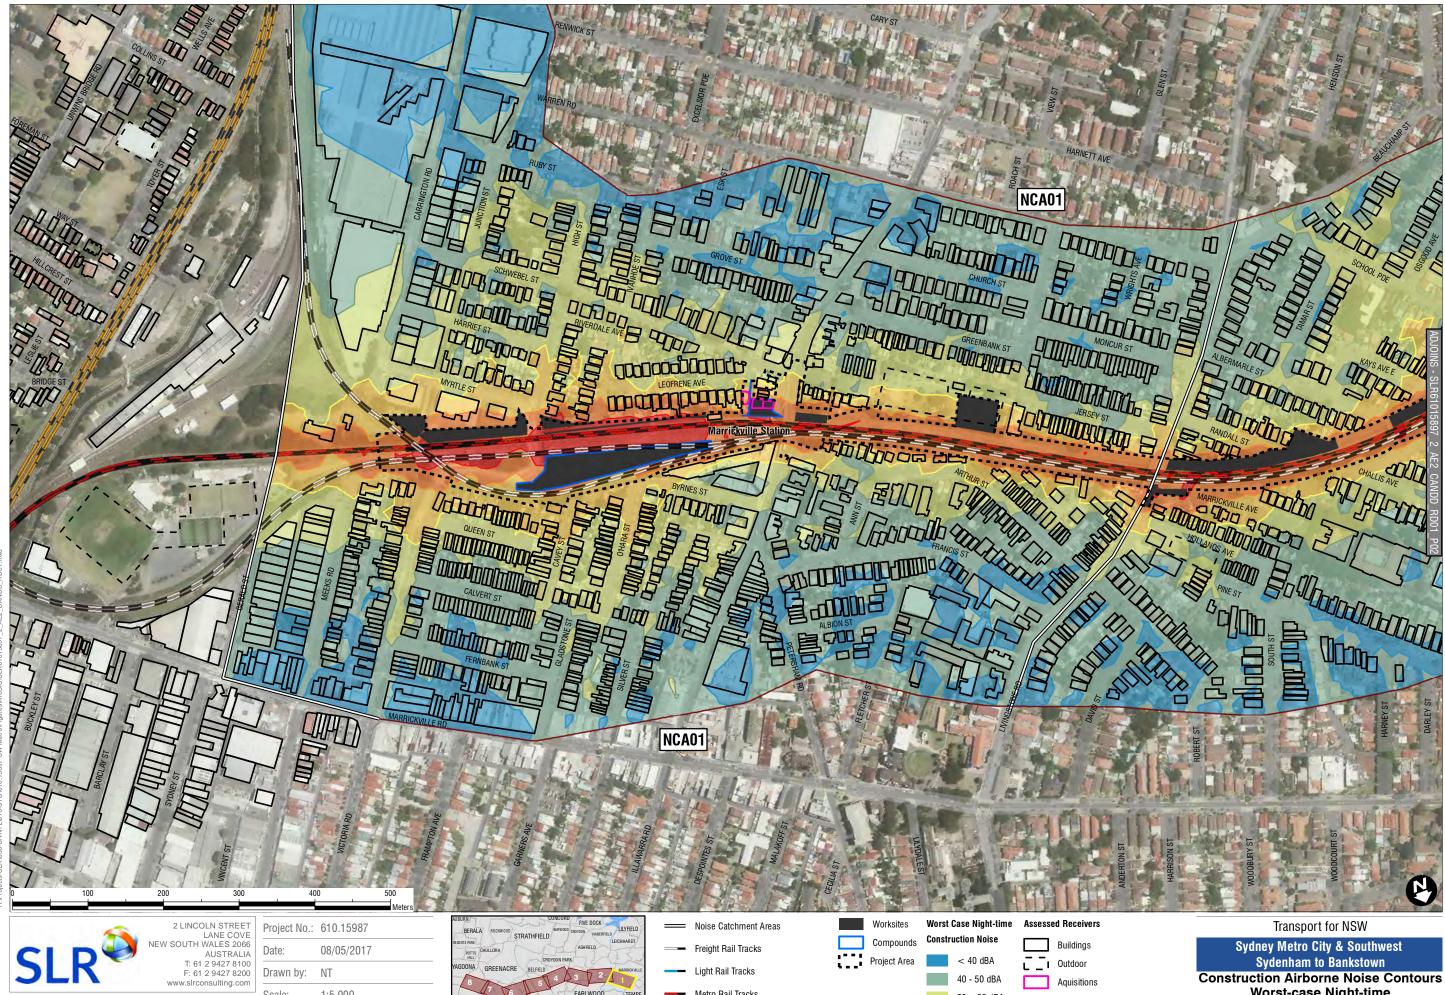
**Worst-case Night-time Construction Noise Predictions** Page 1 of 8

Construction Airborne Noise Contours	- Worst-Case N	light-time LAeq(9h	nr) Construction N	Noise Predictions

the worst-case noise levels predicted for all scenarios operating in the period.

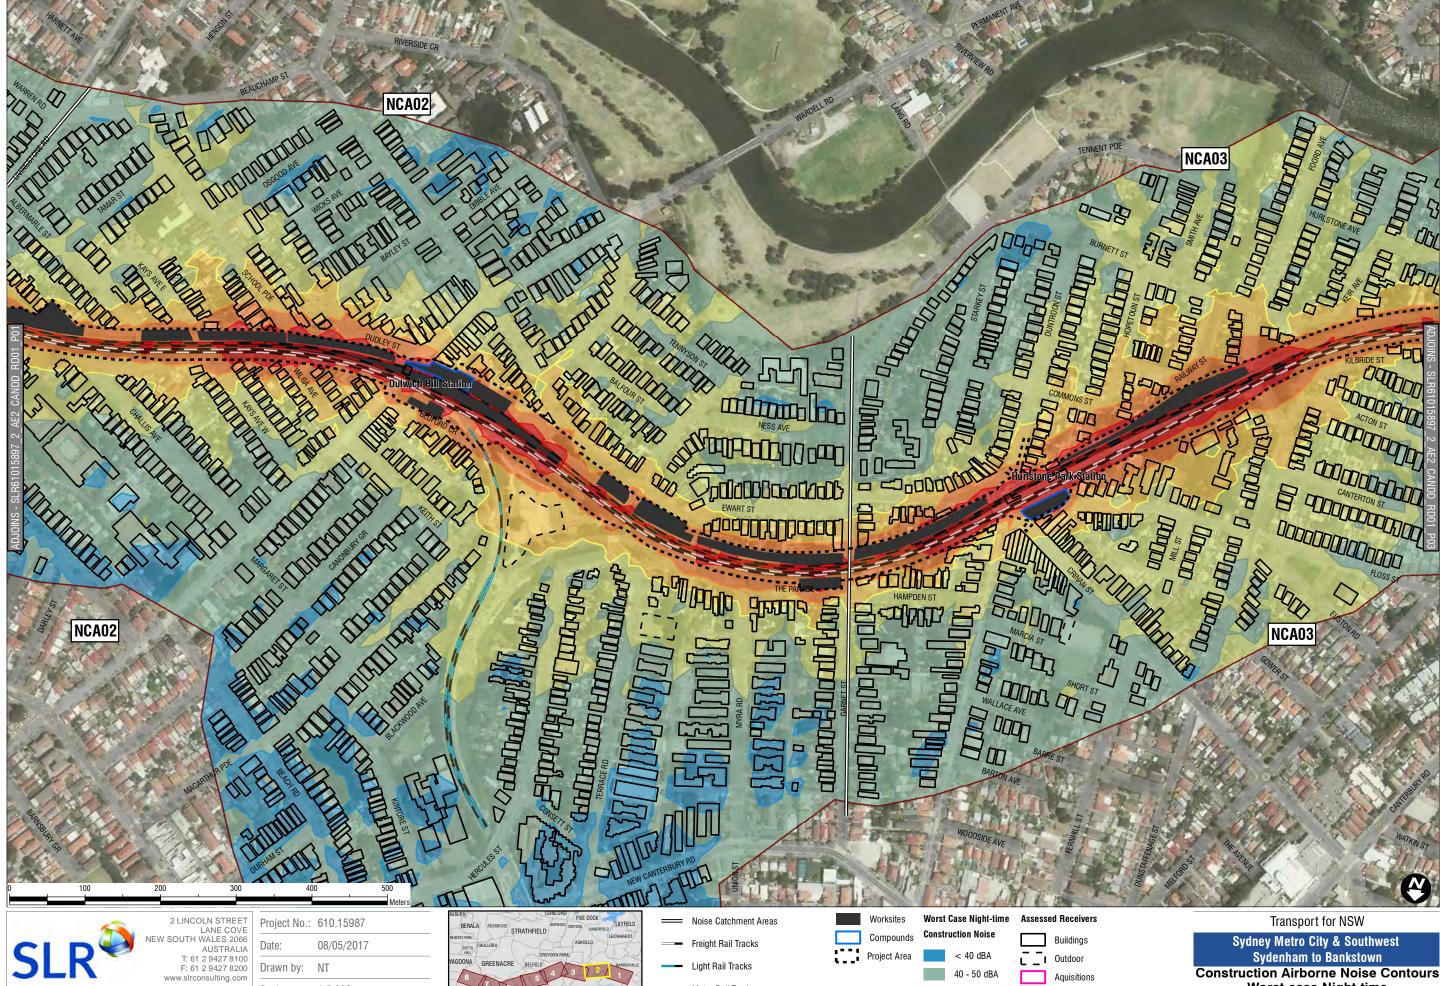
**Worst-case Night-time Construction Noise Predictions** Page 2 of 8

\*Noise contours are indicative and represer

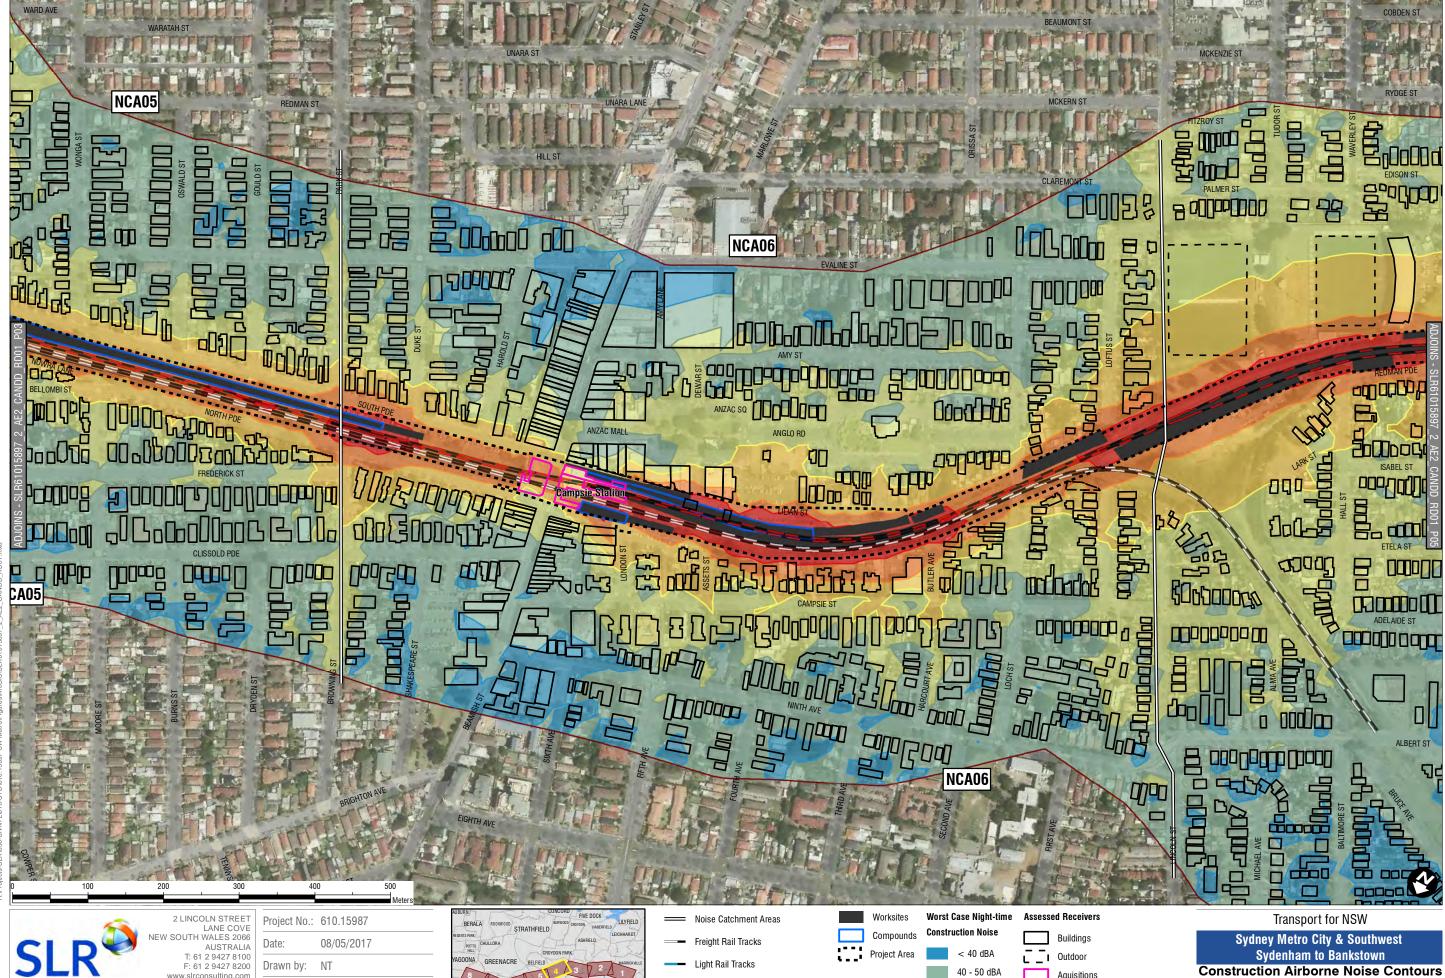
**Worst-case Night-time Construction Noise Predictions** Page 4 of 8

\*Noise contours are indicative and represen the worst-case noise levels predicted for all scenarios operating in the period.

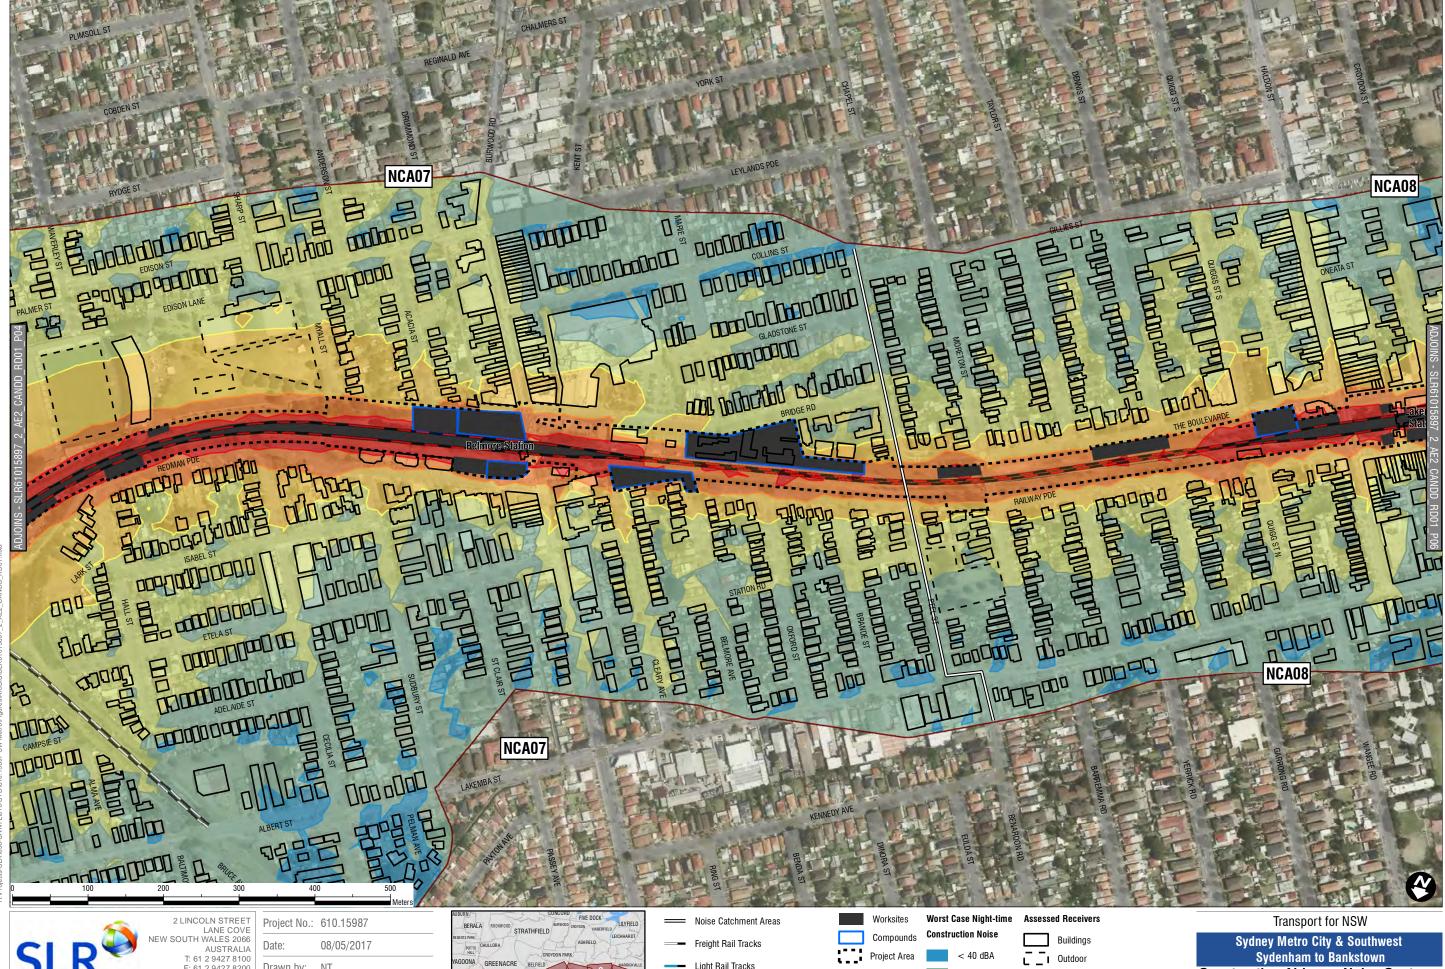
Page 5 of 8 SLR61015897 2 AE2 CANDD RD01 P05

**Construction Airborne Noise Contours Worst-case Night-time Construction Noise Predictions**

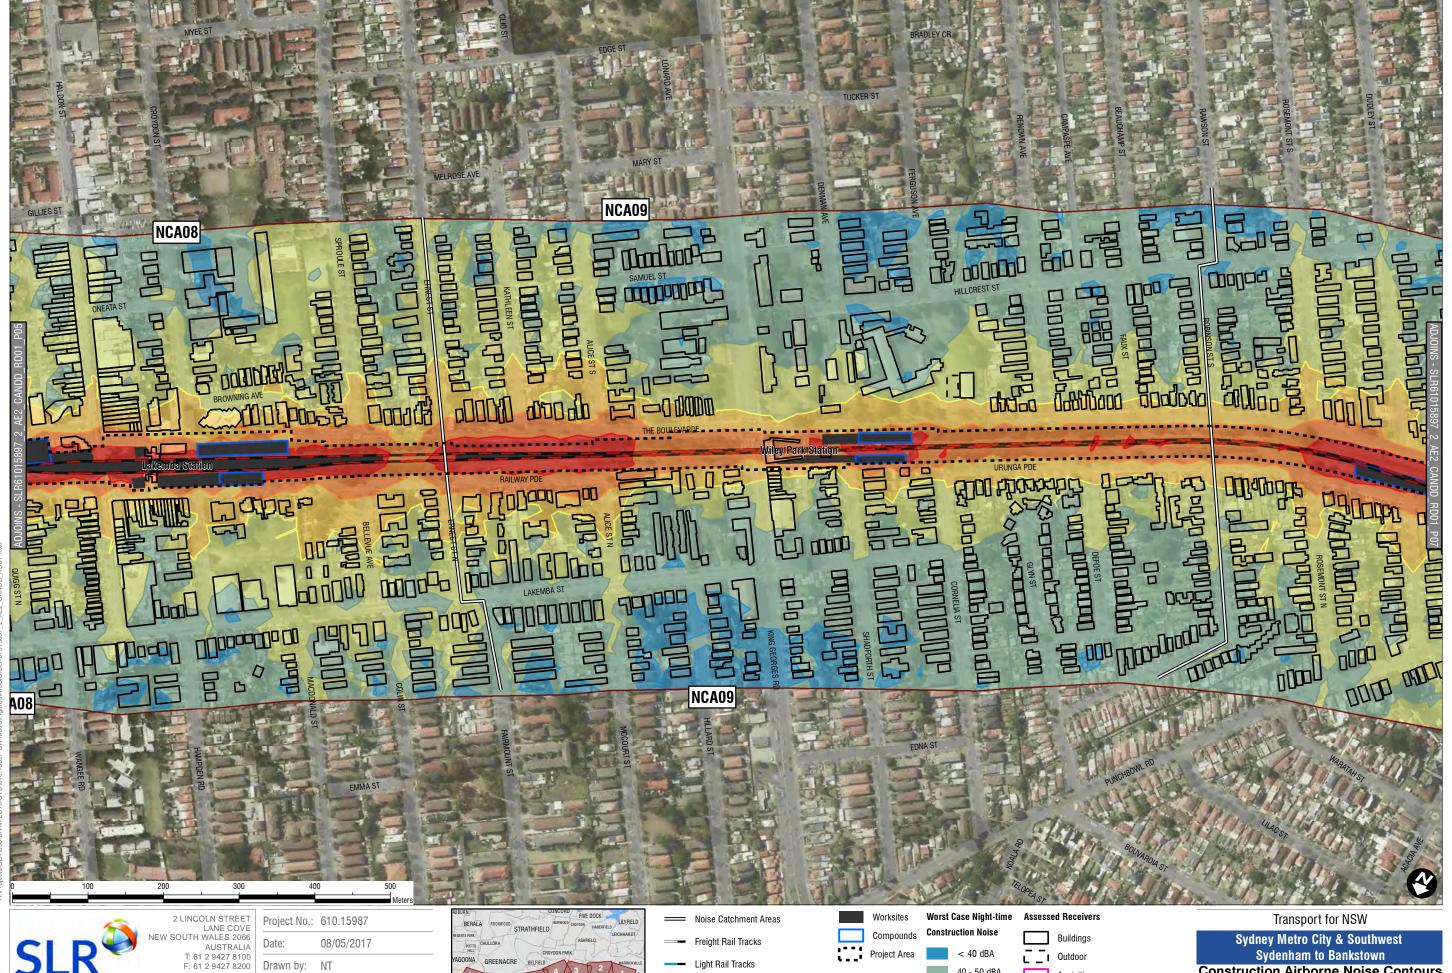
\*Noise contours are indicative and represen the worst-case noise levels predicted for all scenarios operating in the period. **Construction Airborne Noise Contours Worst-case Night-time Construction Noise Predictions** Page 6 of 8

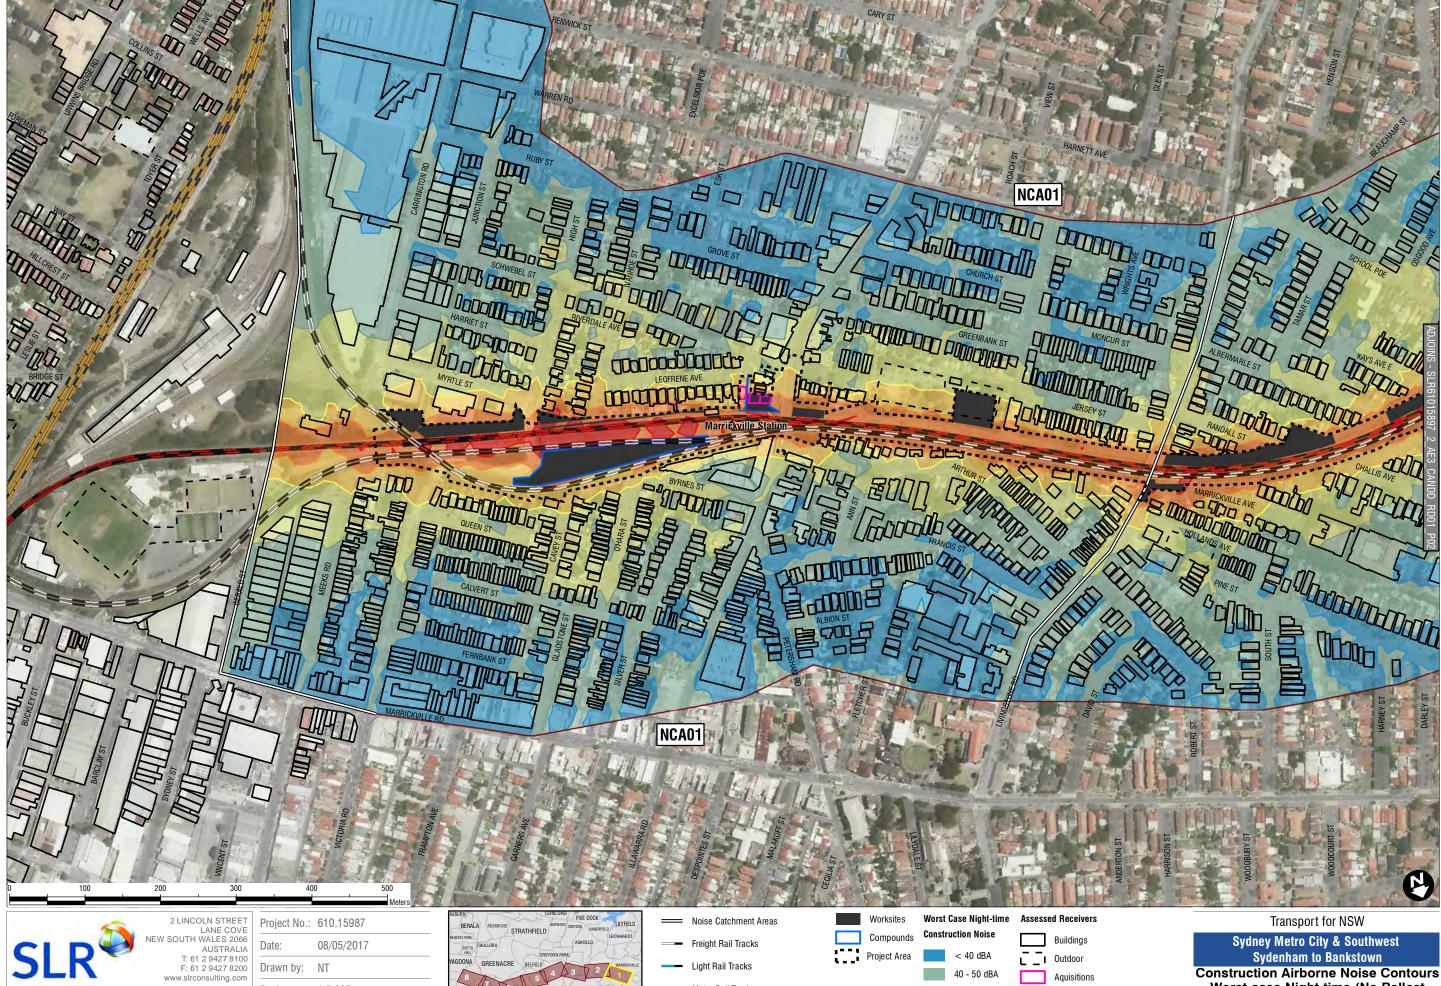
**Worst-case Night-time (No Ballast Tamper) Construction Noise Predictions** Page 1 of 8

Construction Airborne Noise Contours Worst-Case Night-time LAeq(9hr) (No Ballast Tamper) Construction Noise Predictions

the worst-case noise levels predicted for all scenarios operating in the period.

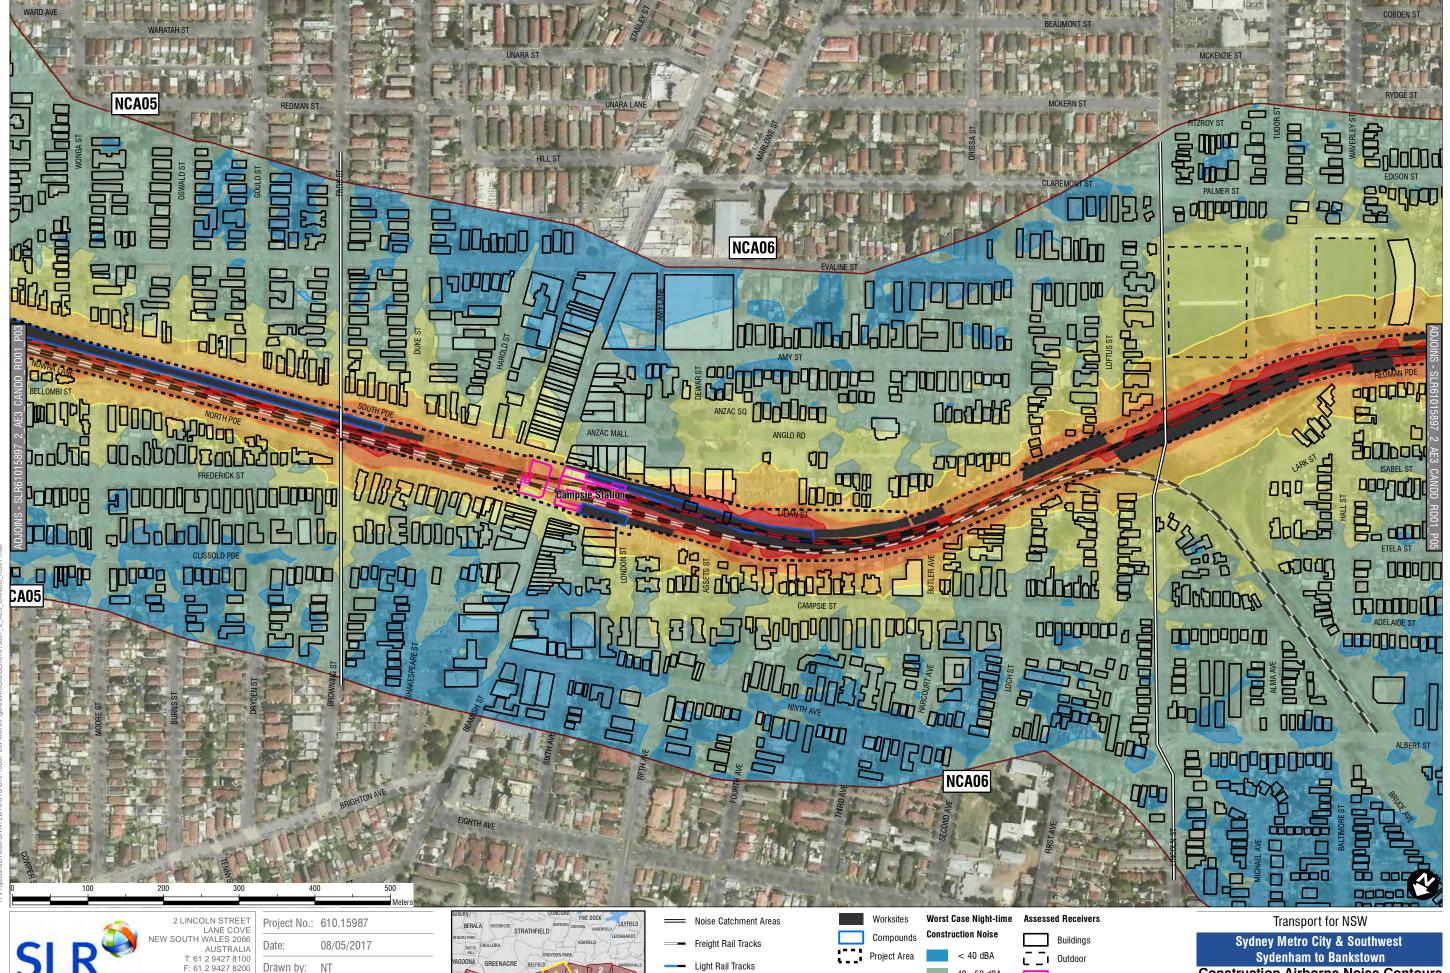
Page 4 of 8

**Construction Airborne Noise Contours Worst-case Night-time (No Ballast Tamper) Construction Noise Predictions**

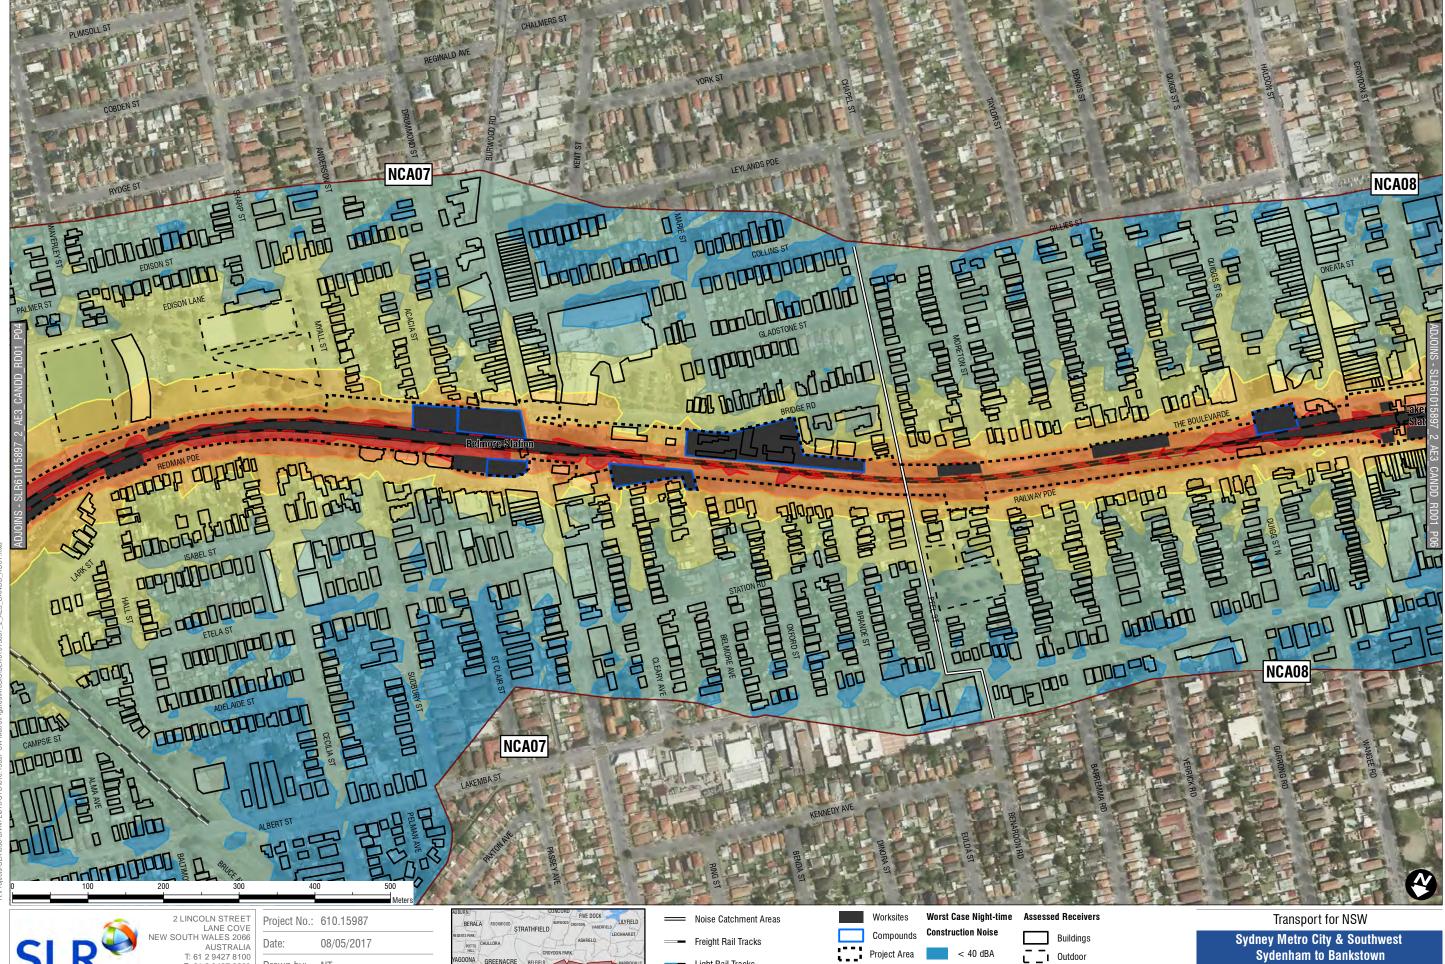
\*Noise contours are indicative and represer the worst-case noise levels predicted for all scenarios operating in the period.

**Construction Airborne Noise Contours Worst-case Night-time (No Ballast Tamper) Construction Noise Predictions** Page 5 of 8

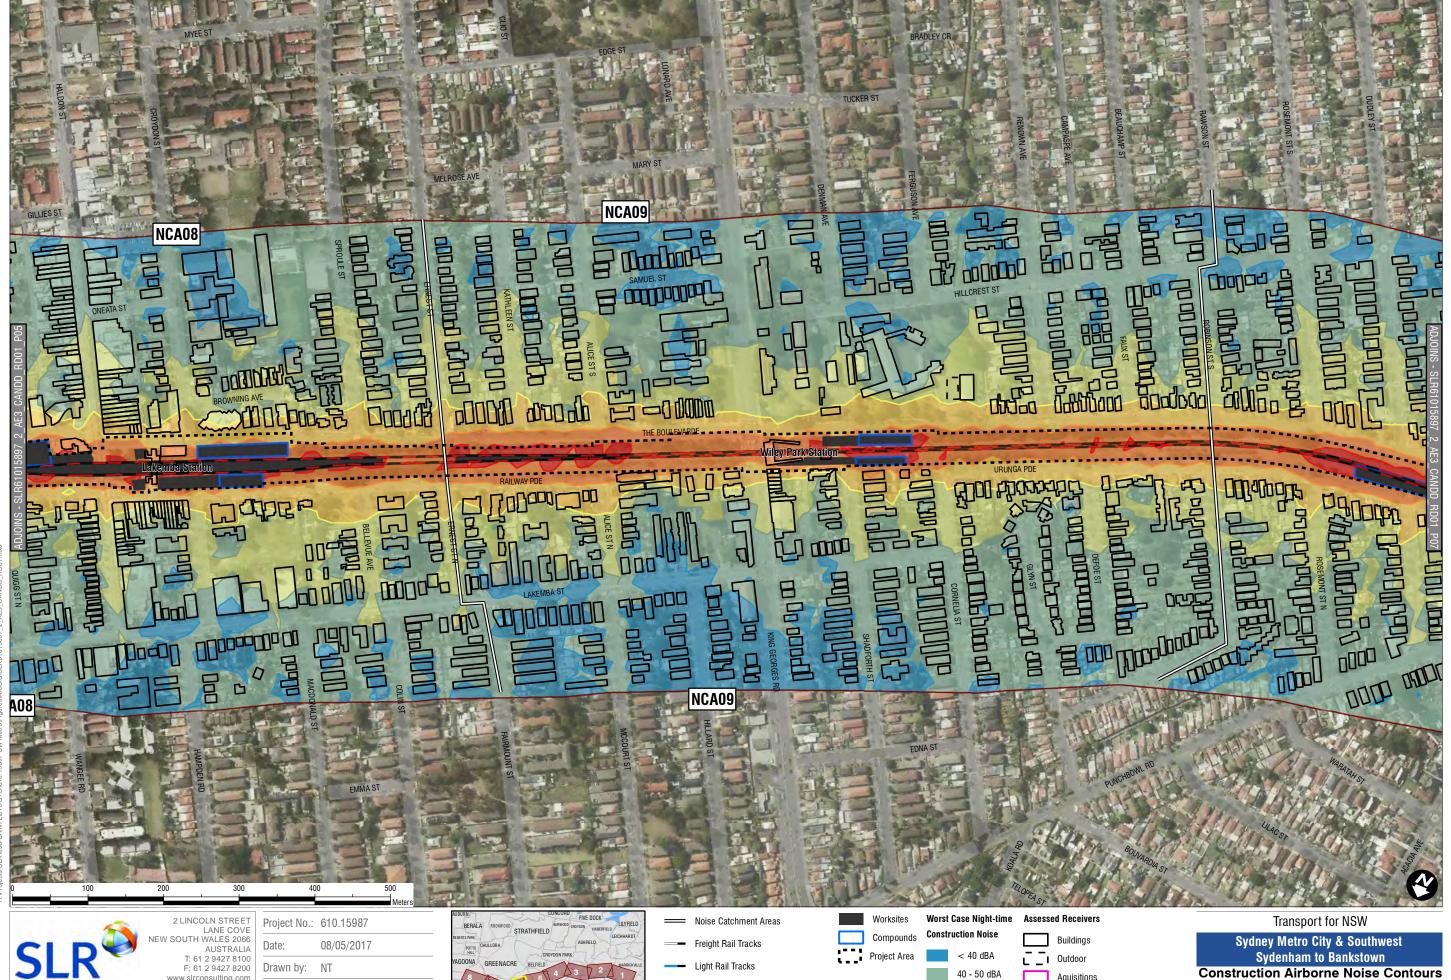
**Tamper) Construction Noise Predictions** Page 6 of 8

**Worst-case Night-time (No Ballast**

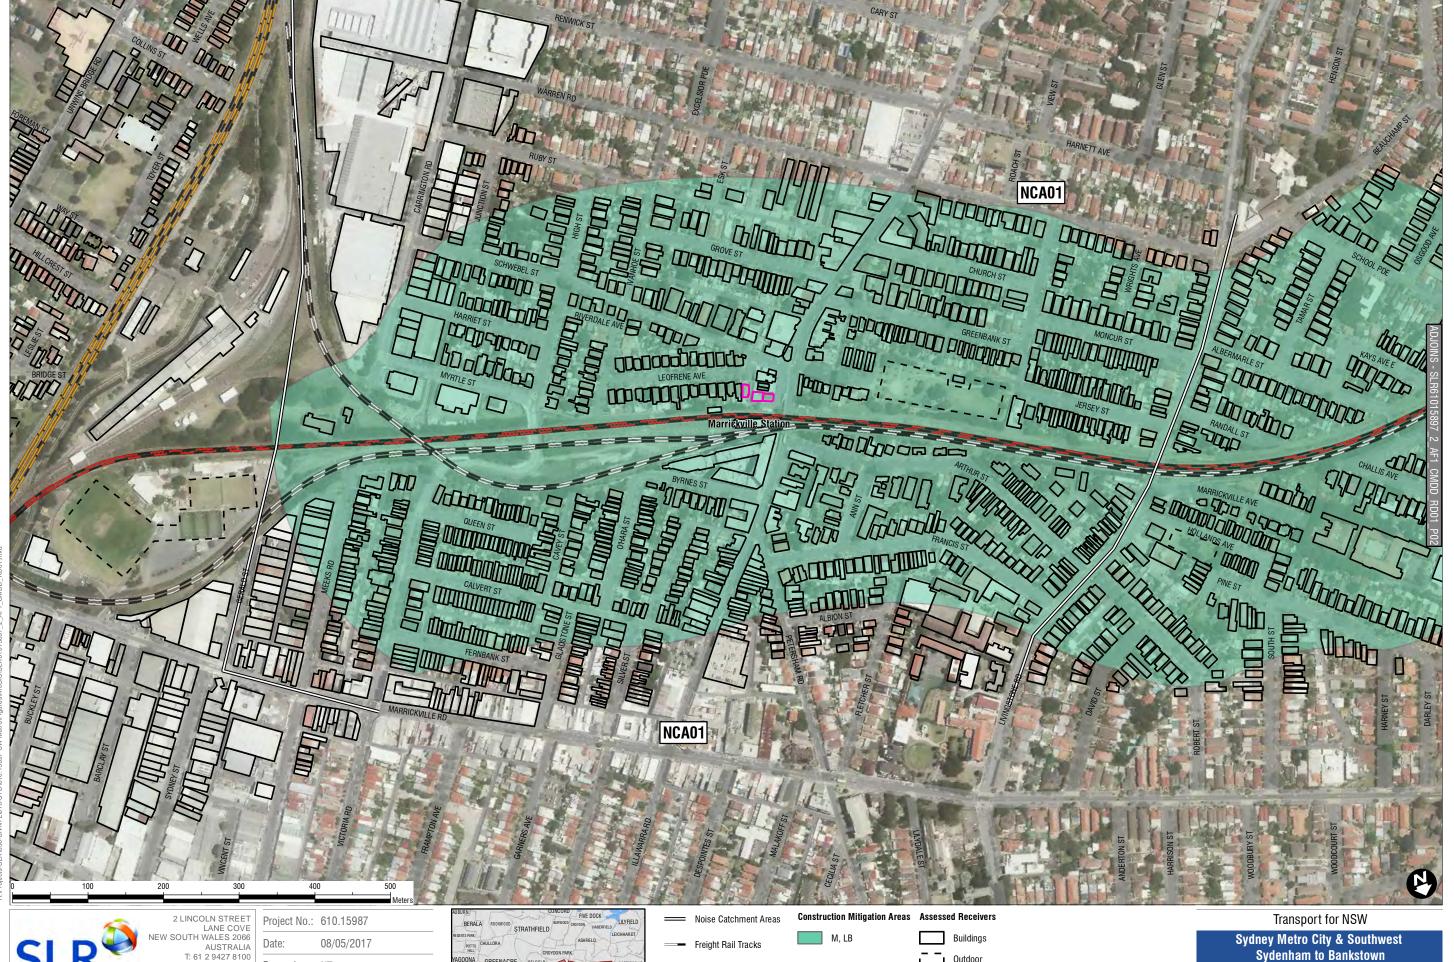
Page 1 of 8

Construction Additional Mitigation - Construction Mitigation Daytime (Indicative)

**Construction Mitigation Daytime (Indicative)**

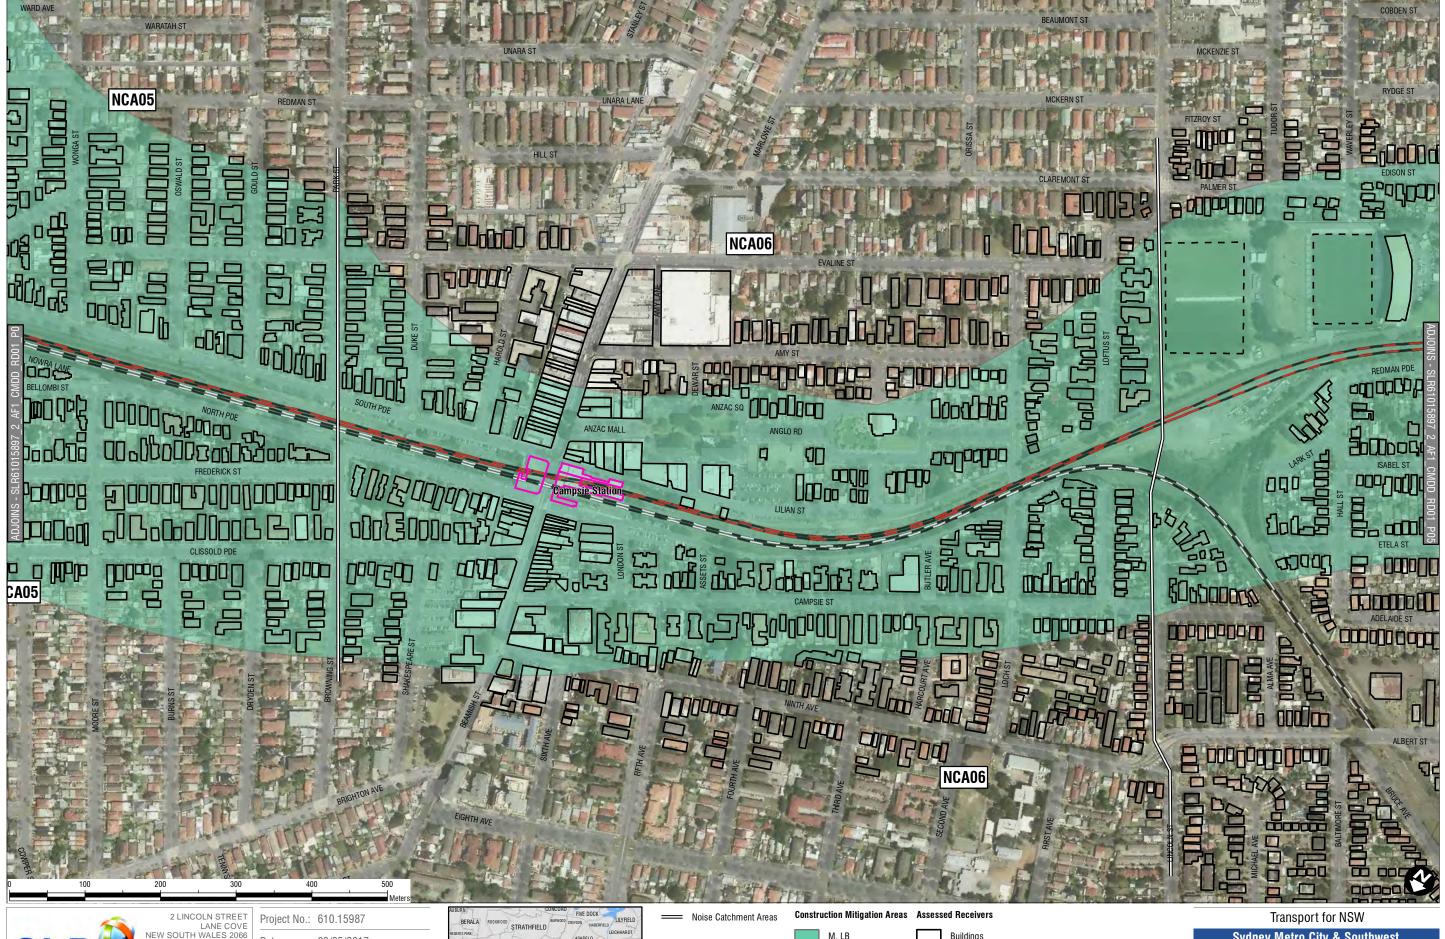
Page 4 of 8

**Construction Mitigation Daytime (Indicative)**

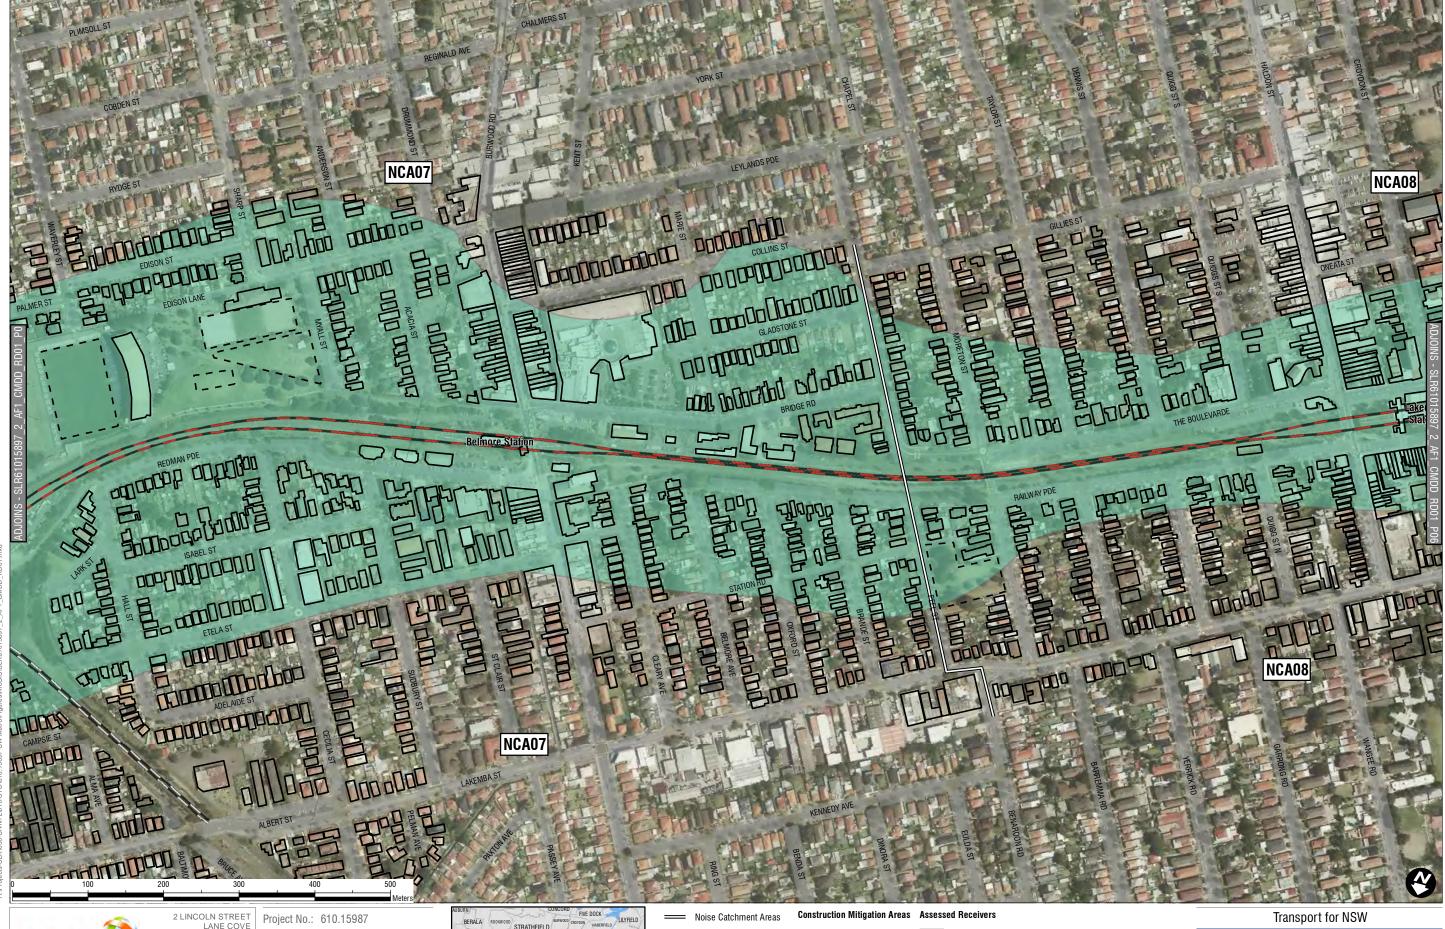
Page 5 of 8

**Construction Mitigation Daytime (Indicative)**
