# Appendix D Report 610.15897R2

Train Passby Noise and Vibration Measurements

### Appendix E Report 610.15897R2

#### Construction Airborne Noise Contours

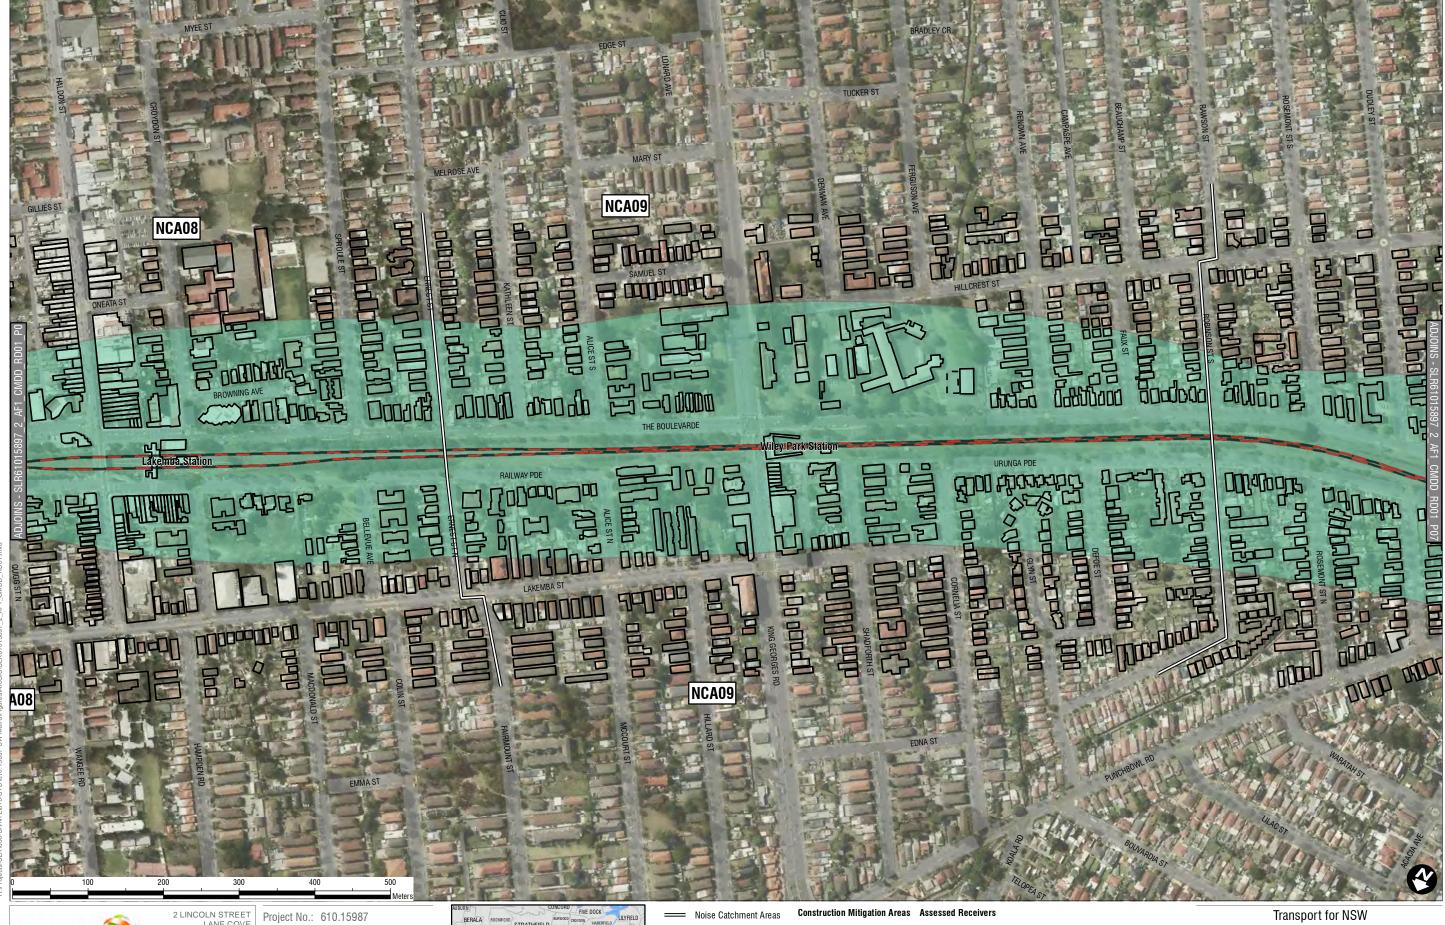
Page 6 of 8

**Construction Mitigation Daytime (Indicative)**

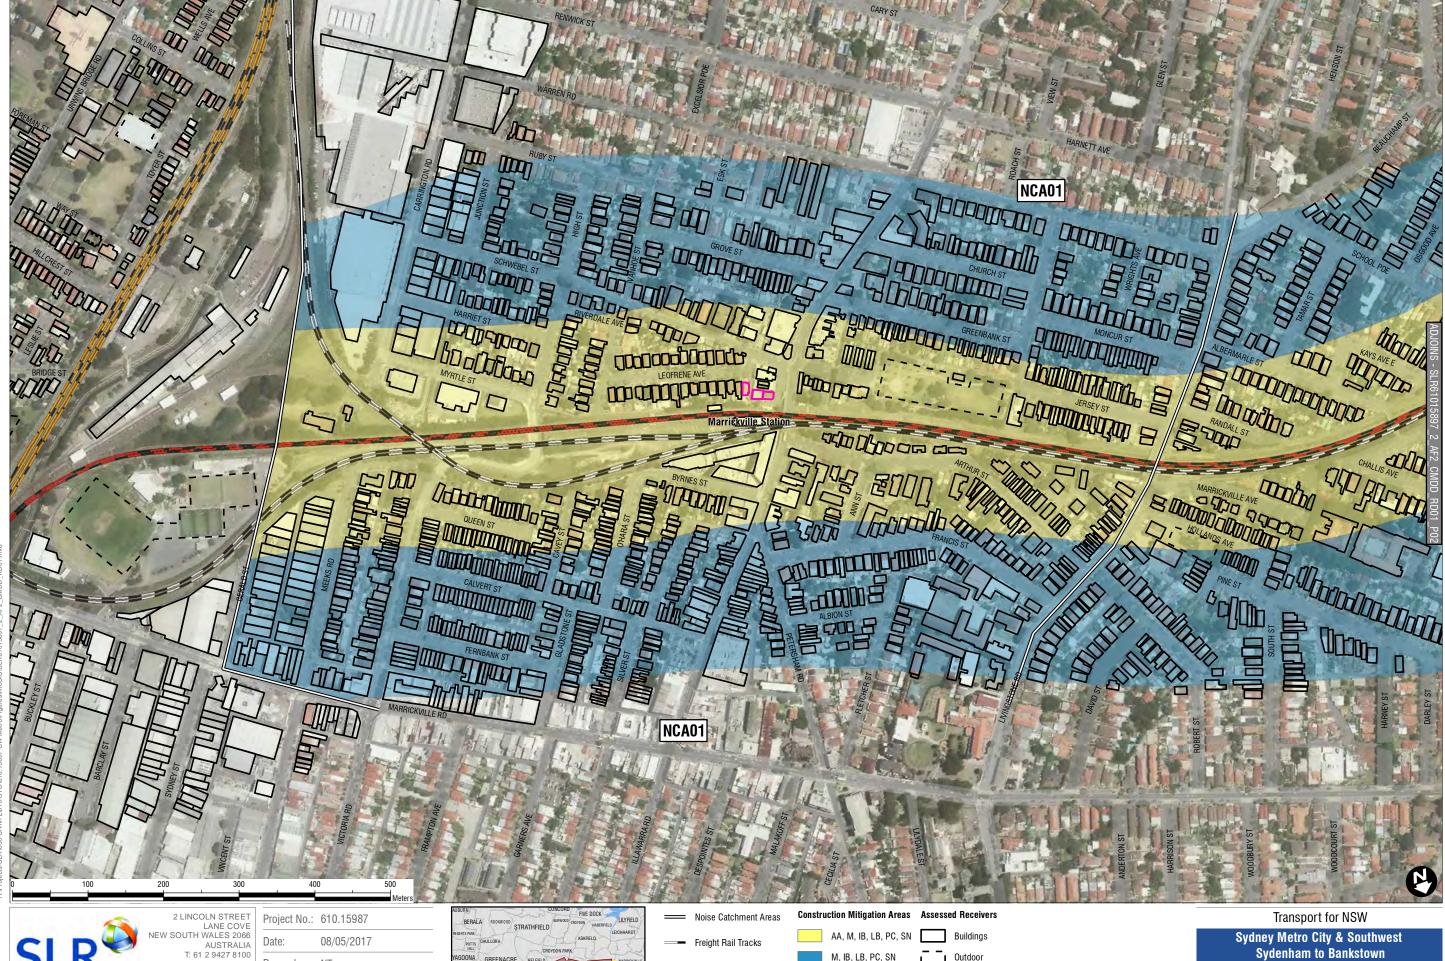
Page 1 of 8

Construction Additional Mitigation - Construction Mitigation Night-time (Indicative)

\*Construction mitigation areas are indicative SLR61015897 2 AF2 CMDD RD01 P01 \*The two most stringent mitigation categories have been shown only.

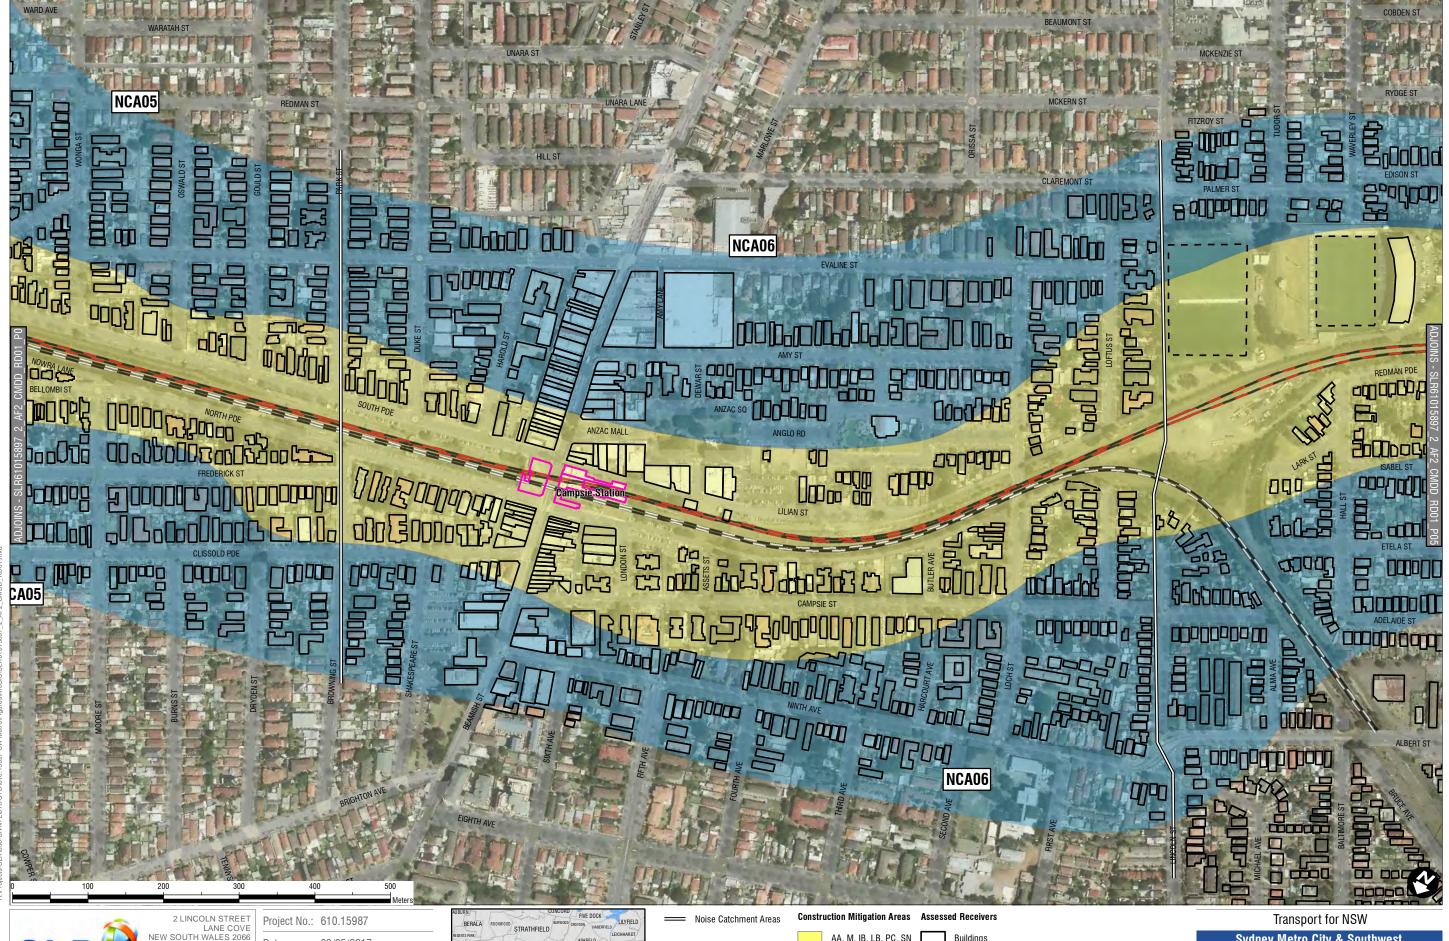
Page 4 of 8

**Construction Mitigation** Night-time (Indicative)

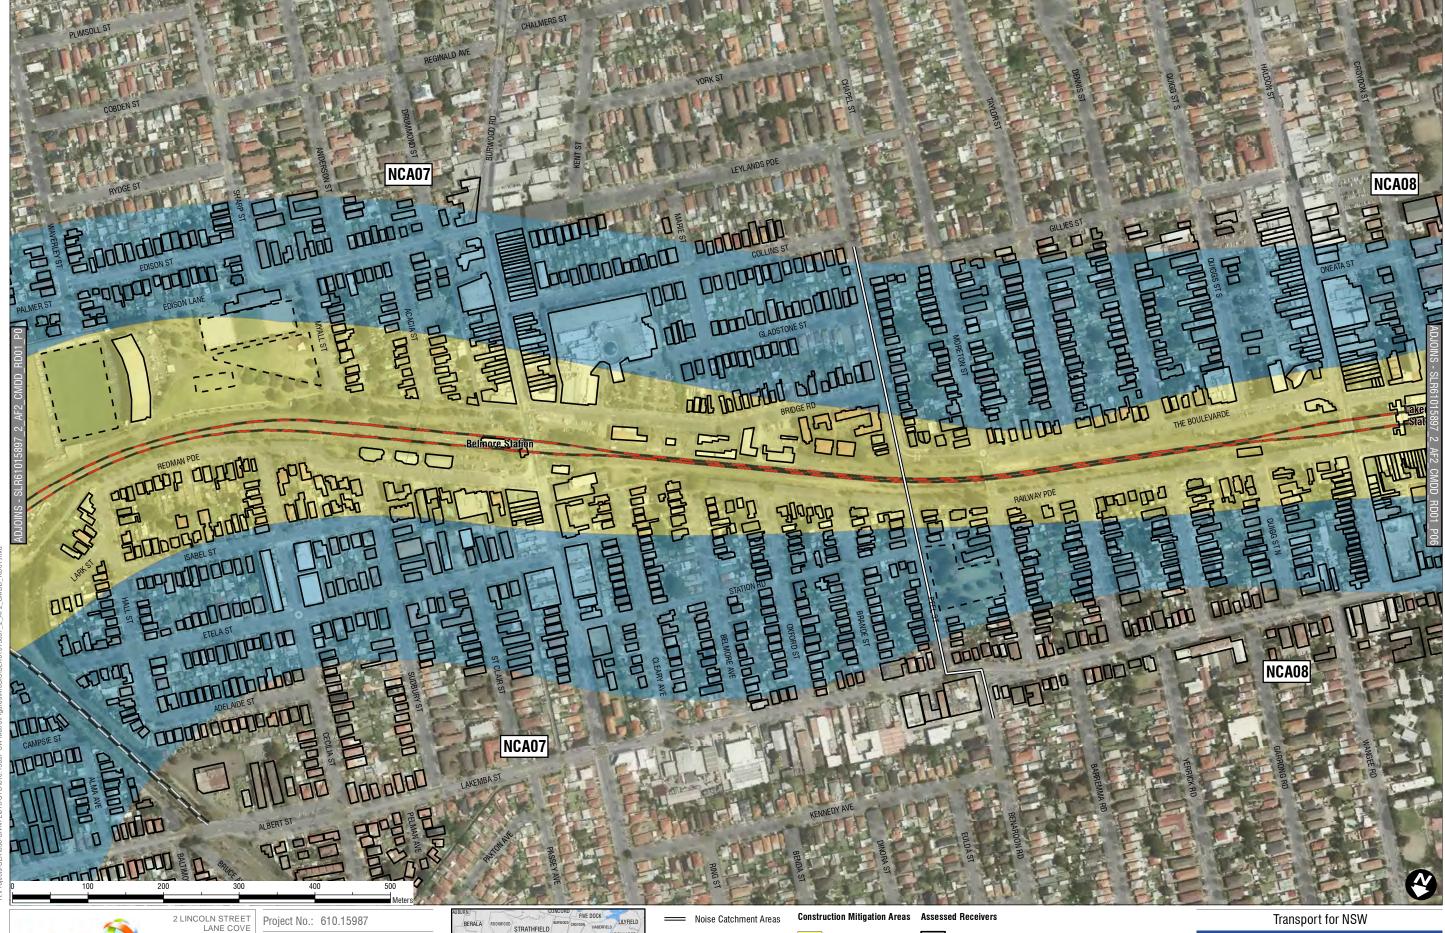
Page 5 of 8

**Construction Mitigation** Night-time (Indicative)

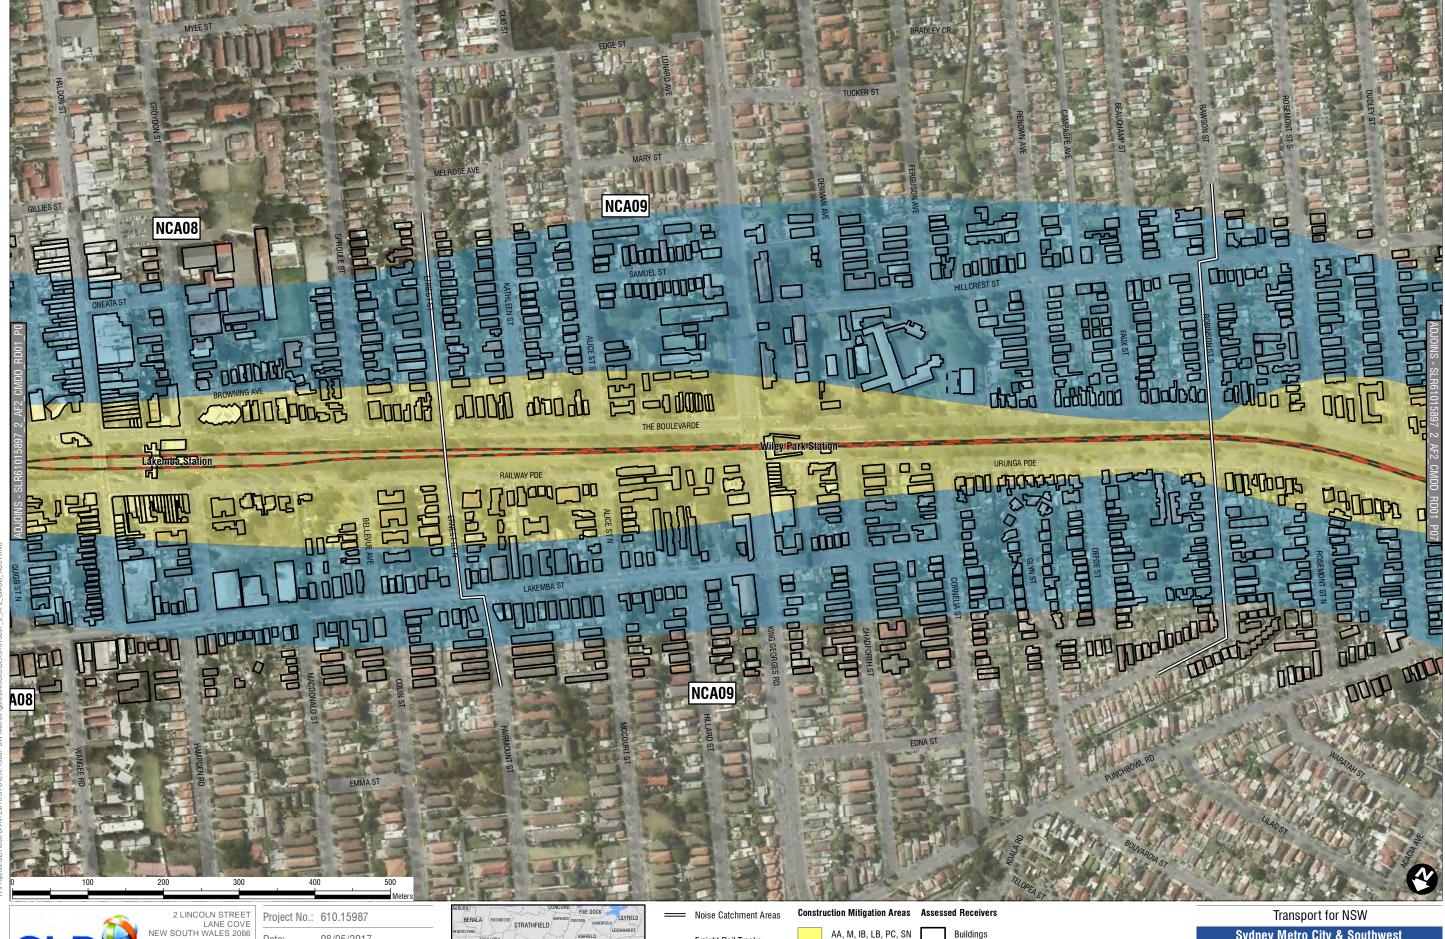
Page 6 of 8

**Construction Mitigation** Night-time (Indicative)
